Department of Civil Engineering

Critical Literature Review on Concrete Crack Repairs

Dissertation presented for the Degree of Master of Engineering in Civil Infrastructure

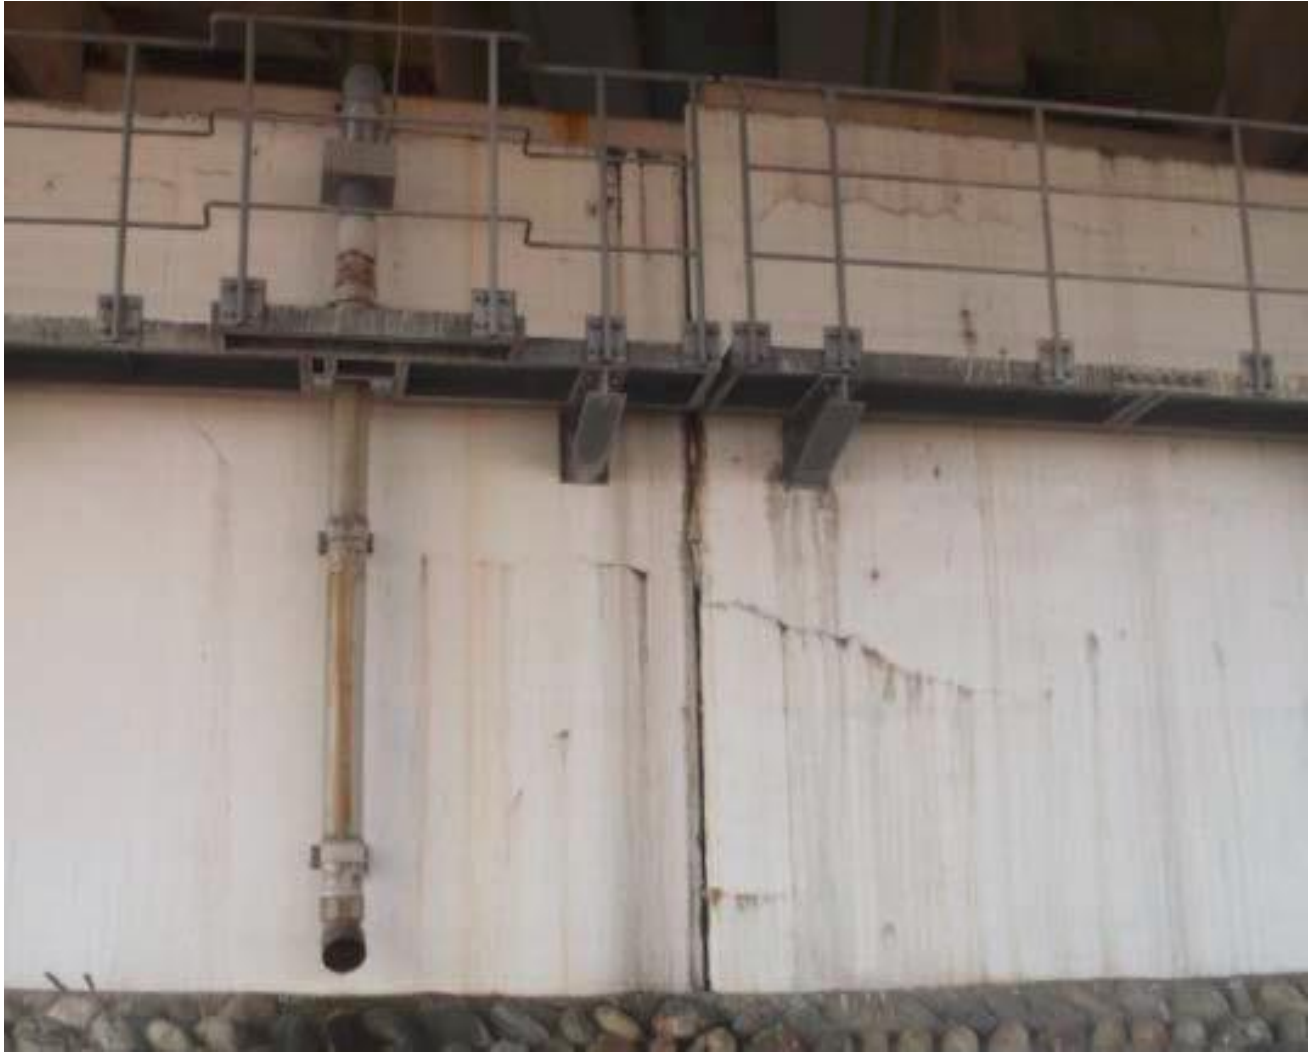
During 1995, the structure shown on Figure 28 above was repaired through surface treatment using sodium silicate. A few years later, cracks had occurred as indicated on Figure 29 below.

Figure 29: Cracks occurred on the repaired structure (Nomura et.al, 2012)

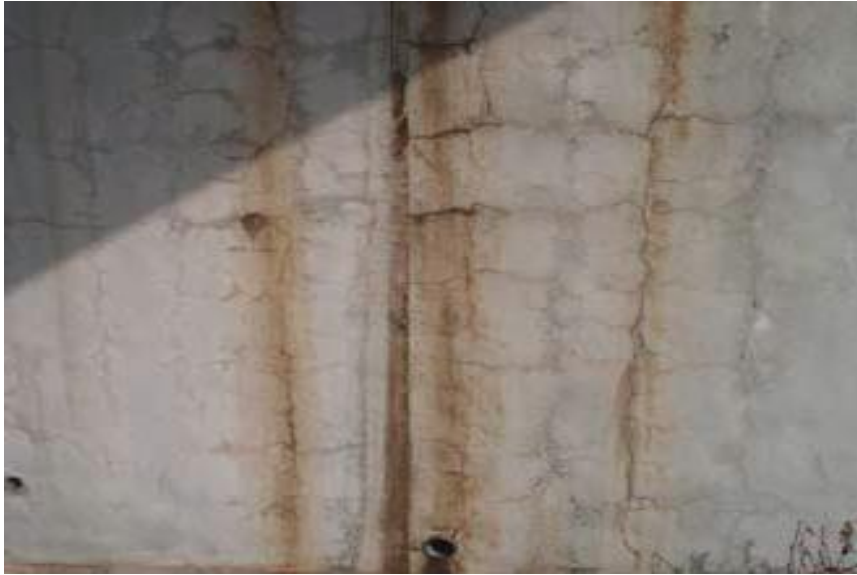
Patch repairs using polymer cement were executed after the removal of the concrete cover. The polymer mortars used contained about 1.5 to 2% short fibers in order to avoid cracking of the material. It was discovered that ASR continued after the repairs and cracks with a width less than 0.2 mm had reoccurred as indicated on Figure 30 below (Nomura et.al, 2012).

Figure 30: Cracks occurred on the patch repair in structure F (Nomura, et.al, 2012)

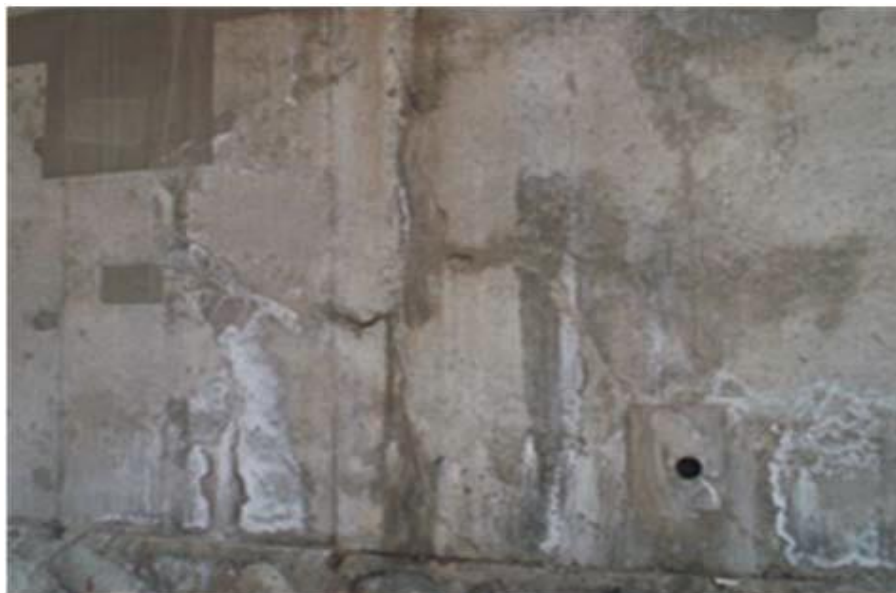
After the removal of the concrete cover, concrete jacketing was done in some structures after placing the reinforcement steel. Crack prevention was achieved through the use of short fibers in the proportion of 0.5% of cement, expansive agents and superplasticiser added as an admixture (Nomura et.al, 2012: 16).

Figure 31: Cracks occurred on the patch repair structure H (Nomura, et.al, 2012)

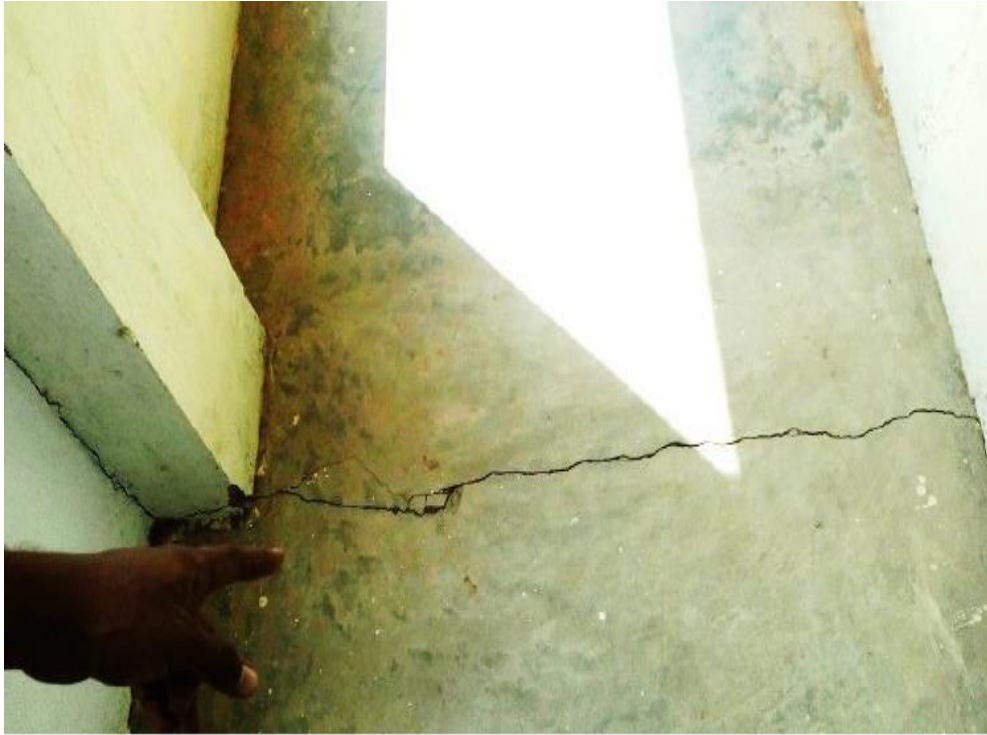
Figure 32: Drying shrinkage cracks within the parking structure (Sika, 2016)

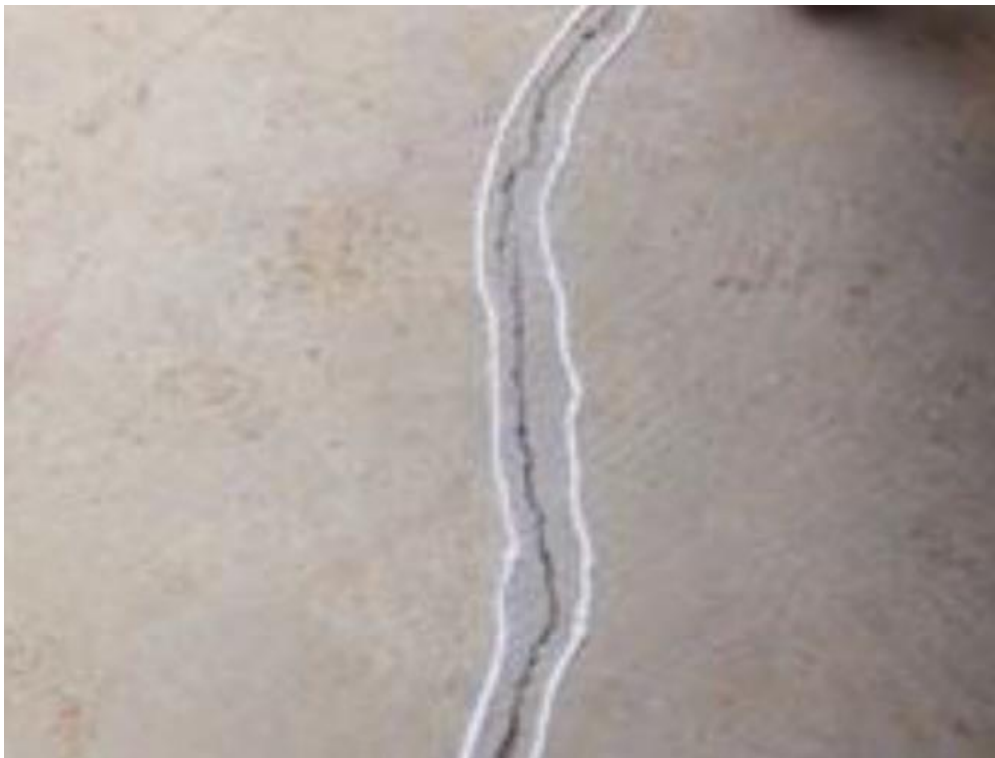
The Sika's repair and management system was essential due the rapid setting characteristics of the products. The Sika Rapid Repair Mortar which is a one component, rapid curing cementitious repair mortar was used to repair all the shrinkage cracking on the surface of the concrete parking floors. The Sika FerroGard-903+ was used to eliminate the risk of reinforcement steel corrosion. This product is a multi-functional liquid corrosion inhibitor and was applied to the chloride contaminated decks. These products have been tested and they do comply with the requirements of Class R4 of BS EN 1504-3. In order to restore the smooth finish of the parking floors, the Sika floor –EB 24 surface resin based finish was applied as shown on Figure 33 below. The repair works were completed within a two months period.

Figure 33: Shrinkage crack repair using dry packing (Sika, 2016)

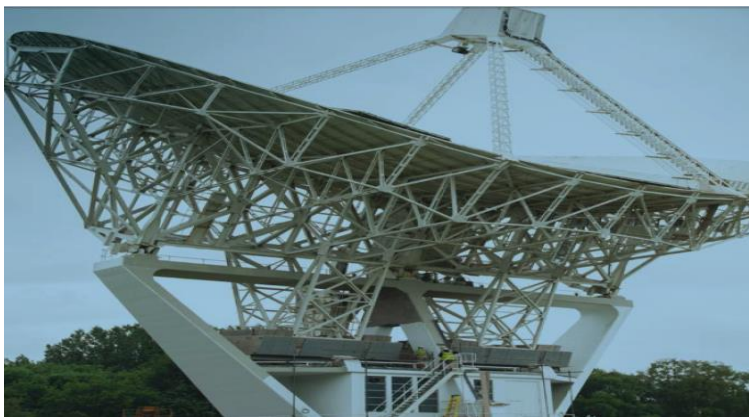
Figure 34: Mark 11 telescope supported by a concrete structure in Cheshire (Sika, 2016)

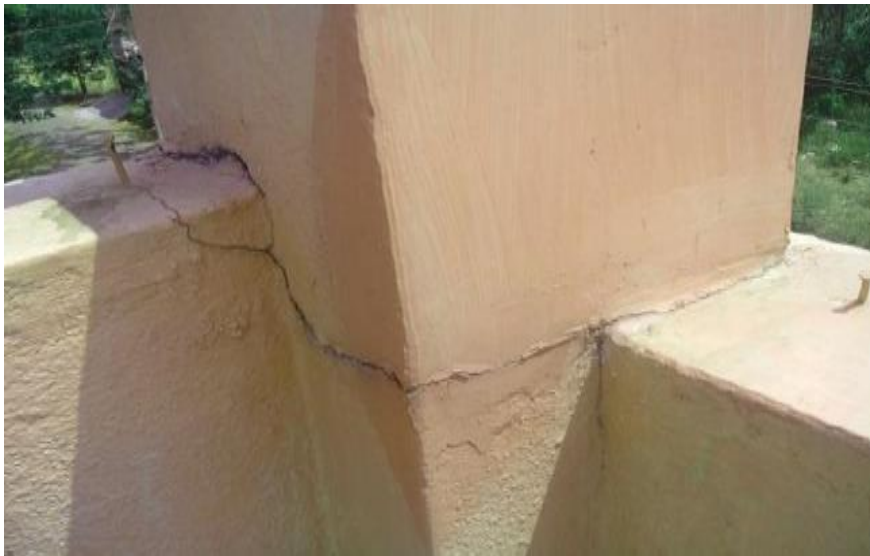
The development of these cracks led to the penetration of deleterious substances resulting in the development of steel reinforcement corrosion. The steel reinforcement bars used were predominantly the 16 mm diameter bars and the concrete strength being 30 MPa with a cover to reinforcement of 25 mm. However, the investigations were not conclusive and it was believed that there are other factors which could have facilitated the development of cracks such as overloading, incorrect design and poor construction workmanship. The cracks needed repairs as they created the seepage of water from the underground to the basement area and would also allow further penetration of deleterious substances to the steel reinforcement bars resulting in corrosion (Trout, 2006). Repairs were done starting from 1999 to 2005 whilst close monitoring was done on the effectiveness of the repairs.

Figure 35: Structural cracks starting to appear due to accidental loading (Trout, 2006)
