# **STRESS CORROSION CRACKING OF NUCLEAR GRADE STEELS.**

**A thesis submitted to the Faculty of Engineering, University of Cape Town,  
in fulfilment of the degree of Master of Science in Engineering.**

**Department of Materials Engineering  
University of Cape Town**

**December 1992**

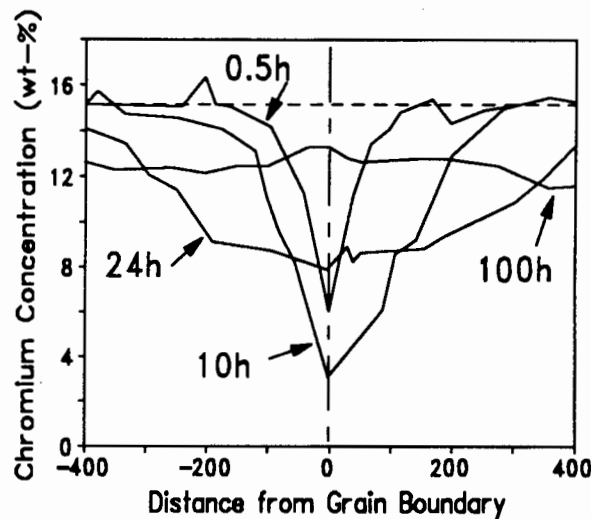
**Figure 2** Variation in grain boundary Cr depletion in Ni-14.7Cr-7Fe-0.03C alloy annealed for 20 mins at 1100°C and aged at 700°C for the times shown. (After Sedriks (20))

The kinetics of sensitization are diffusion controlled and are therefore temperature and time dependent. In this process the diffusion of chromium to the grain boundary leaves the metal adjacent to the grain boundary denuded of chromium, thus establishing a chromium concentration gradient between the interior and exterior of the grains. If the metal is held at elevated temperatures for longer times, chromium from the grain interiors will diffuse down this concentration gradient into the depleted regions (12) thus levelling out the concentration gradient. This will eventually lead to a situation where the grain interiors have a lower bulk chromium content but no isolated regions which are unacceptably depleted of chromium. This process is called healing and is illustrated in fig. 2.

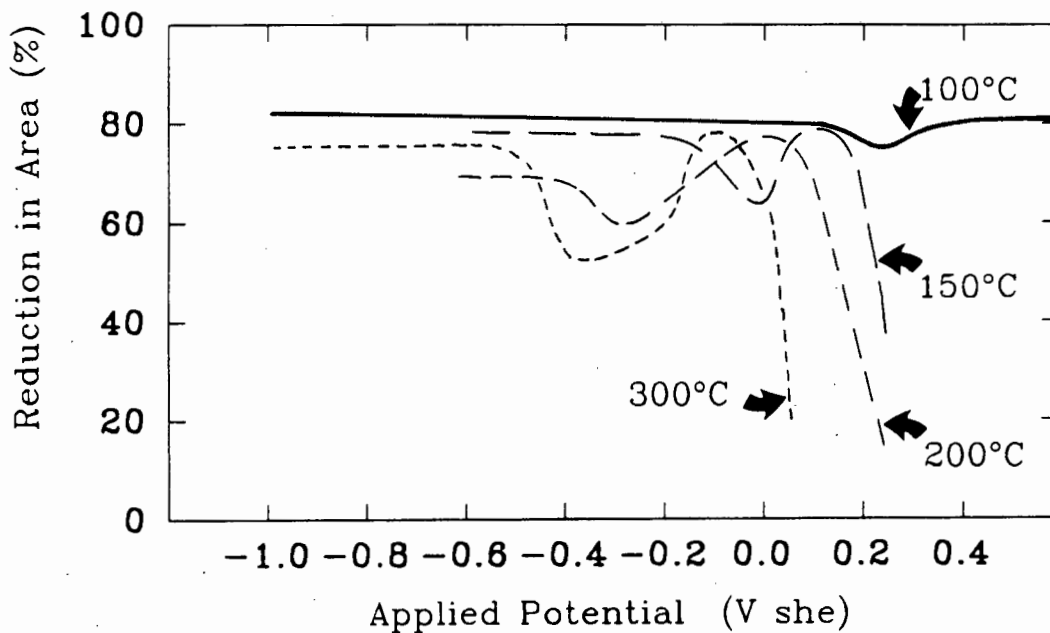
**Figure 11** The effect of temperature on the stress corrosion cracking of 316L in PWR water. (After Congleton *et al* <sup>(65)</sup>).

In subsequent work <sup>(65)</sup> the effect of temperature was investigated. Figure 11 summarizes the findings of this study. The results indicate that for the clean 316L which they studied the chances of stress corrosion cracking occurring at temperatures below 100°C are remote because the oxide layer which forms at these temperatures is thin and ductile. Fracture of the thicker layer which forms at higher temperatures is responsible for initiating the stress corrosion cracking found under these conditions.

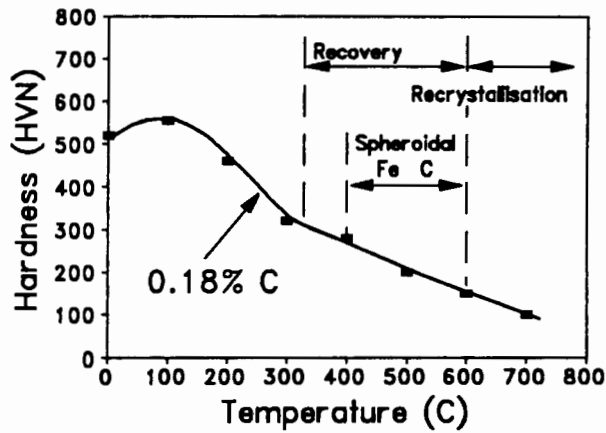
**Figure 14** Hardness of martensitic steel when tempered for 1 hour at a range of temperatures. (After Honeycombe (72))

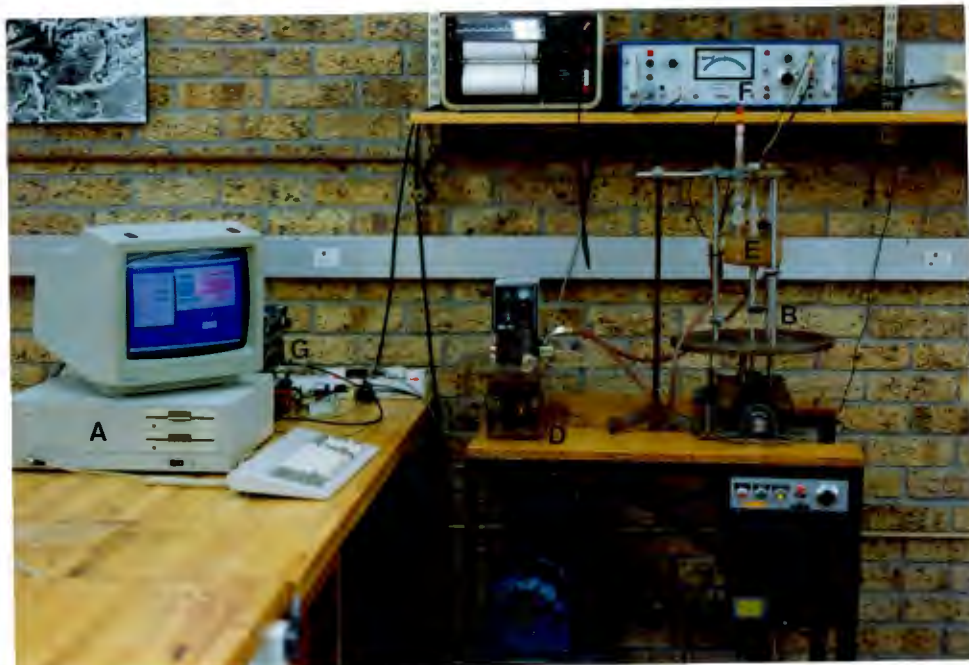
**Figure 18** Photograph of the slow strain rate rig used in this investigation. A. Computer used for data capture; B. Load frame; C. electric motor; D. Water bath; E. Test cell; F. Potentiostat; G. Control electronics.

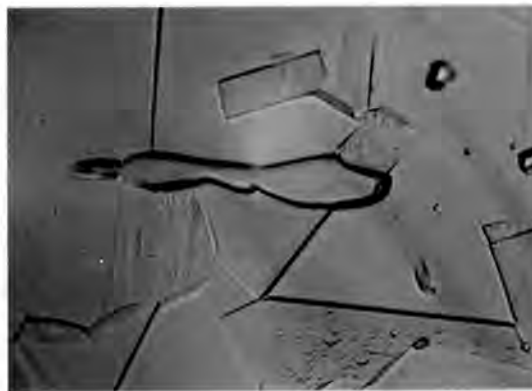
**Figure 31** Microstructure of the 316NG material after sensitizing at 650°C for 24 hours. Etched in 10% oxalic acid solution in accordance with ASTM 262 – A.
