**THE BEHAVIOUR OF PATCH REPAIRED AND FRP
STRENGTHENED REINFORCED CONCRETE BEAMS: AN EX-
PERIMENTAL INVESTIGATION**

**THIS THESIS HAS BEEN SUBMITTED TO THE DEPARTMENT OF CIVIL ENGINEERING, FAC-
ULTY OF ENGINEERING AND BUILT ENVIRONMENT, UNIVERSITY OF CAPE TOWN, IN PAR-
TIAL FULLFILLMENT OF THE REQUIREMENTS FOR AN MSc DEGREE IN CIVIL ENGINEER-
ING**

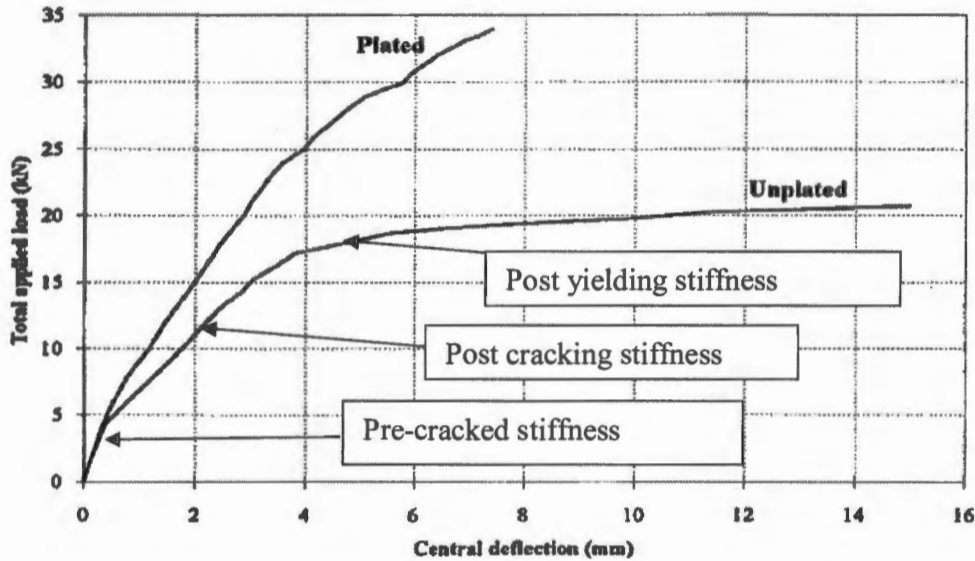
Figure 2.5: Comparison of typical load/deflection response of control beam and a strengthened beam (Hollaway, 1999)

The load deflection graphs of an un-strengthened (Unplated) reinforced concrete beam and a strengthened (plated) beam are shown in Figure 2.5 (Hollaway et al., 1999). The beams were tested under four point loading. The load-deflection curves of the beams exhibit 3 regions of behaviour where the stiffness changes as shown below in Figure 2.5 (Hollaway et al., 1999)

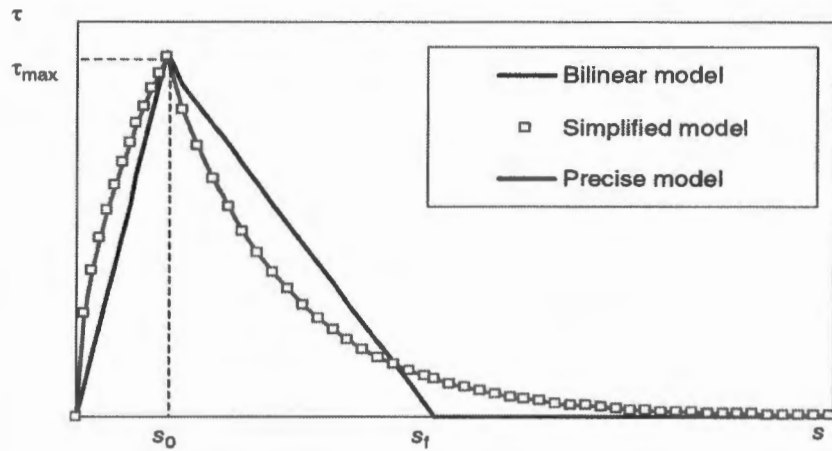
Figure 2.9: Bond slip model by Lu et al. (2005) as described by Hollaway and Teng (2008)

Hollaway and Teng (2008) mentions that for a simply supported beam the magnitude of interfacial stresses, in the region between the support and plate end, greatly depends on the elastic modulus and thickness of FRP and adhesive layer. In order to understand debonding behaviour Hollaway and Teng (2008) mention that knowledge on bond behaviour is required between the FRP plate and the concrete substrate. Simple pull-off tests and finite element modelling (FEM) have been used by various researchers in the attempt of understanding bond behaviour. Good bond slip models (Figure 2.9) have been proposed by Lu et al. (2005) for modelling purposes in search of bond strength cognizance.

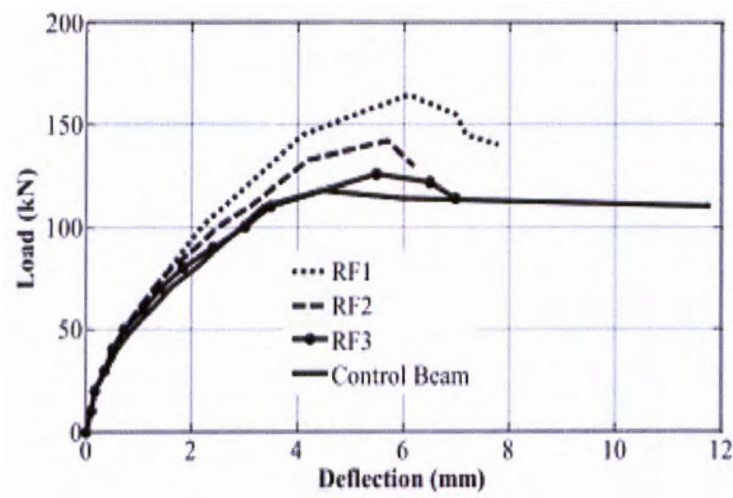
Figure 2.11: Comparison between the mean load-deflection curves for the retrofitted beams and the control beam (Obaidat et al., 2011)

beam became. The longer CFRP strips provided more anchorage outside the maximum moment region.

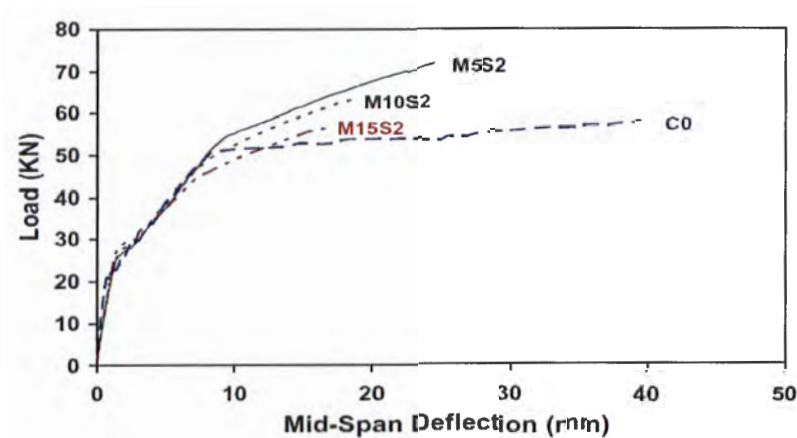
Figure 2.14: Load-deflection curve of the strengthened corroded beams and a control beam (Al-Saidy et al., 2010)

In another study by Al-Saidy et al. (2010) it was shown that strengthened beams M5S2, M10S2 and M15S2, with different corrosion levels but the same strengthening scheme, were able to recover the original strength of the control beams with the exception of M15S2, refer to Figure 2.14 below.

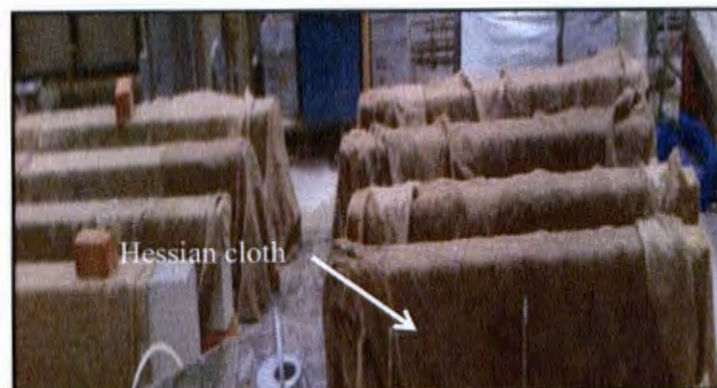
Figure 3.8: Beams being cured by covering with hessian cloth

Once polystyrene had been installed on all 12 damaged beams, 25mm cover blocks were attached to the sides of reinforcement cages at strategic points so as to maintain constant cover around the beams. The beams were kept in the steel mould for 7 days to ensure that enough strength had been gained for stripping. A damp hessian cloth was used to cover the exposed portion of the beams while they were in the mould. After stripping was performed the beams were stored upside down at the back of the laboratory and wrapped in a moist hessian cloth, as shown in Figure 3.8 and Figure 3.9. The hessian cloth was kept damp by a watering can which was applied to all the beams every morning up to 28 days.

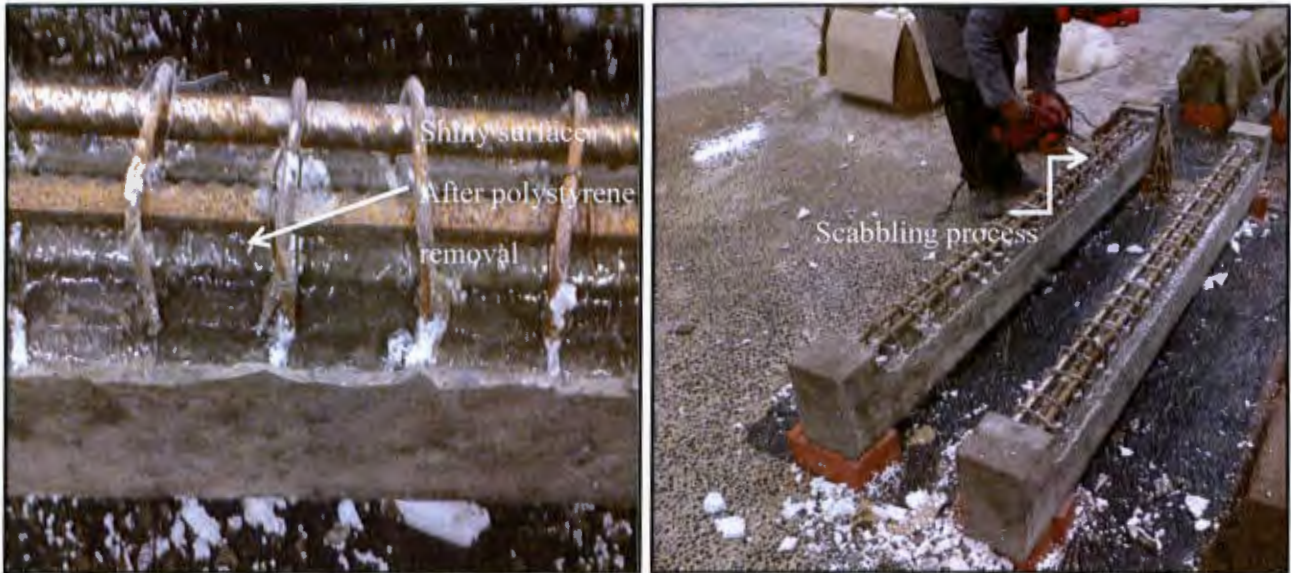
Figure 3.10 Concrete surface after the removal of polystyrene (left) and surface preparation by the scabbling process (right)

The surface of the concrete that was in contact with polystyrene had a smooth shiny surface after the removal of the polystyrene (Figure 3.10). The smooth surface was roughened through the process of scabbling. The roughened surface, refer to Figure 3.11, was such that the aggregates were exposed.

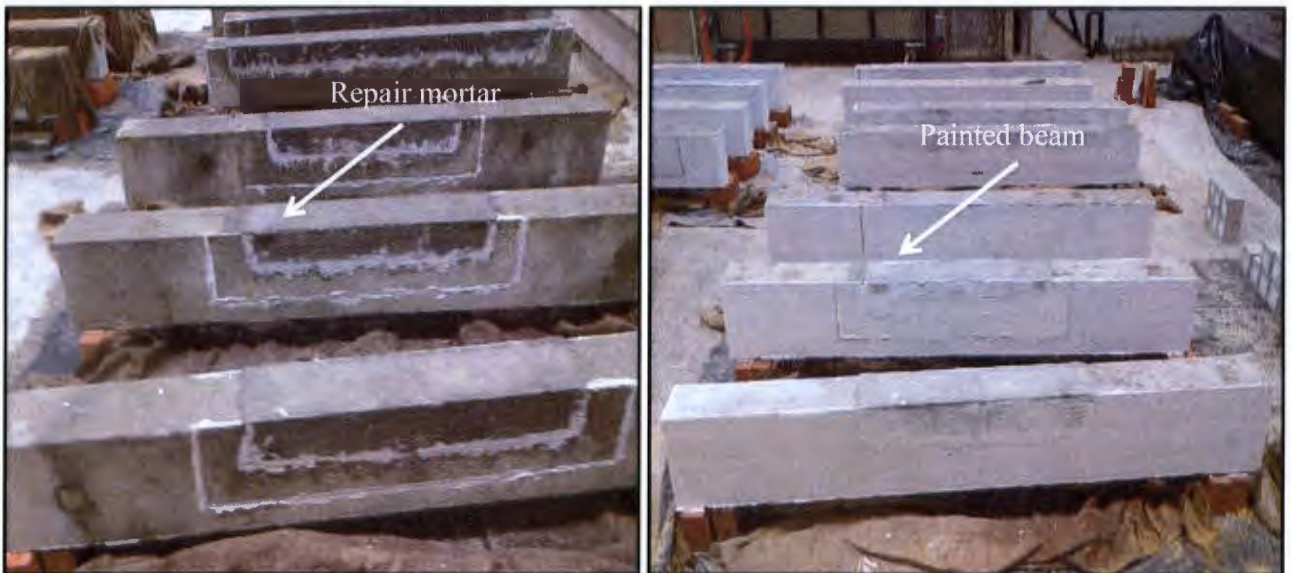
Figure 3.13: Beams after 28days (left) and beams after being painted white (right)

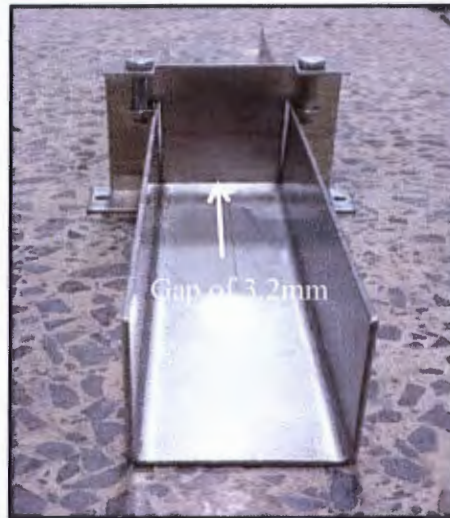
Figure 3.14: The applicator used to apply a constant epoxy adhesive thickness

made for the application of constant epoxy thickness (as shown in Figure 3.14). The CFRP strip used on all strengthened beams were identical in size, 50mm wide x 1.2mm thick and were bonded at the centre of the beam soffit over a length of 1700mm, as shown in Figure 3.15 below.

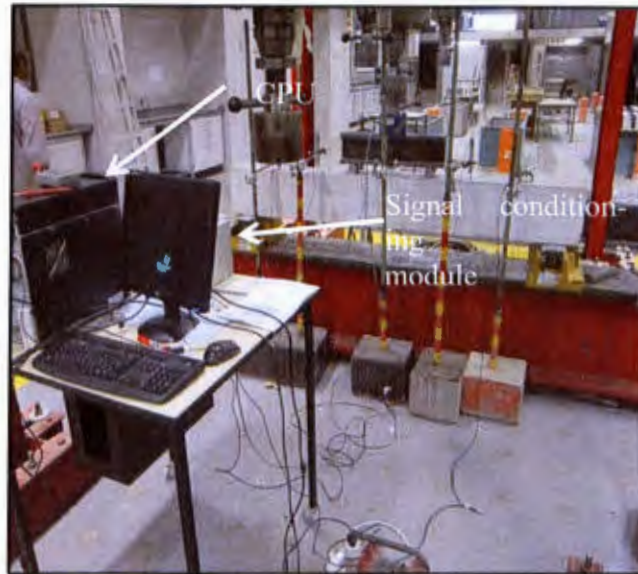
Figure 3.18: Electronic setup for the load and deflection measurements

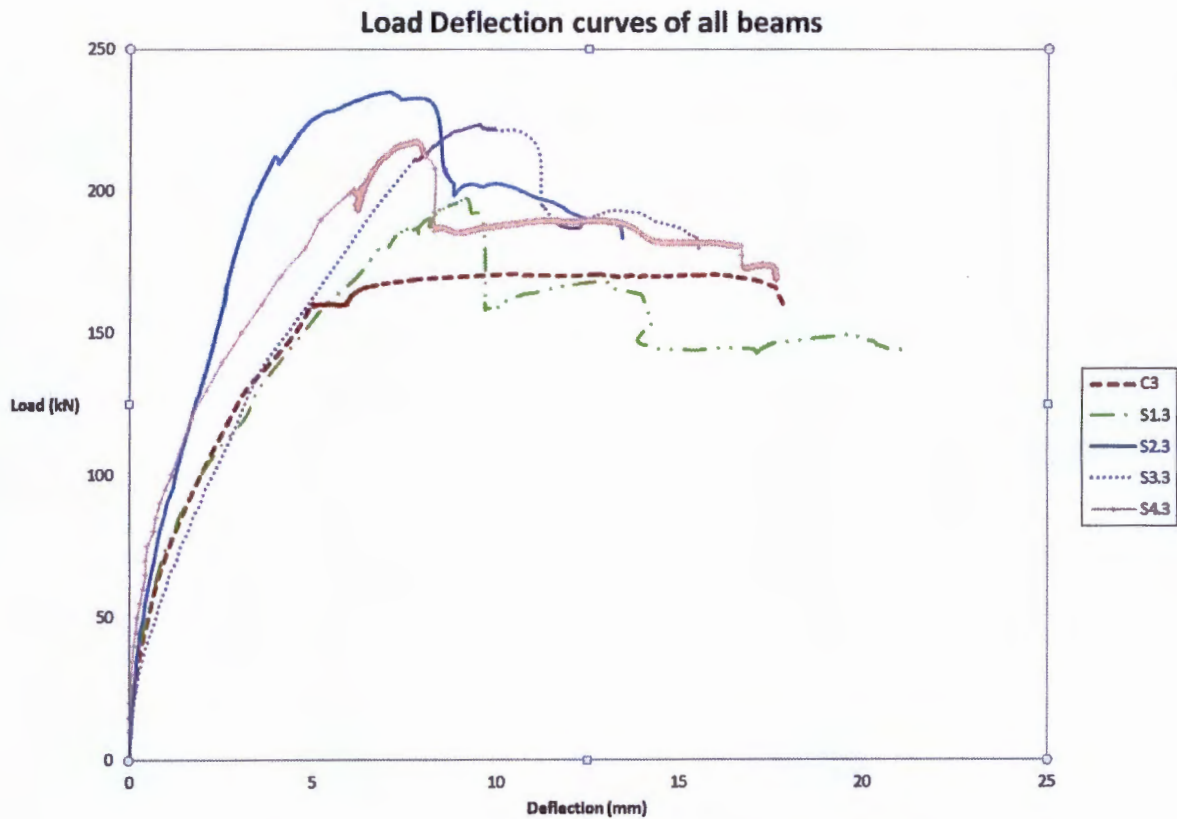
Figure 4.21: Load- deflection of one beam from each set

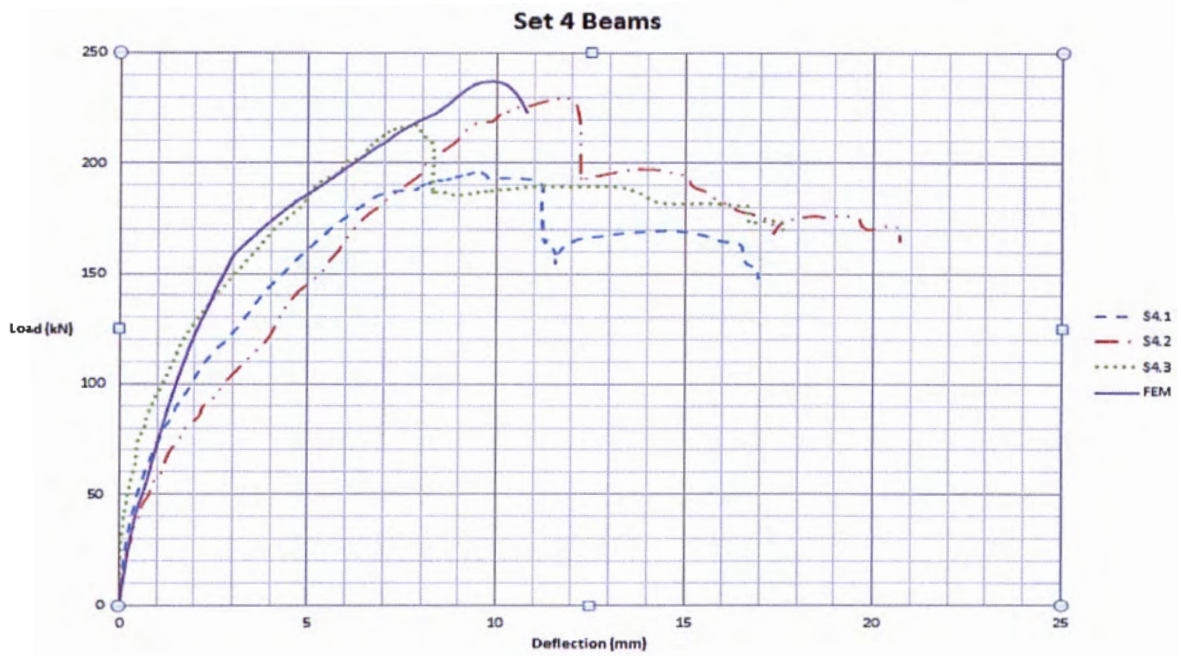
Figure 4.24: Load-deflection behaviour of RS beams S4.1, S4.2, S4.3 and FEM

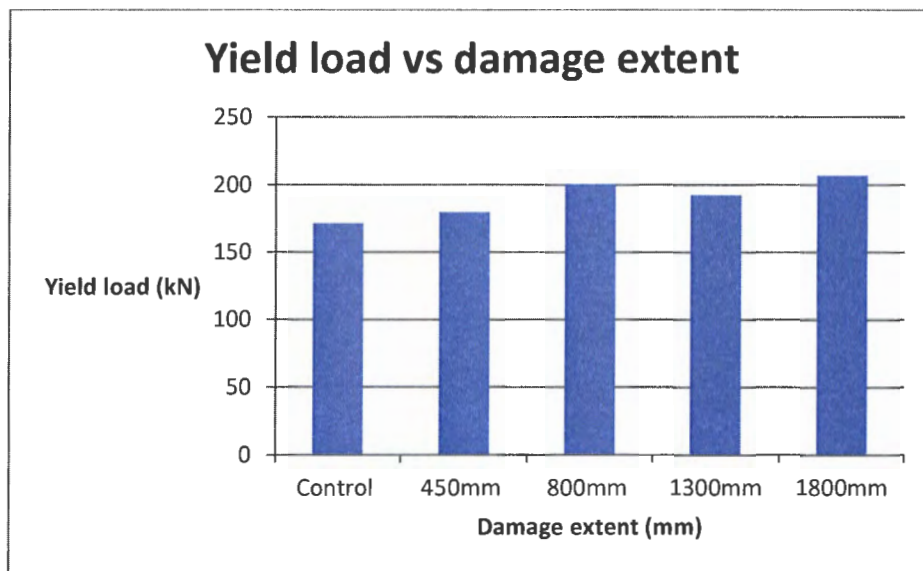
Figure 4.27: Average yield load results for the different groups of beams
