**UNIVERSITY OF CAPE TOWN**

**MSc. Dissertation**

**The Performance Assessment of Patch Repaired and CFRP  
Strengthened RC T-beams under Transverse Impact Loading**

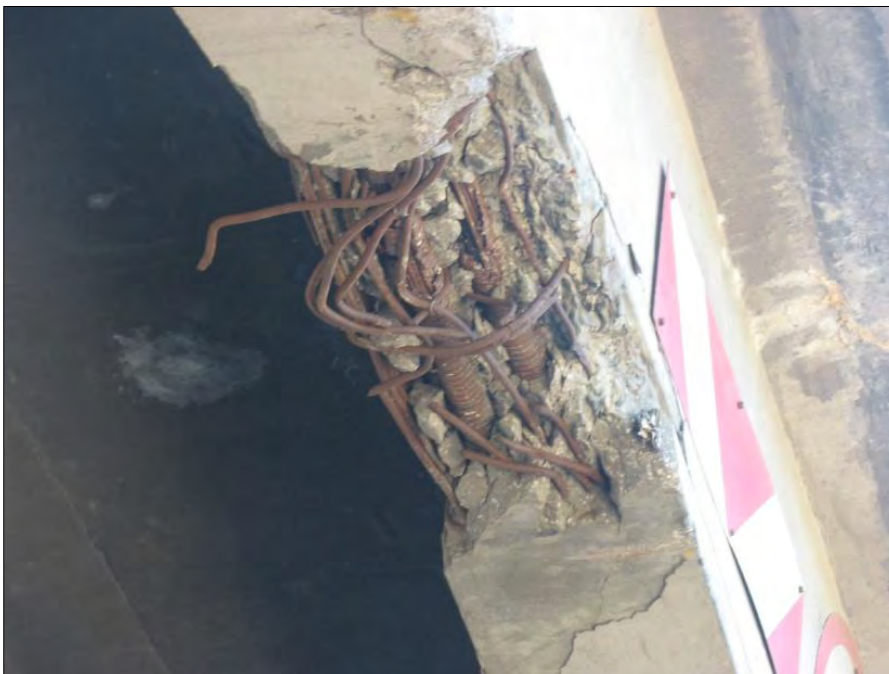
*Figure 1: Bridge beam damaged as a result of transverse vehicular impact (SMEC, 2007)*

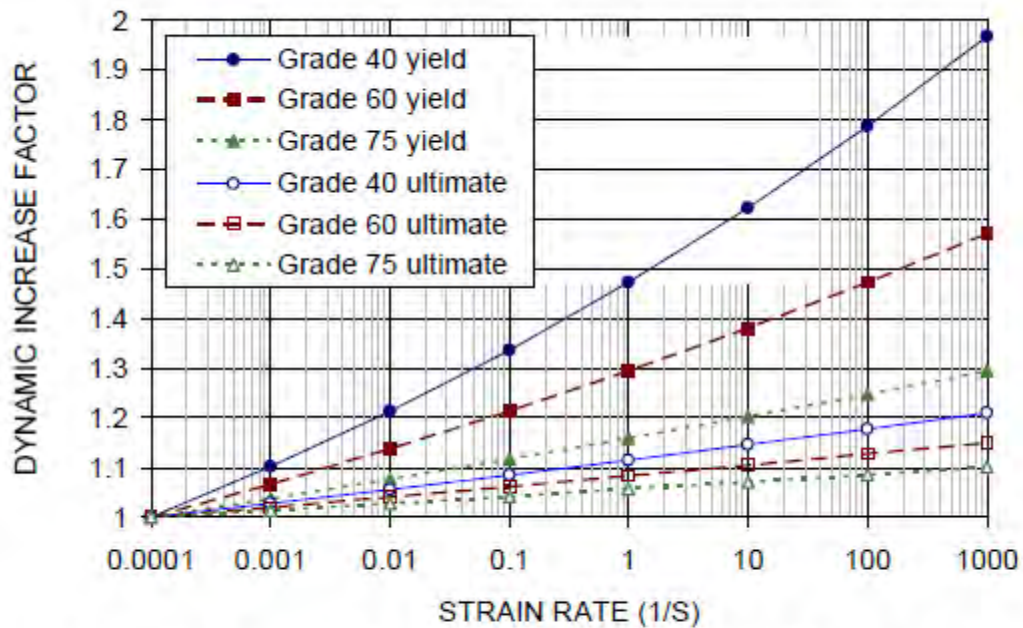
Figure 4: Proposed DIF for ASTM Grade, 40, 60 and 75 steel rebar (Assuming yield stresses of 48, 69 and 87 ksi respectively), (Cusatis, 2011)

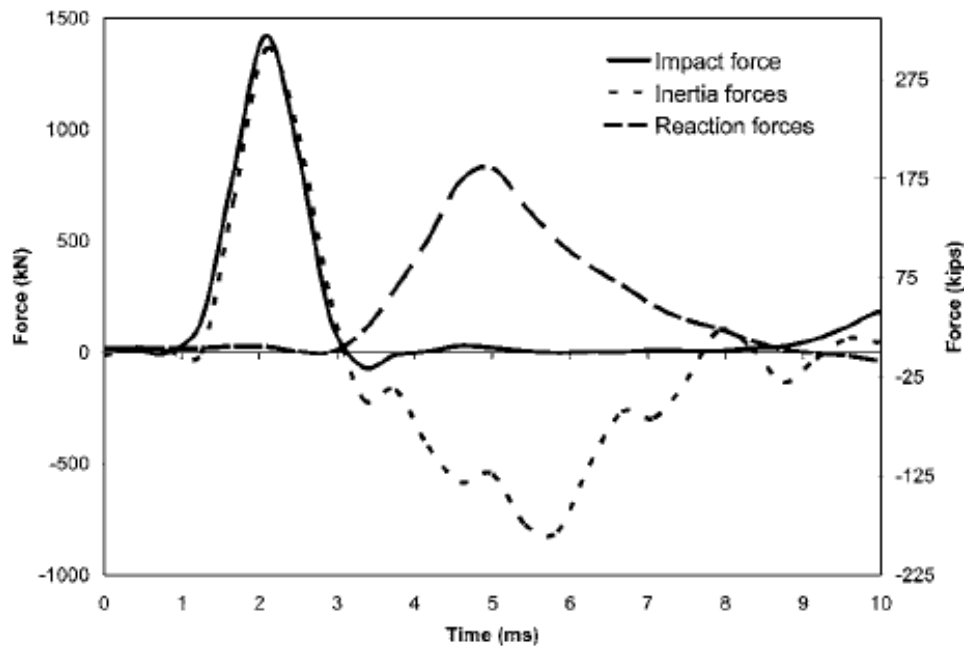
clear that the impact force is immediately resisted by the development of the inertia force. As the impact force is imparted to the beam, the stress wave generated by the impact eventually reaches the reactions at which stage a negative inertia force is generated to ensure dynamic equilibrium. The time taken for the stress wave to reach the supports is dependent on the span of the beam as well as the beam cross-sectional dimensions.

Figure 7: Experimental data depicting impact force, inertia force and reaction force responses (Saatci and Vecchio, 2009)

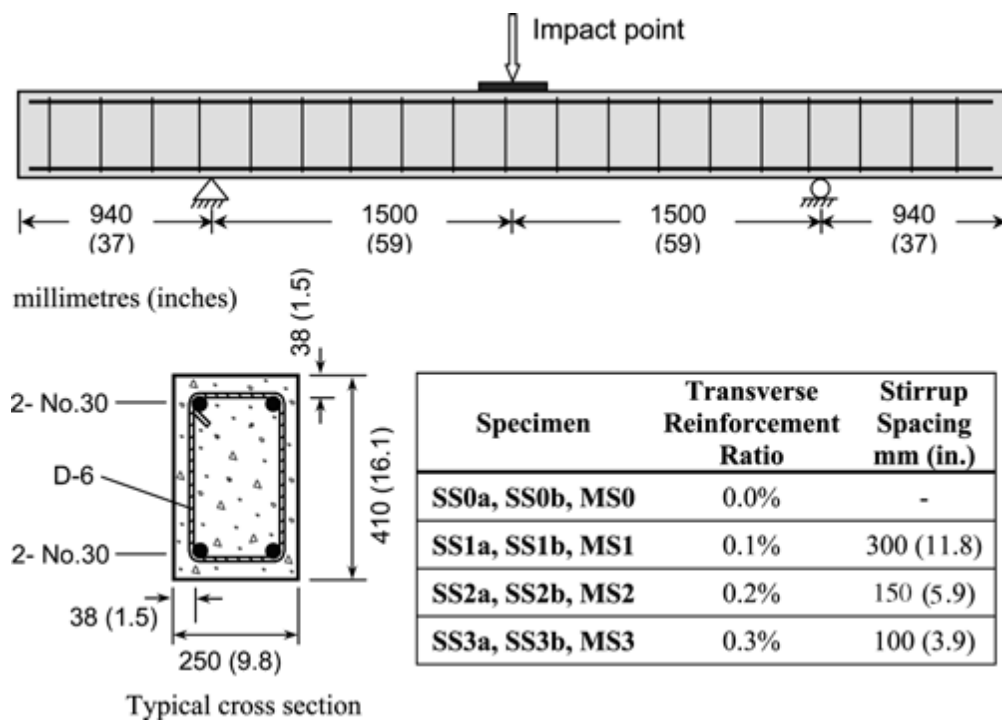
Saatci and Vecchio (2009) conducted static loading tests and drop hammer impact loading tests on a total of 12 RC beams. Eight (8) of the beams were subjected to drop hammer impact at their midspans, whilst the remaining 4 beams were subjected to static loading. All of the specimens had identical longitudinal reinforcement, but varying shear reinforcement ratios. The primary aim of the study was therefore to investigate the effects of shear capacity on impact behaviour. A total of 20 impact tests were conducted with multiple impact tests conducted on some of the beams. Figure 9 illustrates the beam dimensions and the reinforcement layout.

Figure 9: Specimen details (Saatci and Vecchio, 2009)

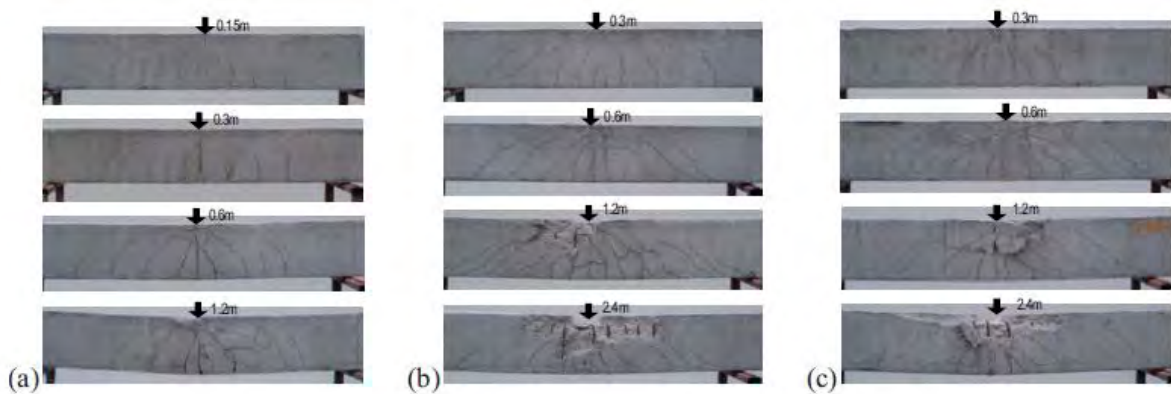
Figure 17: Damage observed in various specimen groups: a) S1616, b) S1322, c) S2222 (Fujikake et al, 2009)

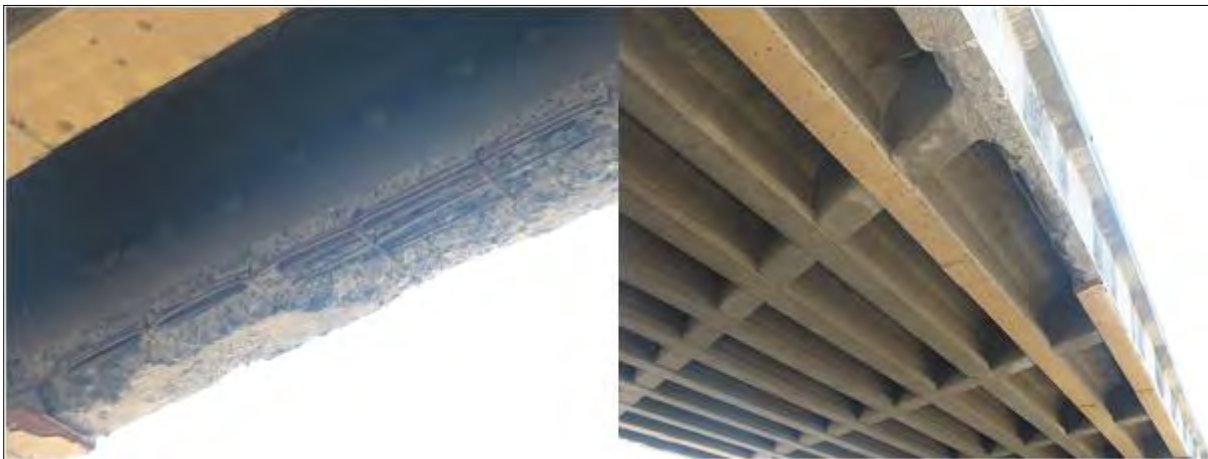
*Figure 19: Bridge beam damaged due to transverse vehicular impact (SMEC, 2007)*

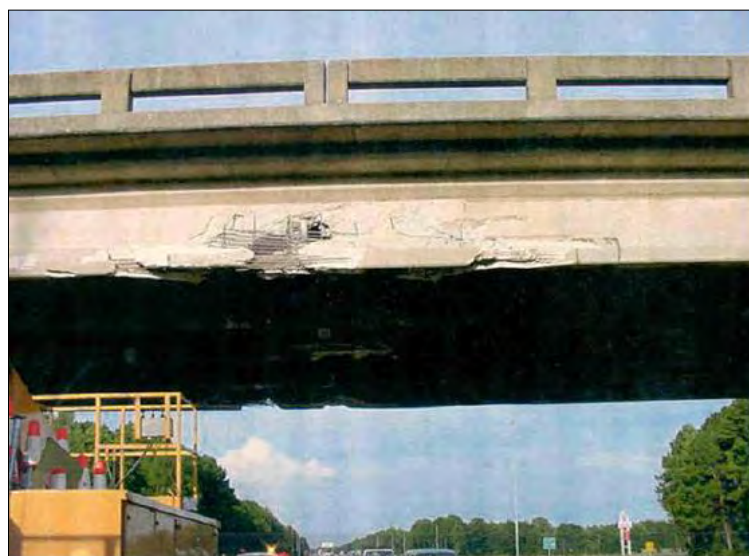
*Figure 20: Severely impact damaged bridge beam (Chhabra, 2014)*

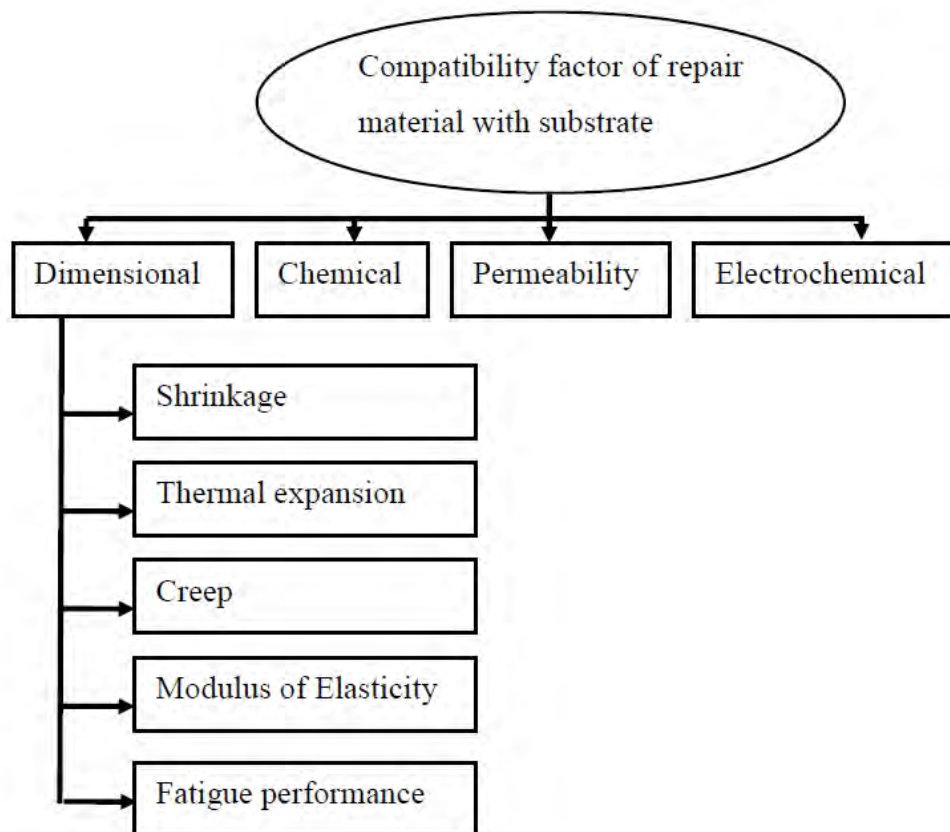
Figure 22: Compatibility factors between repair material and substrate ( Vaysburd, 2006)

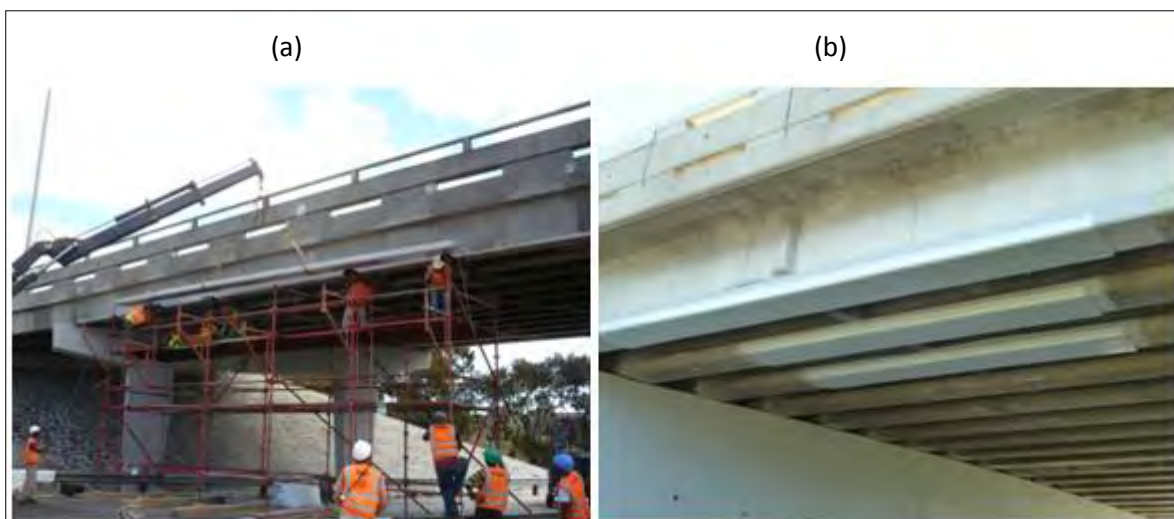
Externally epoxy-bonded steel plates have traditionally been used as a means of enhancing the flexural strength, load carrying capacity and stiffness of under-designed or damaged concrete bridge structures (Beushausen, 2009). Although this is an established and relatively simple method of strengthening there are certain deficiencies related to application difficulties and long term durability. Steel plates are generally heavy and bulky and therefore pose problems in transport, delivery and handling. Application requires the use of scaffolding and expensive auxiliary bolting to support the self weight of the plates during the curing process (Ryall, 2010). Additionally the steel plates are susceptible to corrosion damage which could result in bond deterioration at the steel-concrete interface (Bakis et al, 2002). Figure 23 shows steel plates externally bonded to damaged bridge beams.

*Figure 23: Damaged bridge beams strengthened using externally bonded steel plates a) scaffolding required for placement b) after completion (SMEC, 2007)*

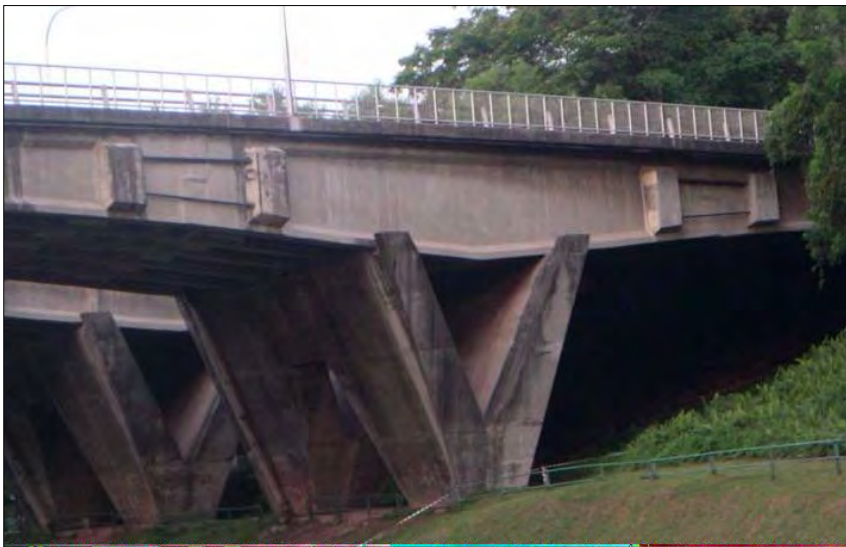
External post-tensioning is a more specialized method utilized for the strengthening of bridge beams, decks or girders. This method is effective in increasing both flexural and shear strength, and is usually utilized to compensate for prestress losses or deficiencies. However, the primary purpose of this procedure is to restore serviceability by relieving dead-load bending effects resulting in reduced deflections and cracking (Ryall, 2010).

*Figure 24: External post tensioning use (Chhabra, 2014)*

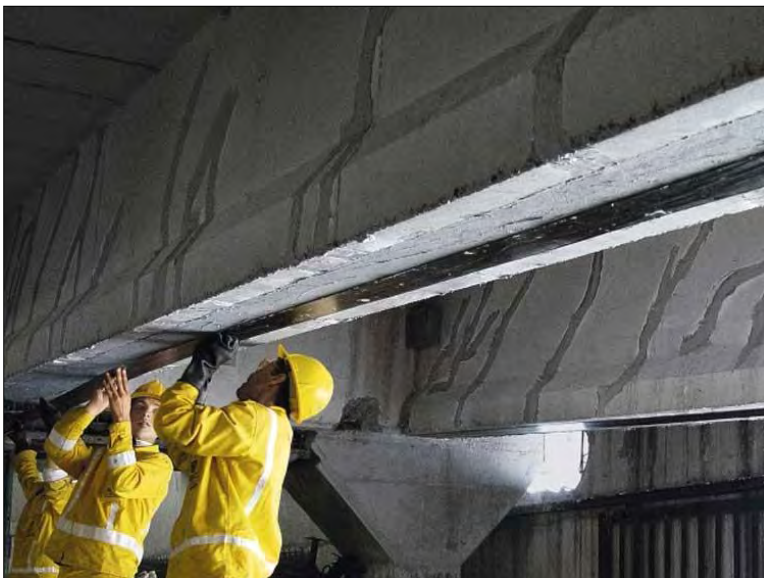
*Figure 26: Externally bonded CFRP plate system (Structural strengthening, n.d.)*

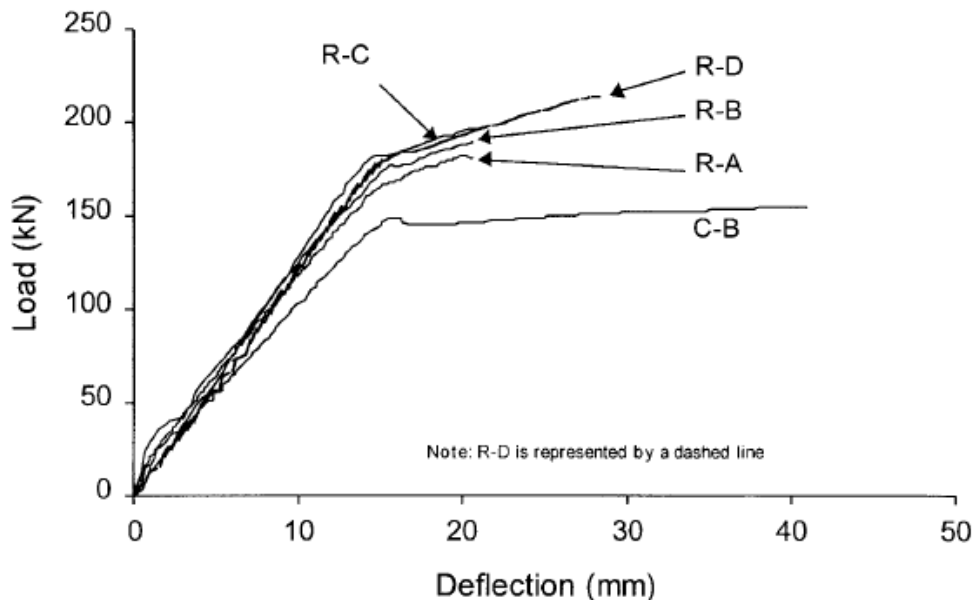
Figure 32: Load-deflection results for R-type CFRP strengthened beams (White et al, 2001)

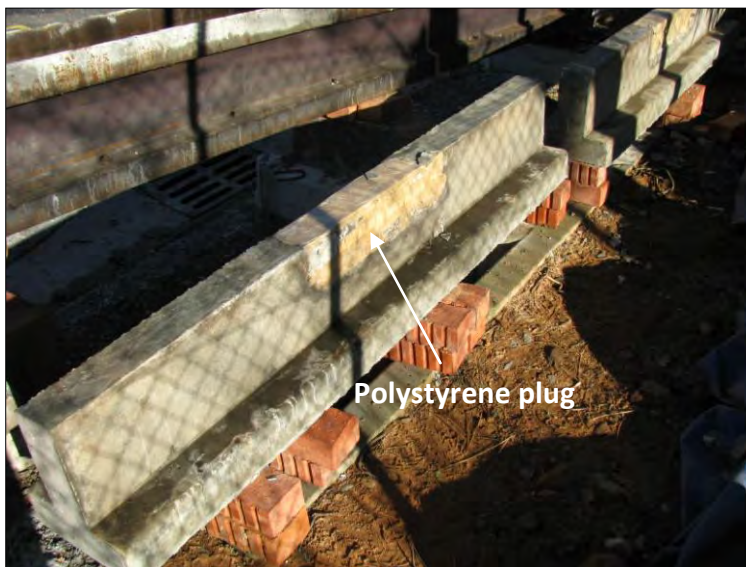
In practice, standard repair procedure entails that once the damaged location has been identified, the surrounding concrete in the location of the contact area should be removed and replaced with standard patch repair concrete. The removal of concrete in the contact zone requires the use of machinery which was not provided by the university. Therefore an alternative method to simulate the removal of the concrete was devised. Before specimens R-80, RS-80, R-160 and R-240 were cast they were fitted with rectangular polystyrene plugs to prevent concrete from hardening in the repair zone. The polystyrene plugs were 600mm in length, 140mm in height and 100mm wide (same width as the web). Once the concrete had set the polystyrene plugs were removed leaving a prismatic void at the centre of each beam with the same dimensions as the polystyrene plug. Figure 43 shows one of the T-beams fitted with a polystyrene plug after the T-beam was removed from the mould. Figure 44 shows the void left in the T-beam after the removal of the polystyrene plug.

*Figure 43: Demoulded beam with polystyrene plug*

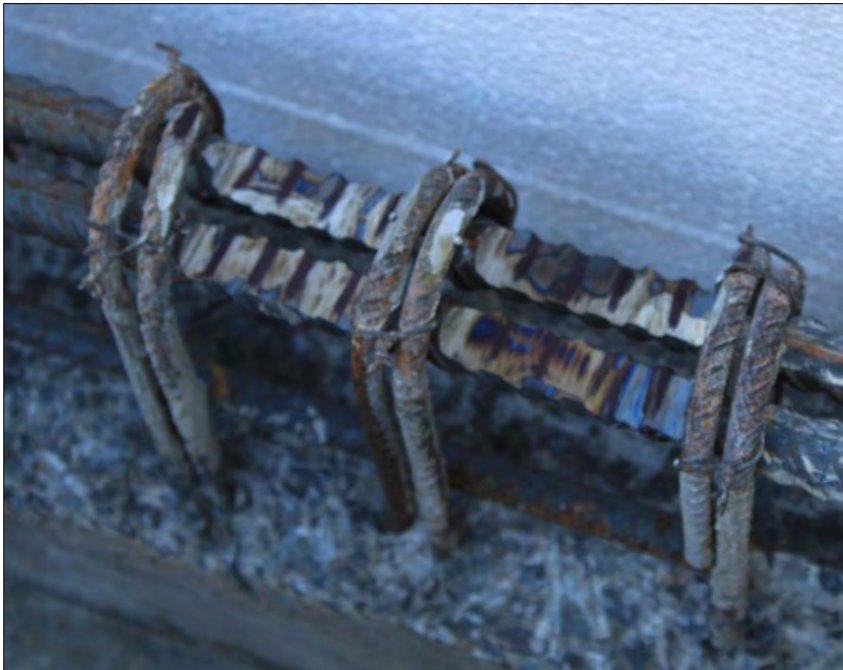
The longitudinal grinding length varied between 140mm and 160mm, however, the targeted depth was kept constant at 4.8mm. Figure 46 shows one of the T-beams after grinding.

*Figure 46: Reduced cross-sectional area of steel reinforcement*

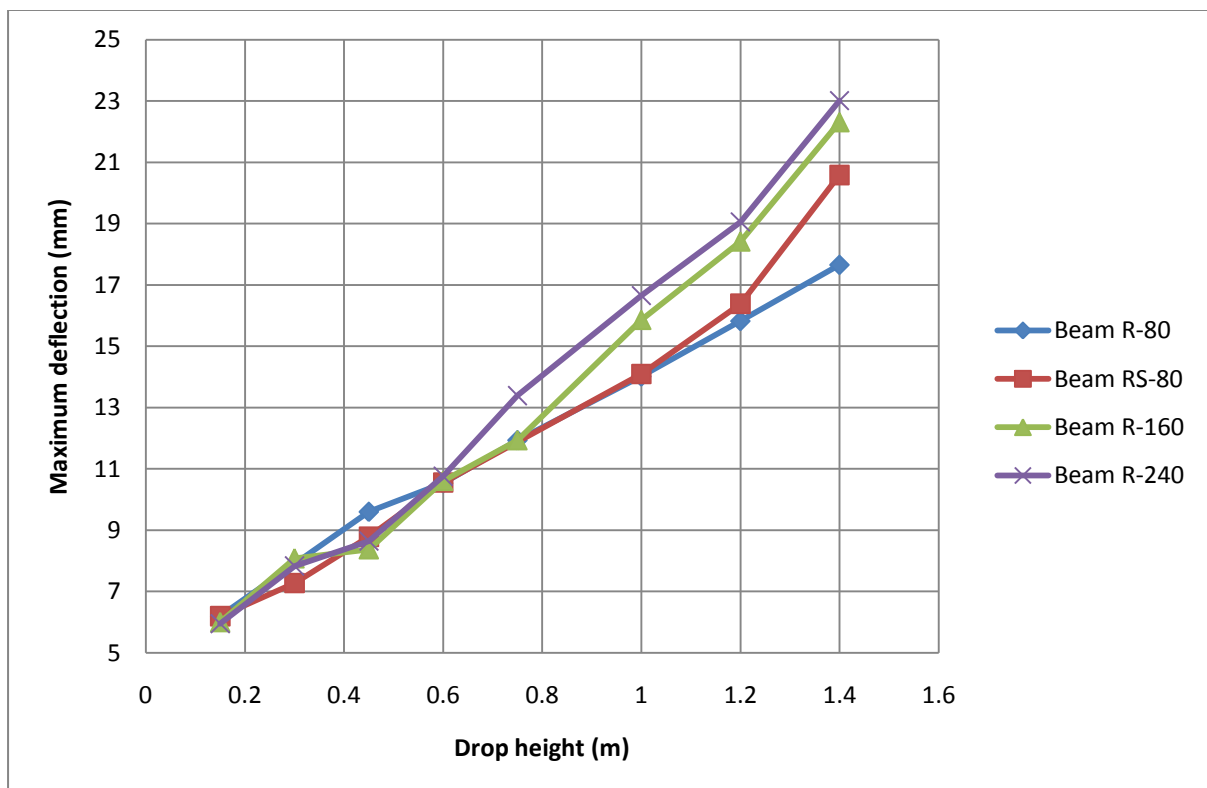
Figure 61: Maximum midspan deflection versus drop height

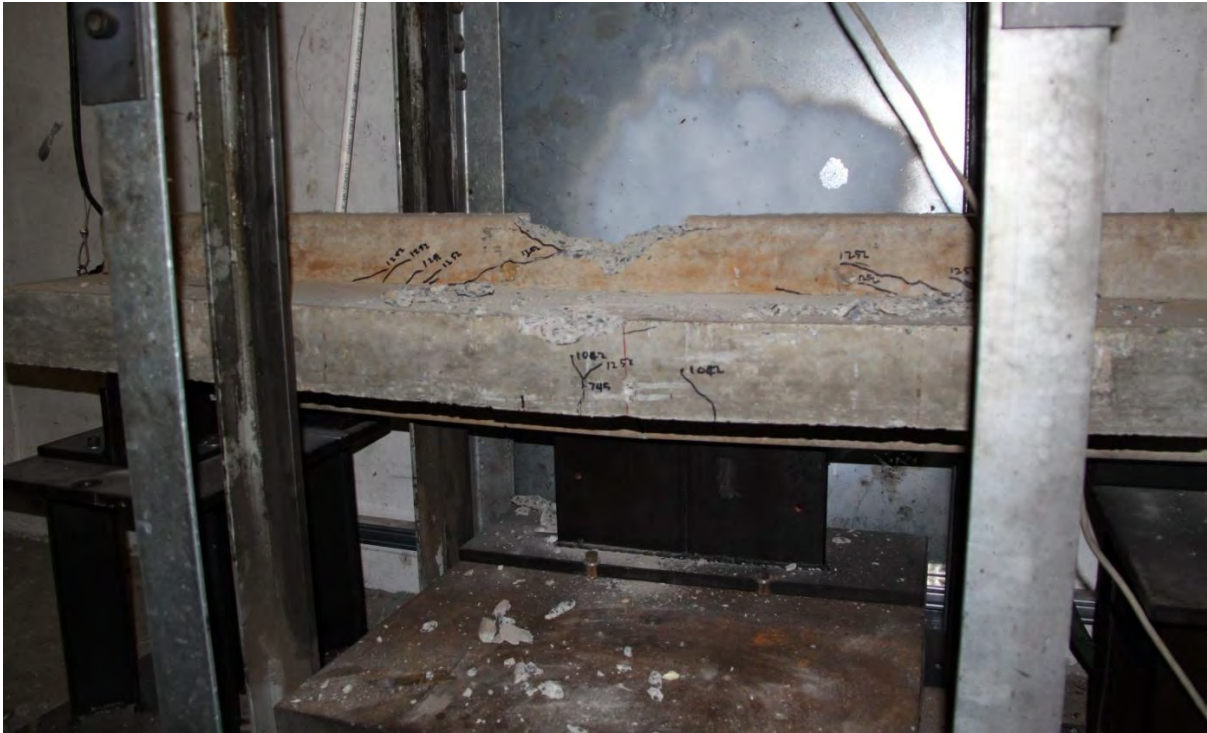
Figure B5: Damage observed after consecutive drop tests conducted on beam C-80

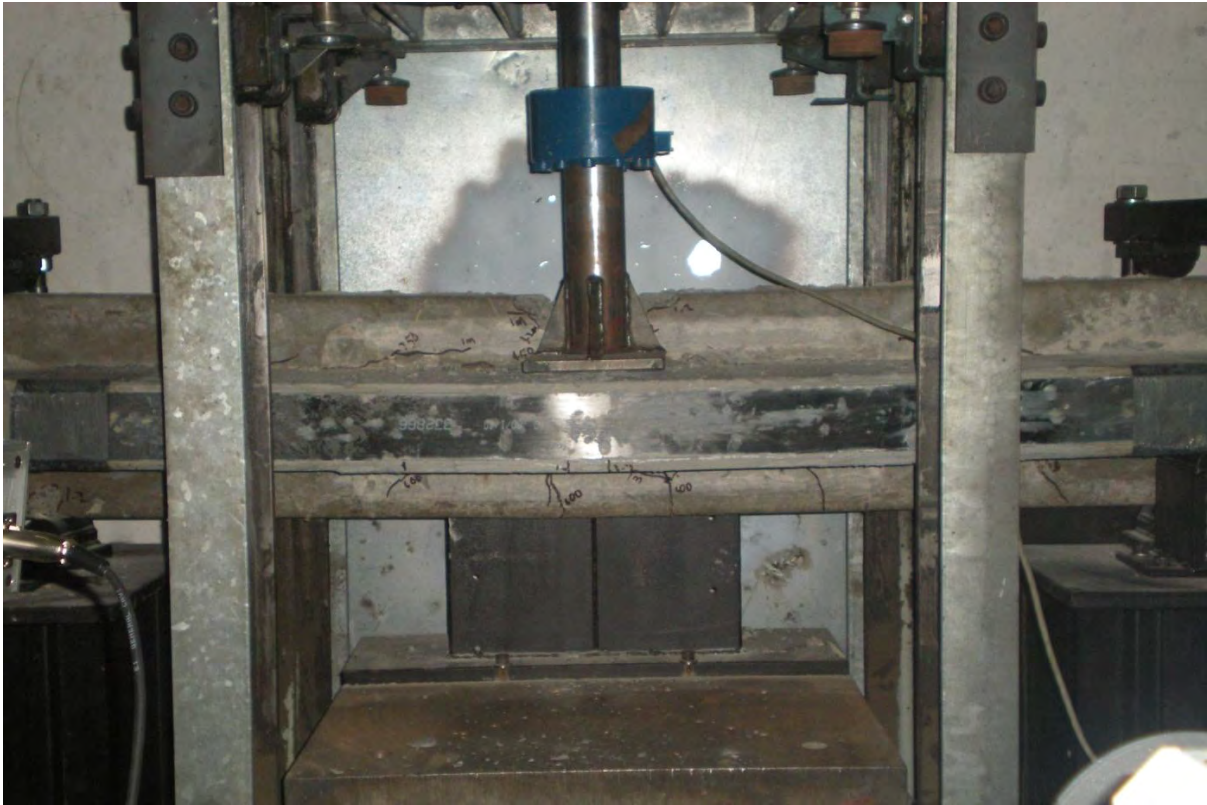
Figure B10: Damage observed after consecutive drop tests conducted on beam R-80

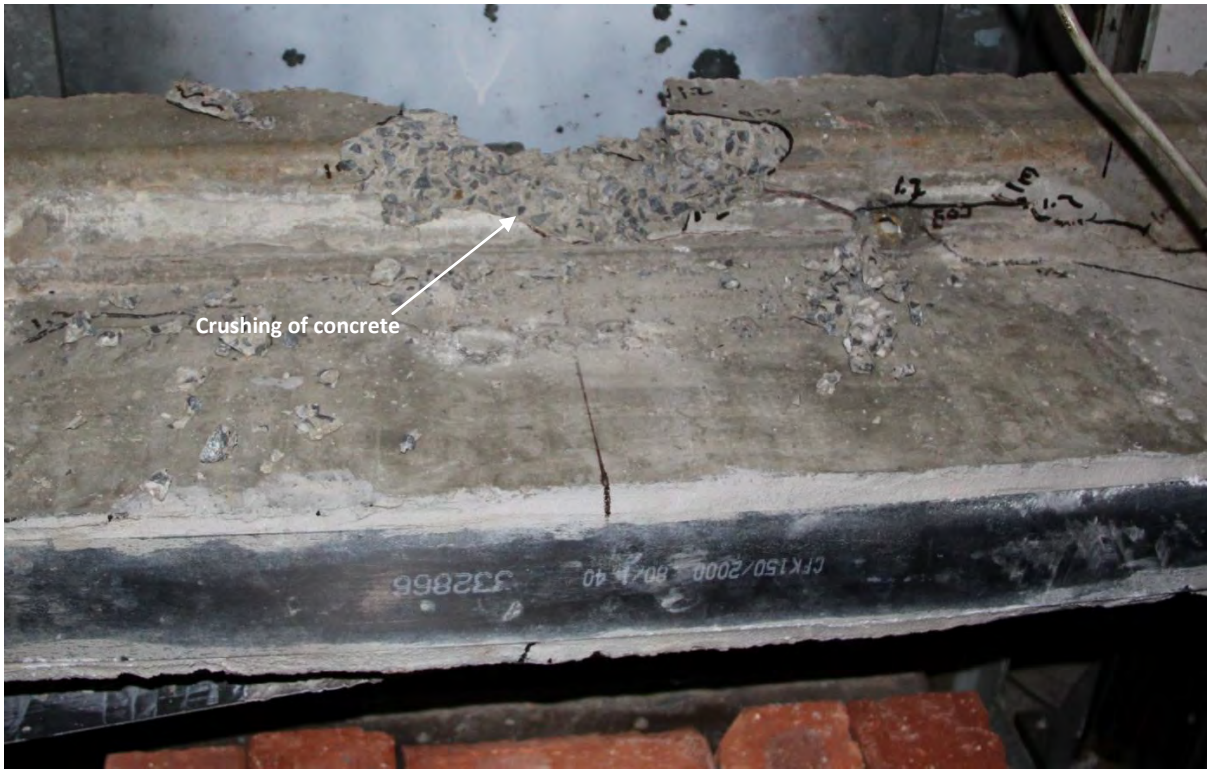
Figure B14: Compression damage and local damage (beam RS-80)

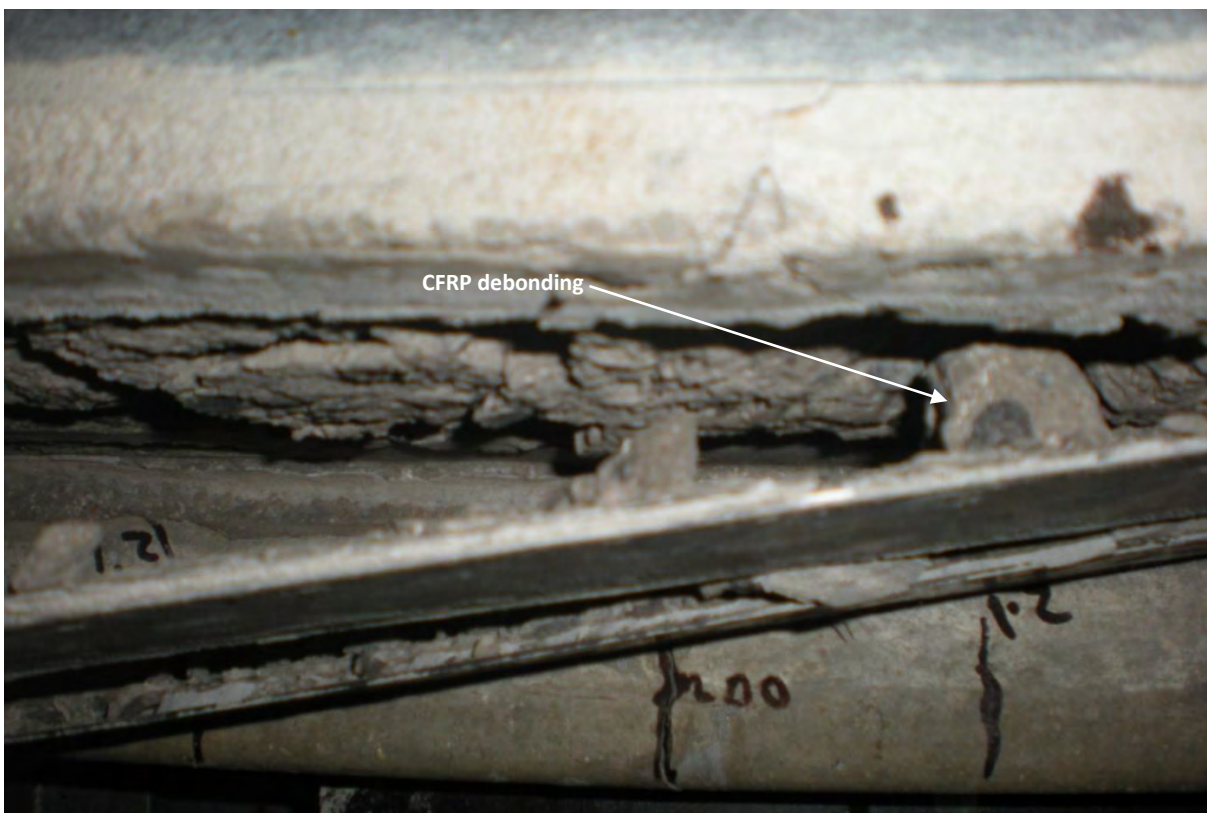
Figure B15: Debonding of additional CFRP applied for horizontal strengthening (beam RS-80)

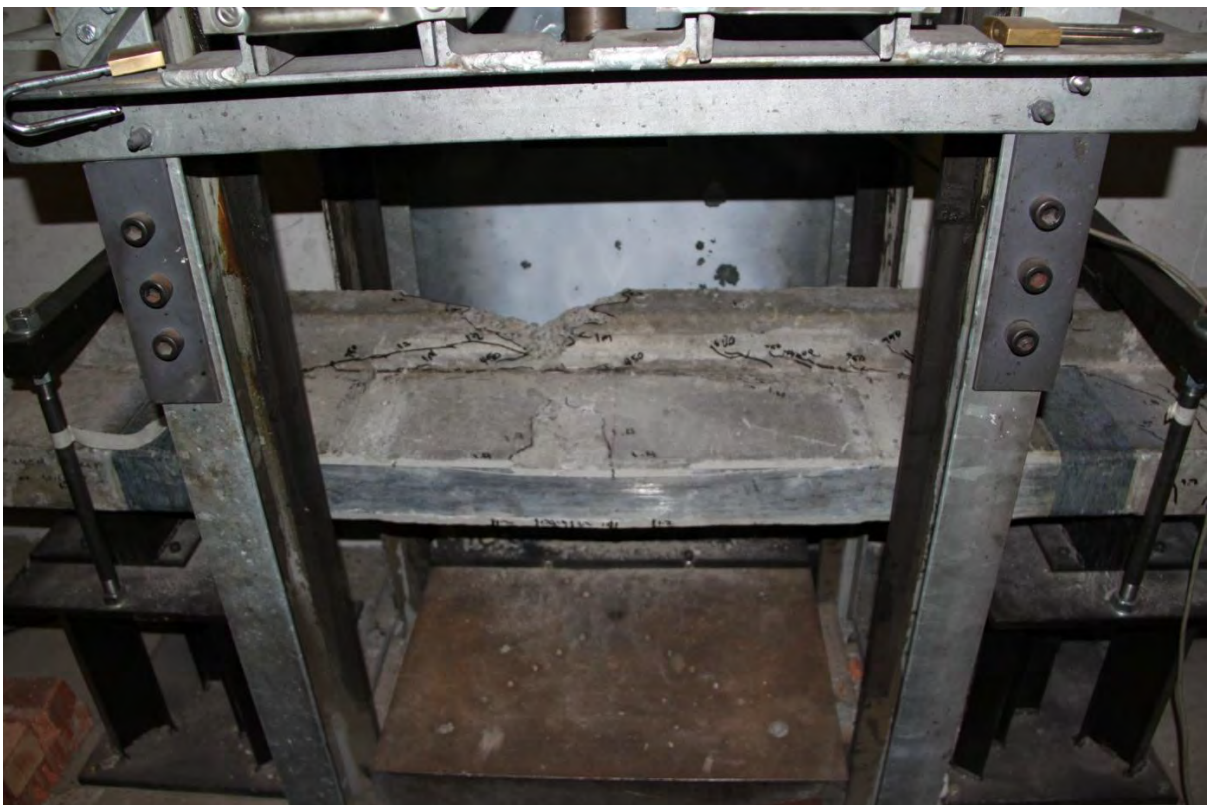
*Figure B17: Damage observed after consecutive drop tests conducted on beam R-160*

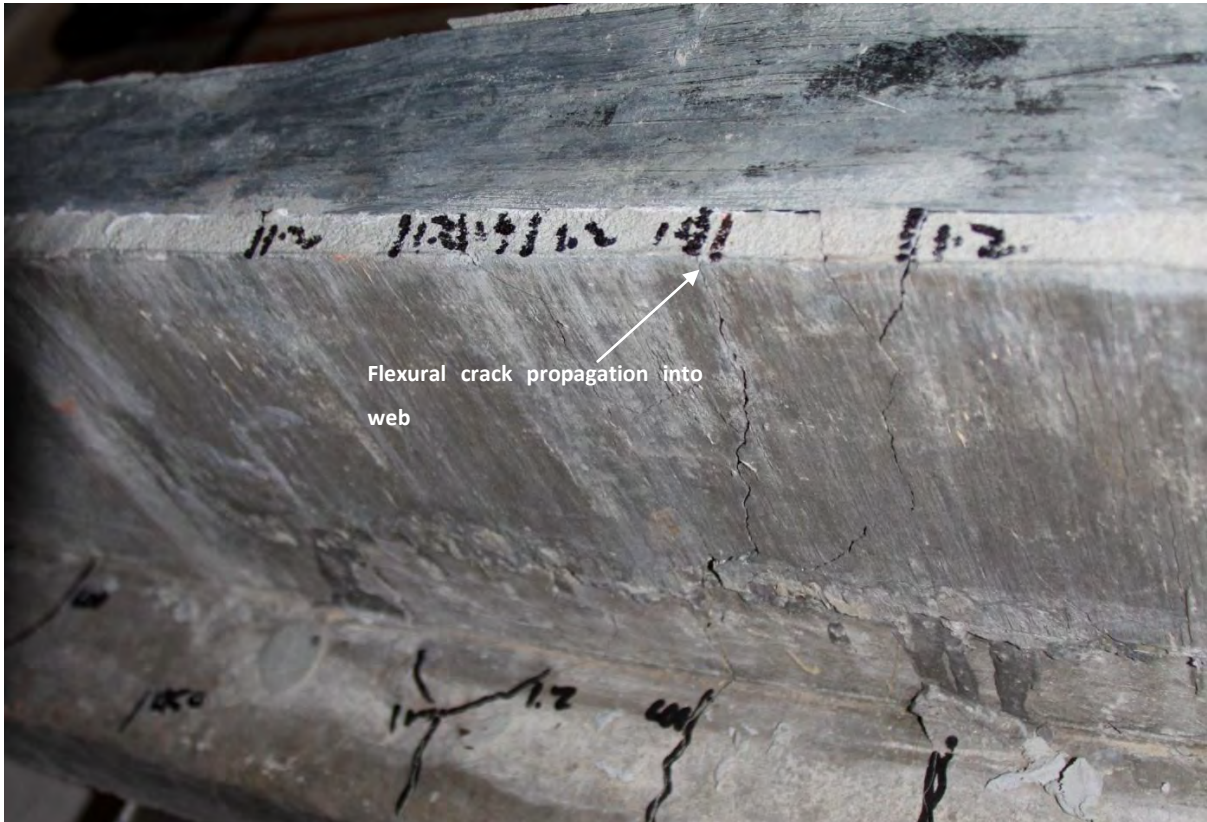
Figure B19: Flexural crack propagation (beam R-160)
