PD TRENDING AND TVA TEST READINGS ARE GOOD INDICATORS OF THE CONDITION OF AGED STATOR BAR INSULATION

A dissertation submitted to the Faculty of Engineering and the Built Environment, University of Cape Town, in fulfilment of the requirements for the degree of Master of Science in Engineering in Electrical Engineering

March 2012

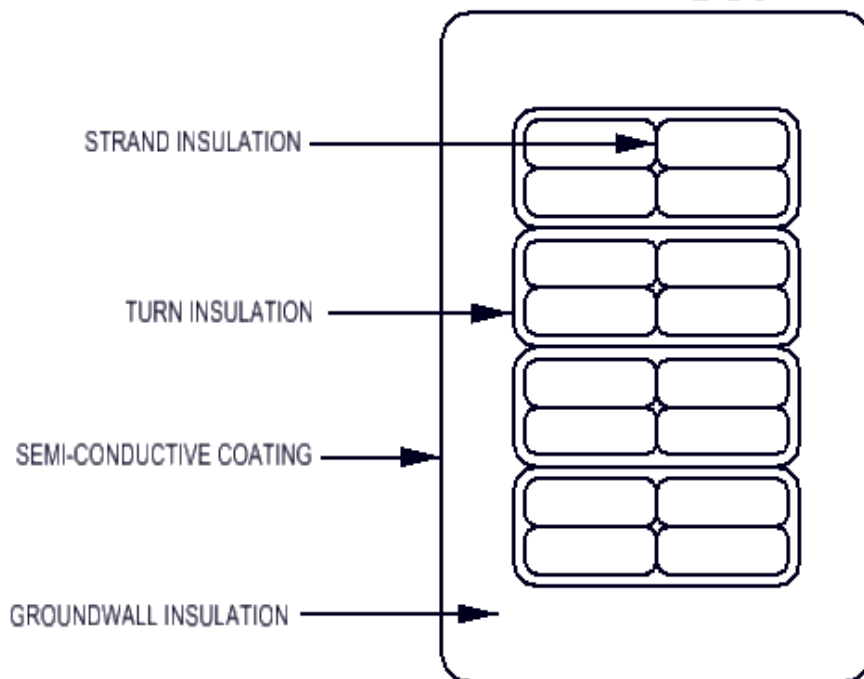
Figure 1.1: Construction of stator bar

The basic construction of a stator bar consists of copper strands, strand insulation, turn insulation, (not applicable to Roebel bars), groundwall insulation, semiconductive coating and silicon carbide coating as illustrated in Figure 1.1. The typical insulation of a stator bar as per figure 1.1 would be made of epoxy mica. The stator bar dimensions of a 122 MVA (13.2 kV) would typically be 20 X 74 mm with 48 strands and 3 mm thick groundwall insulation material. The electric field across the insulation would depend on the actual stator bar voltage. The electric field of a stator bar with phase-to-ground potential difference would have an electric field of approximately 2.5 kV/mm across the groundwall insulation.

In a Roebel bar the individual strands get transposed, commonly either 360 or 540 degrees, down the slot of the core. This allows each strand to occupy all strand positions in the slot. The strand will exit at the same position relative to it's entry point.

- Strand insulation: To lower the skin effect and stray current losses by reducing the cross sectional area of the copper conductors.
- Turn insulation: To prevent shorts between turns in a stator bar. When a turn is shorted it appears as the secondary winding of an auto-transformer. Consequently, a high circulating current will flow in the shorted turn, causing it to overheat. This will eventually lead to a stator earth fault caused by the melted copper burning through the groundwall insulation (Stone et al, 2004).
- Groundwall insulation: To prevent electrical contact between copper strands and the earthed core.
- Semi-conductive coating: Prevents discharges between the stator bar and the core.
- Silicon carbide coating: Grounding of stator bar in endwinding region.

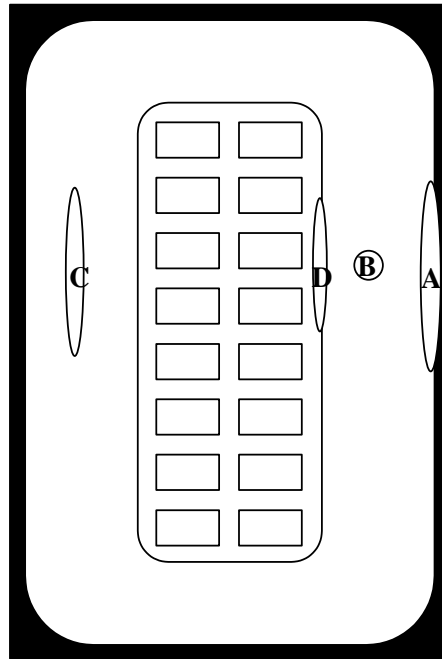
Figures 3.1 and 3.2 show typical PD discharge locations in hydro generator stator bars (Eskom Guideline GGG 0826, 1999)

Figure 3.1: PD locations in stator bar
A: Void between the main insulation and the slot wall
B: Void in the main insulation
C: Delamination between the layers of insulation
D: Delamination between the winding stack and the

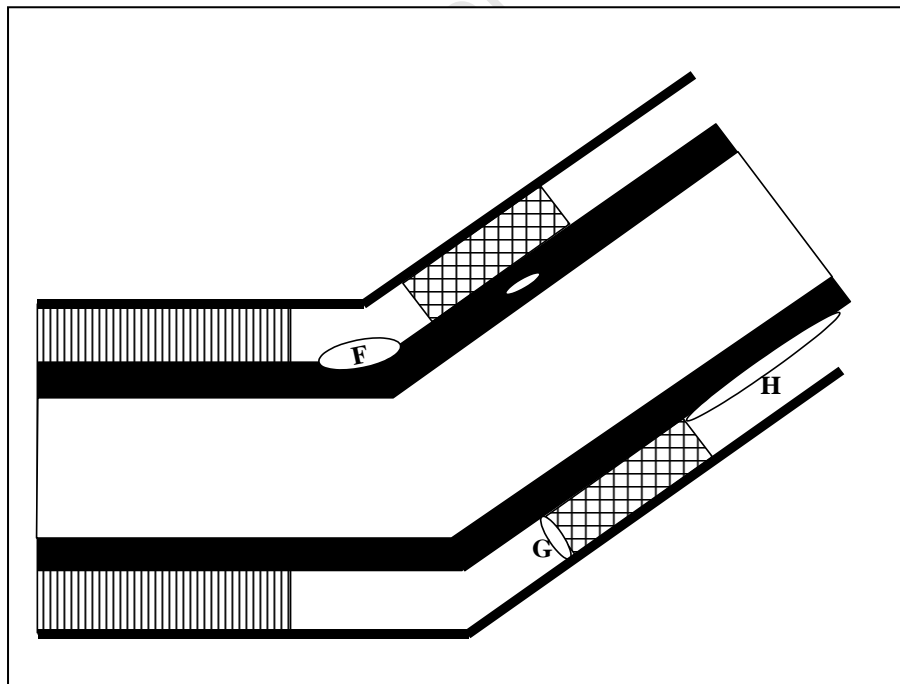
Figure 3.2: PD locations in endwinding region
F: Delamination of the insulation at the elbow
G: Tracking between bars
H: Surface tracking

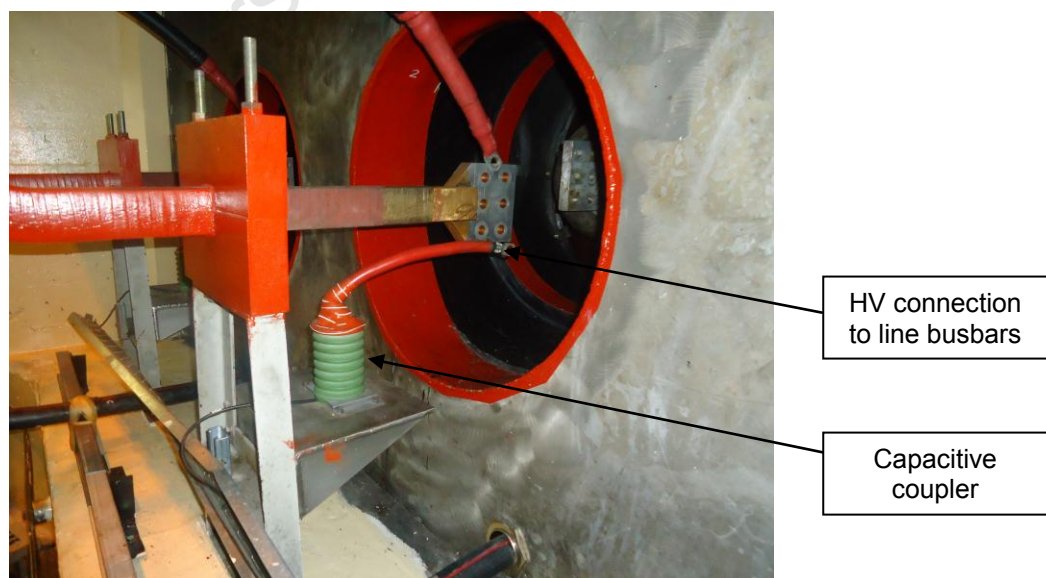
Figure 3.6: Capacitive coupler with HV connection

Figures 3.6- 3.11 show an installed capacitive coupler and a typical test set.

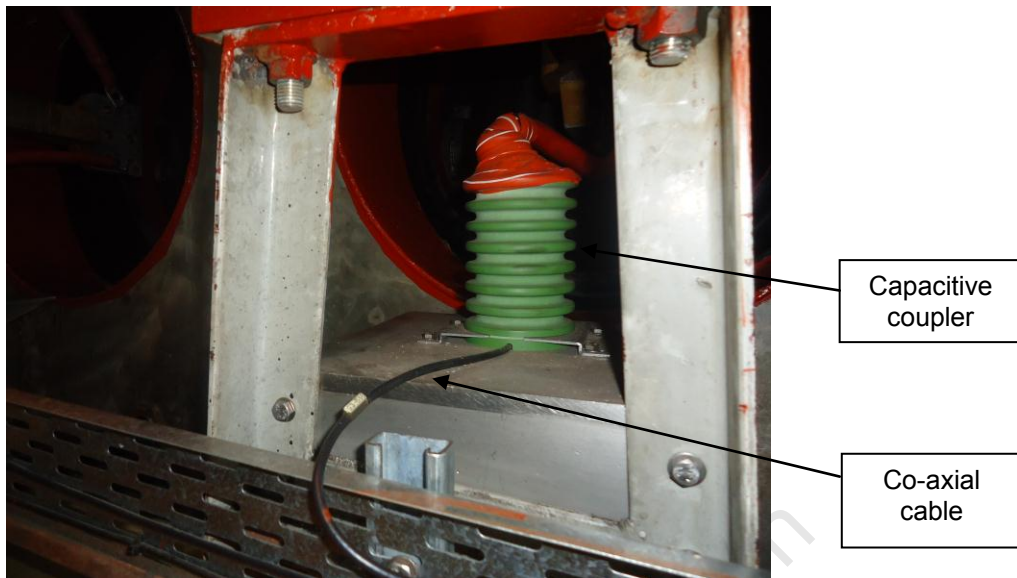
Figure 3.7: Capacitive coupler with co-axial connection for transfer of high frequency of PD signal

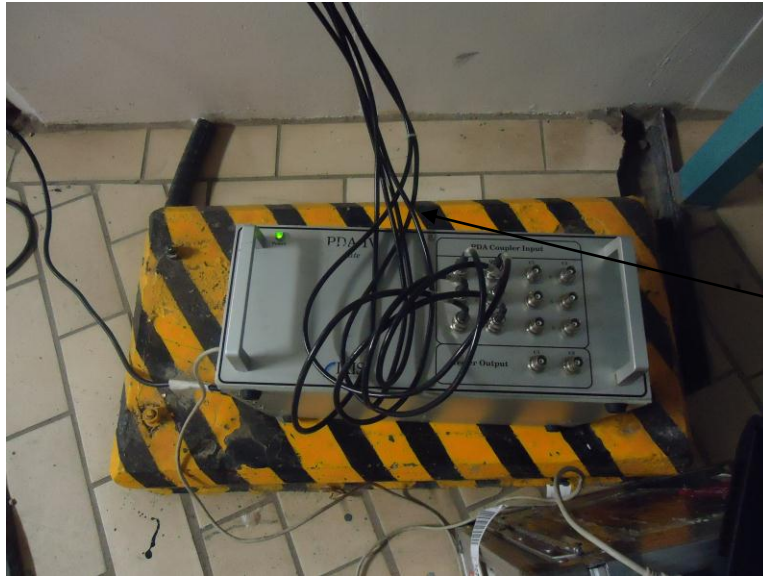
Figure 3.9: PDA-IV test set

Paired
couplers BNC
cables coming
from
termination
box.

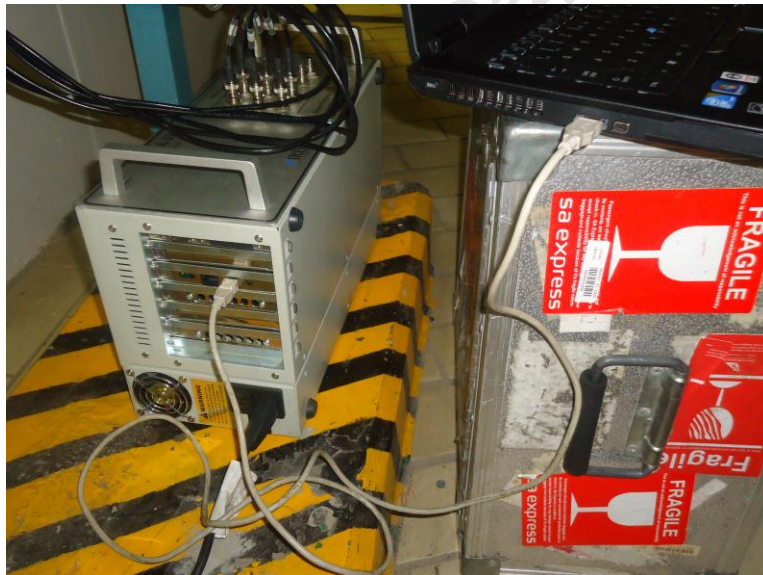
Figure 3.10: PDA-IV test setup showing Ethernet connection to software interface

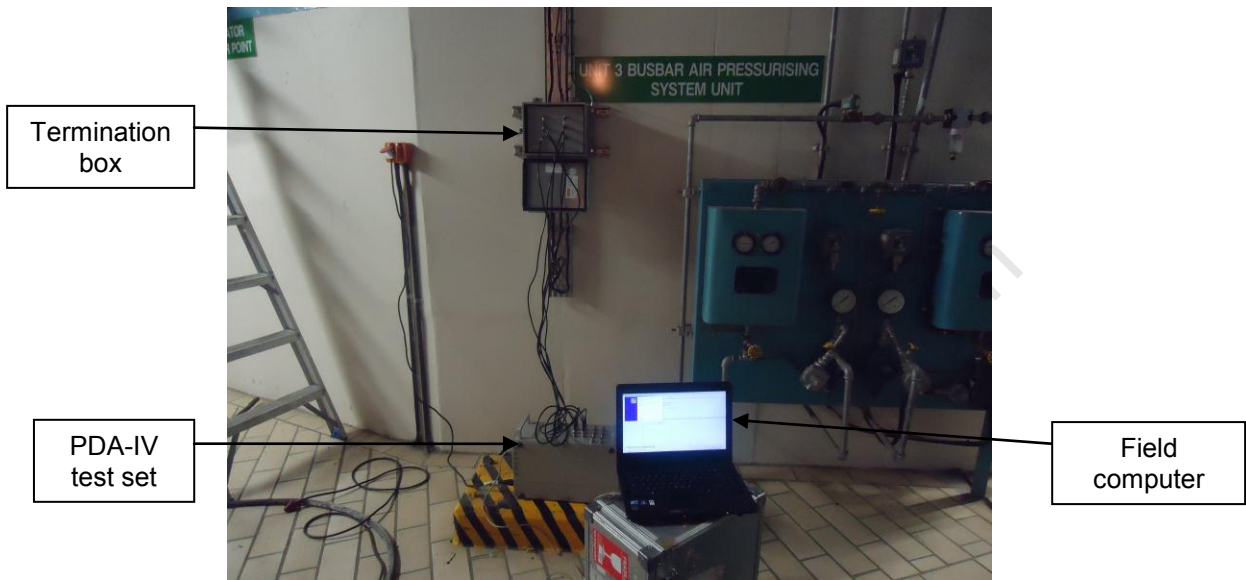
Figure 3.11: Typical PD data collection test setup

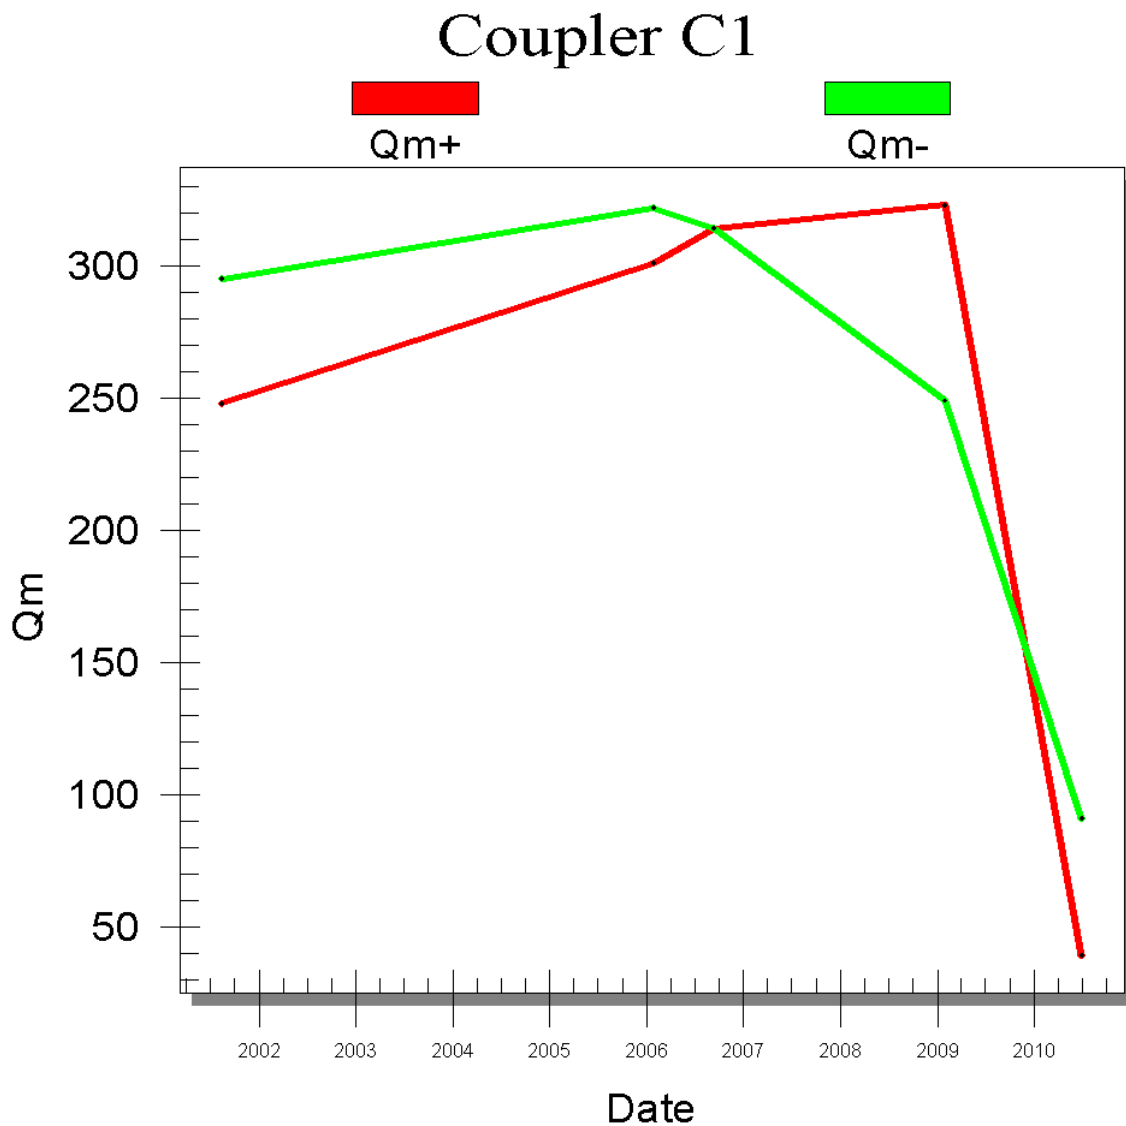
Figure 6.1: Gariep Unit 4 Red phase trend

As can be seen from the above figure, there is a steady increase in both positive PD (Q_{m+}) and negative PD (Q_{m-}) values with no significant polarity predominance until around 2006. This is an indication that the PD activity is occurring within the groundwall (Shunyuan and Chow, 2007). After 2006 there is a decrease in Q_{m-} and a steady increase in Q_{m+} , meaning that the failure mechanism could be driven by slot discharges (Shunyuan and Chow, 2007). This was one of the failure mechanisms identified from the 2-D and 3-D plot analyses as listed in Table 5.2. On the other hand, the failure mechanism could have been driven by the Q_{m-} as PD can possibly decrease just before insulation failure (Bartnikas, 1979).

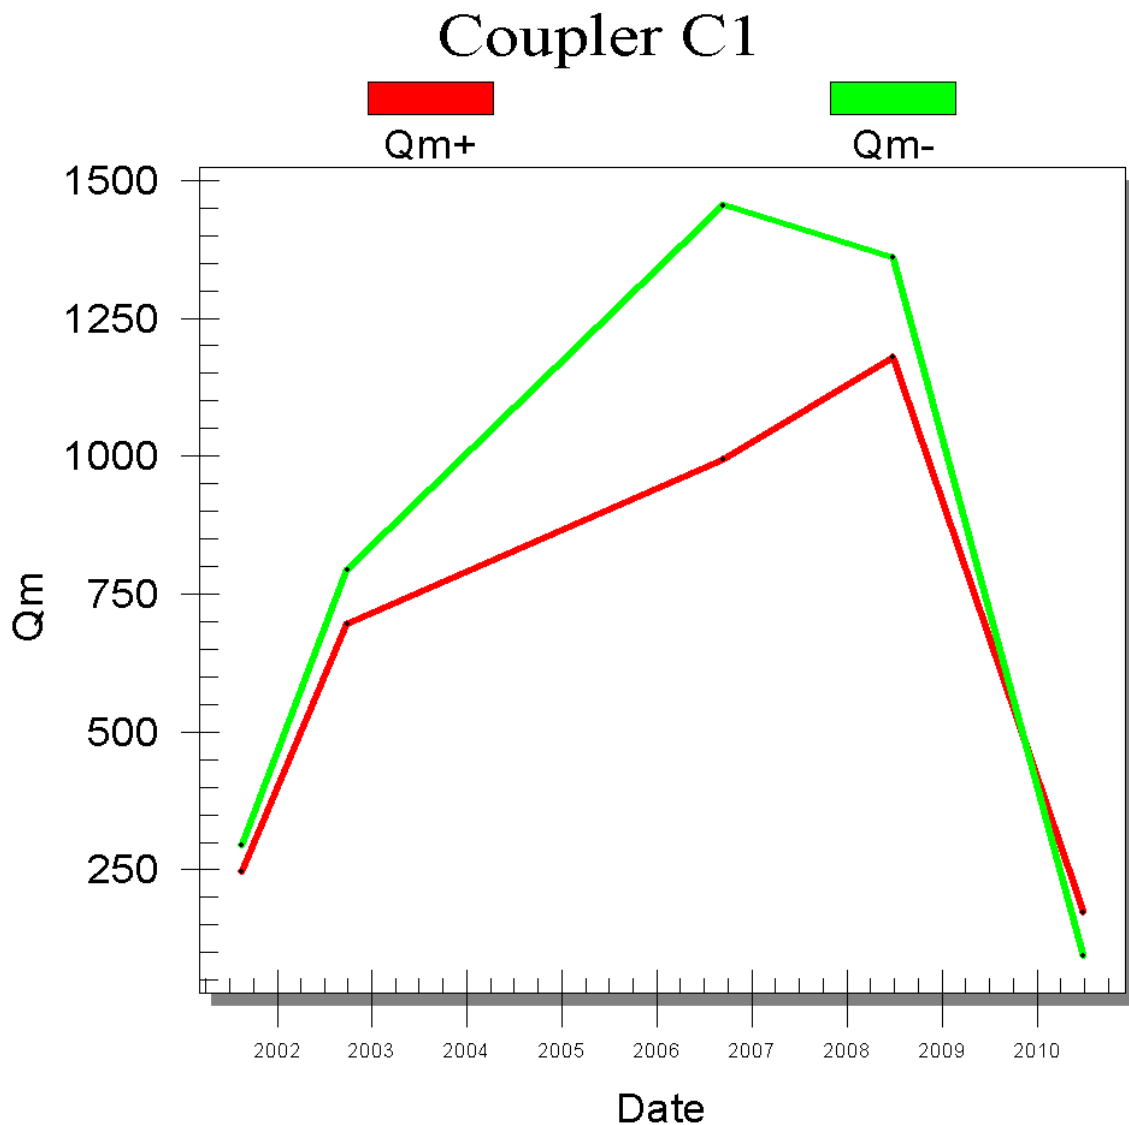
Figure 6.2: Gariep Unit 4 White phase trend

Figure 6.2 shows an increase in both positive PD (Q_{m+}) and negative PD (Q_{m-}). Initially until somewhere in 2002 there is no polarity pre- dominance. Hence the PD activity is occurring within the groundwall (Shunyuan and Chow, 2007). From about 2003 to 2006 there is a significant increase in PD with Q_{m-} predominance. This is an indication that the PD is occurring at the copper and groundwall interface (Shunyuan and Chow, 2007). This could indicate a failure of bonds between the copper and groundwall insulation (Stone et al, 2004). After 2006 there is a decrease in Q_{m-} and a steady increase in Q_{m+} , meaning that the failure mechanism could be driven by slot discharges (Shunyuan and Chow, 2007). This was one of the failure mechanisms identified from the 2-D and 3-D plot analyses as listed in Table 5.2. Again, the failure mechanism could have been driven by the Q_{m-} as PD can possibly decrease just before insulation failure (Bartnikas, 1979).

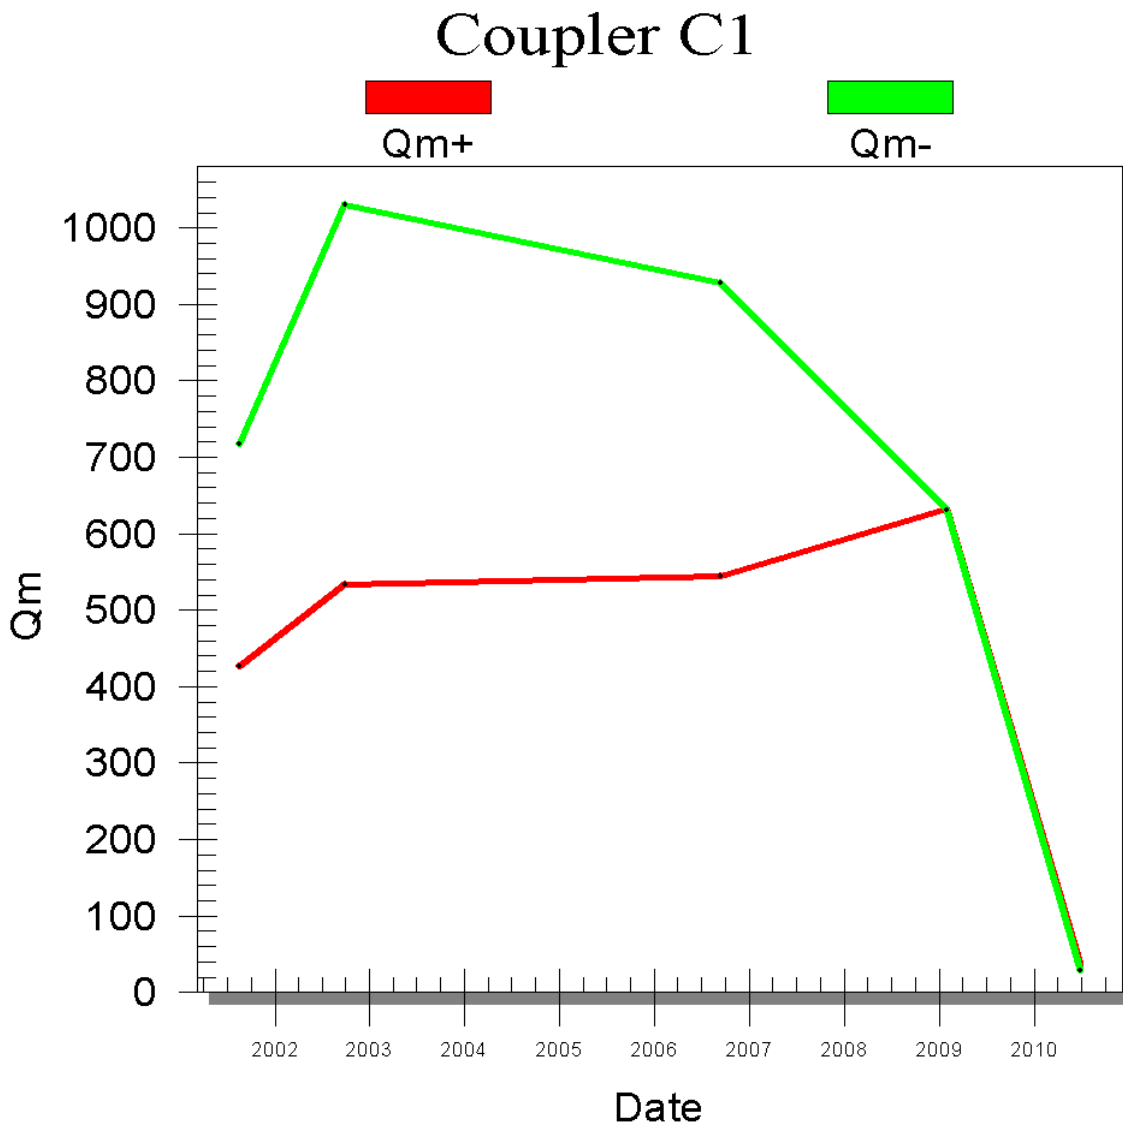
Figure 6.3: Gariep Unit 4 Blue phase trend

Figure 6.3 shows an increase in both positive PD (Qm+) and negative PD (Qm-) with Qm- predominance. Hence, PD is occurring at the copper and groundwall interface (Shunyuan and Chow, 2007). Even with a decrease of Qm- and steady increase of Qm+ between 2003 and 2006, the pre-dominant failure mechanism may still be driven by the Qm-. In other words, the PD is still occurring at the copper and groundwall interface due to the significant Qm- predominance, almost double the Qm+ value (Iris PD seminar, 2000). After 2006 there is a decrease in Qm- and an increase in Qm+ with PD levels becoming approximately equal. This indicates that the pre-dominant PD failure mechanism has moved to within the groundwall insulation. This could also indicate that pre-dominant PD failure mechanism could change over the lifespan of a generator without any repair intervention. Alternatively, the failure mechanism could, once again, have been driven by the Qm- as PD can possibly decrease just before insulation failure (Bartnikas, 1979).

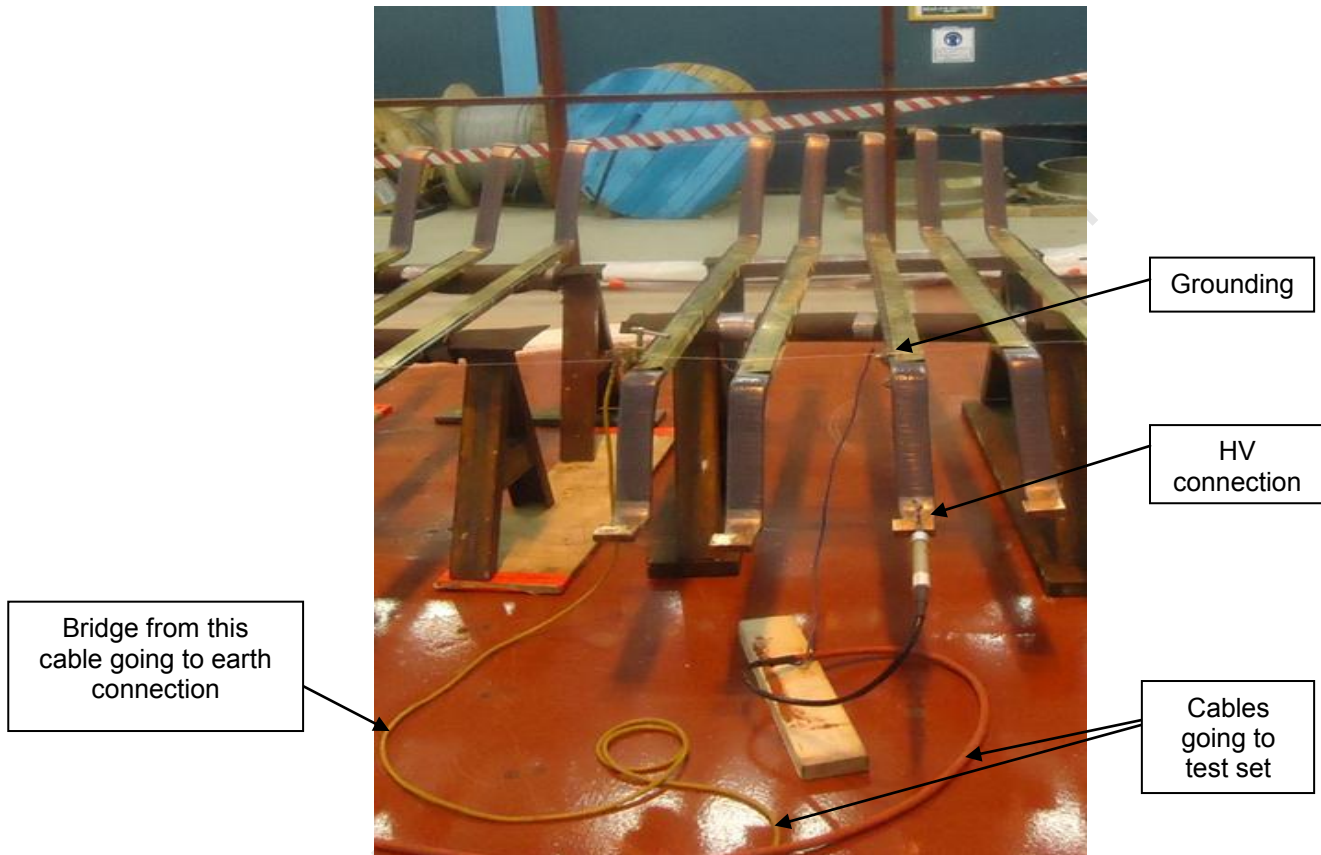
Figure 7.1: Typical HV test set-up

A typical test set-up and the actual test set-up are illustrated in Figures 7.1 and 7.2 respectively.

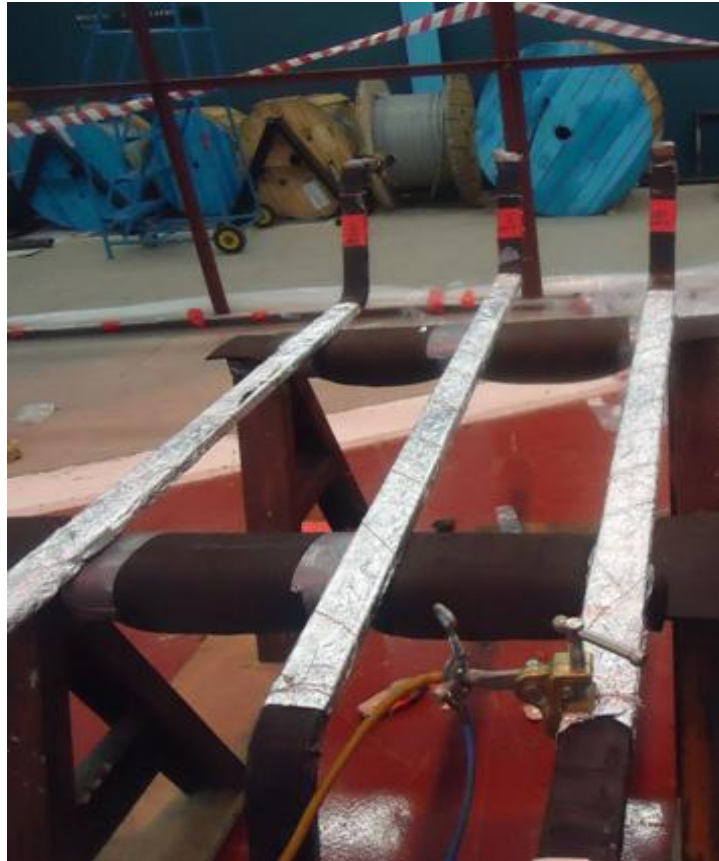
Figure 7.2: Test set-up for test specimens as per Figure 7.1

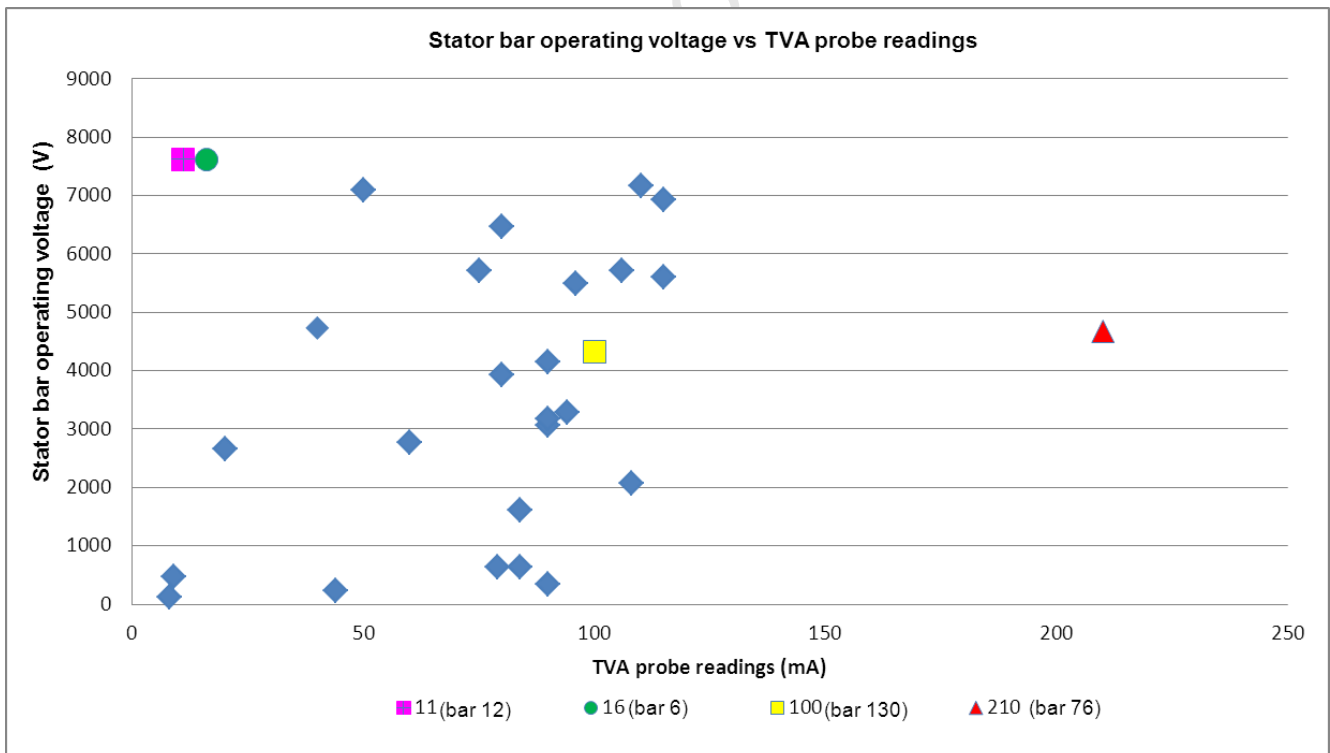
Figure 8.1: Stator bar operating voltage vs TVA probe readings

There is no direct correlation between TVA probe measurements and voltage breakdown values. Figure 8.1 suggest that it is rather a combination of the TVA probe value and the operating voltage of the stator bar that will contribute as a failure mechanism. However, the test values for Stator Bar 12 seem to suggest otherwise.

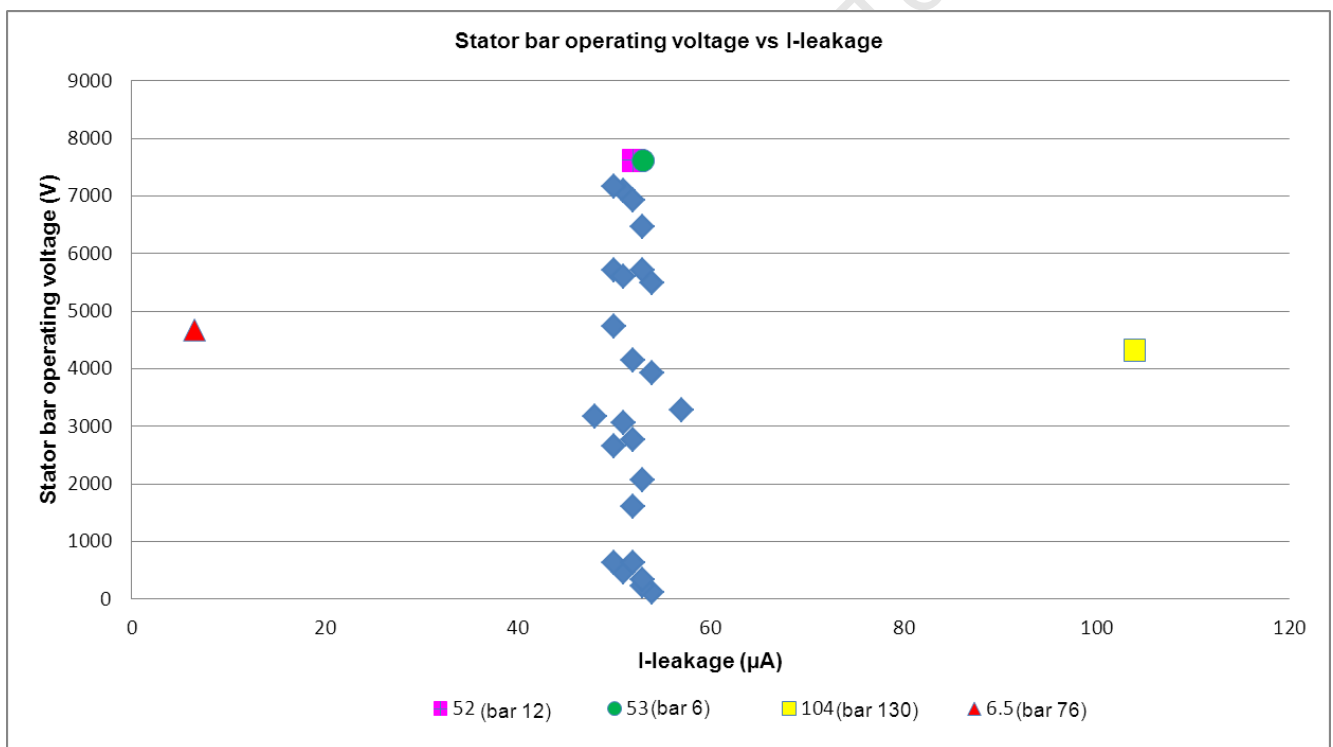
Figure 8.2: Stator bar operating voltage vs I-leakage

Comparing the stator bar operating voltage value to the leakage current presents a picture of a “window of leakage currents” between the values of 48 (μA) and 57 (μA). Stator Bars 76 (6.5 μA) and 130 (104 μA) are completely outside of this window. Stator Bar 6 (53 μA) is lying within this window and its failure can be attributed to the fact that it is operating at a higher voltage than Stator Bars 76 and 130; 7621V compared to 4676V and 4330V respectively. Once again Stator Bar 12 seems to contradict this. The same scenario presents itself for the operating voltage compared to the stator bar capacitance. All the bars are clustered between 3.2 (nF) and 3.9 (nF), except Stator Bars 76 and 130 at 2.9 (nF) and 6.7(nF) respectively.

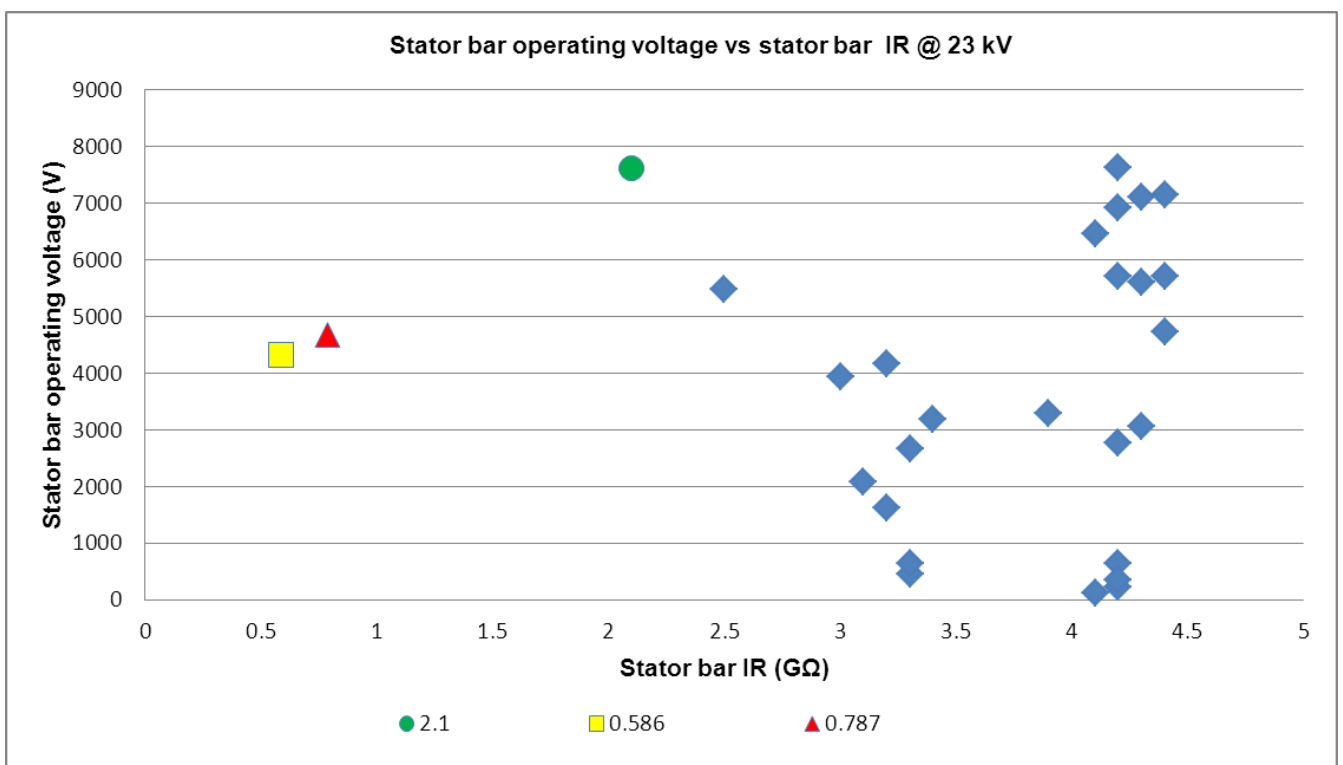
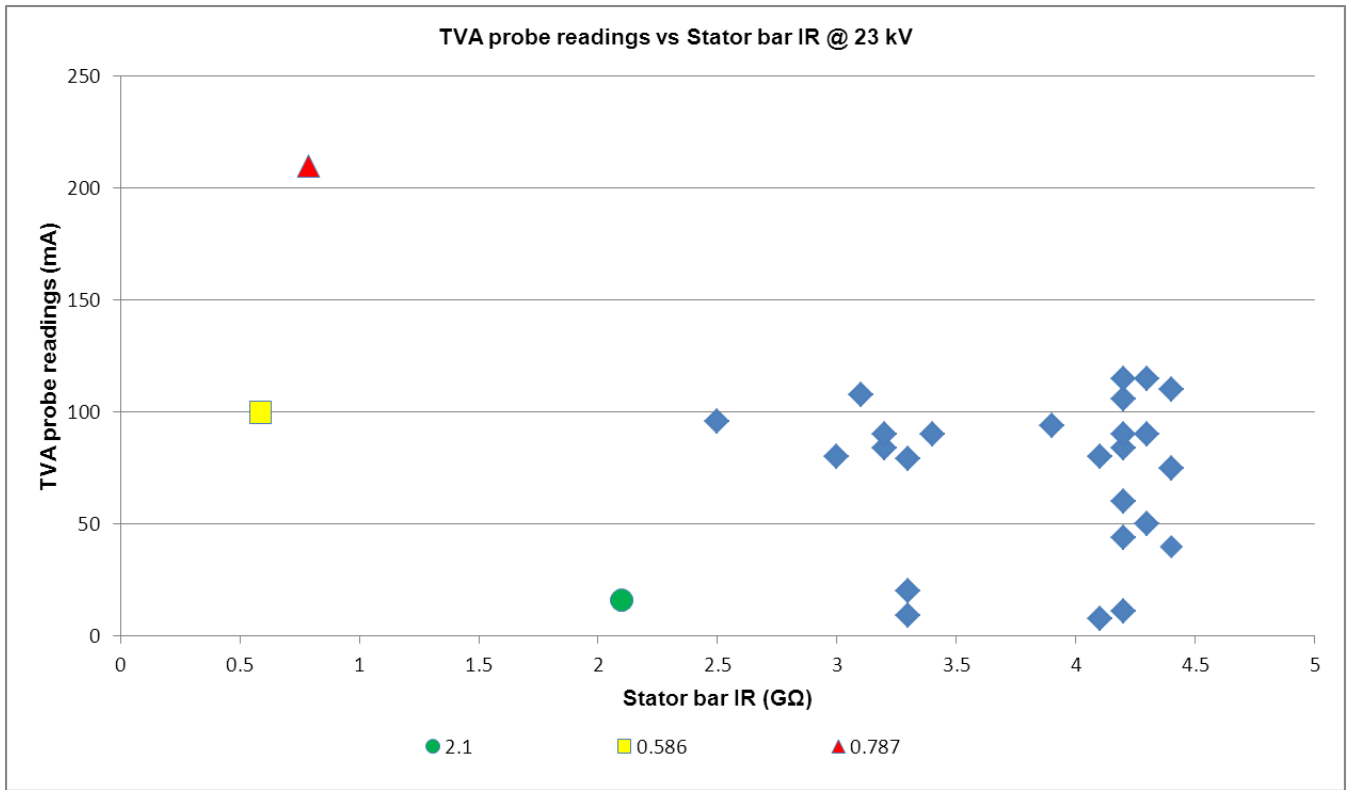
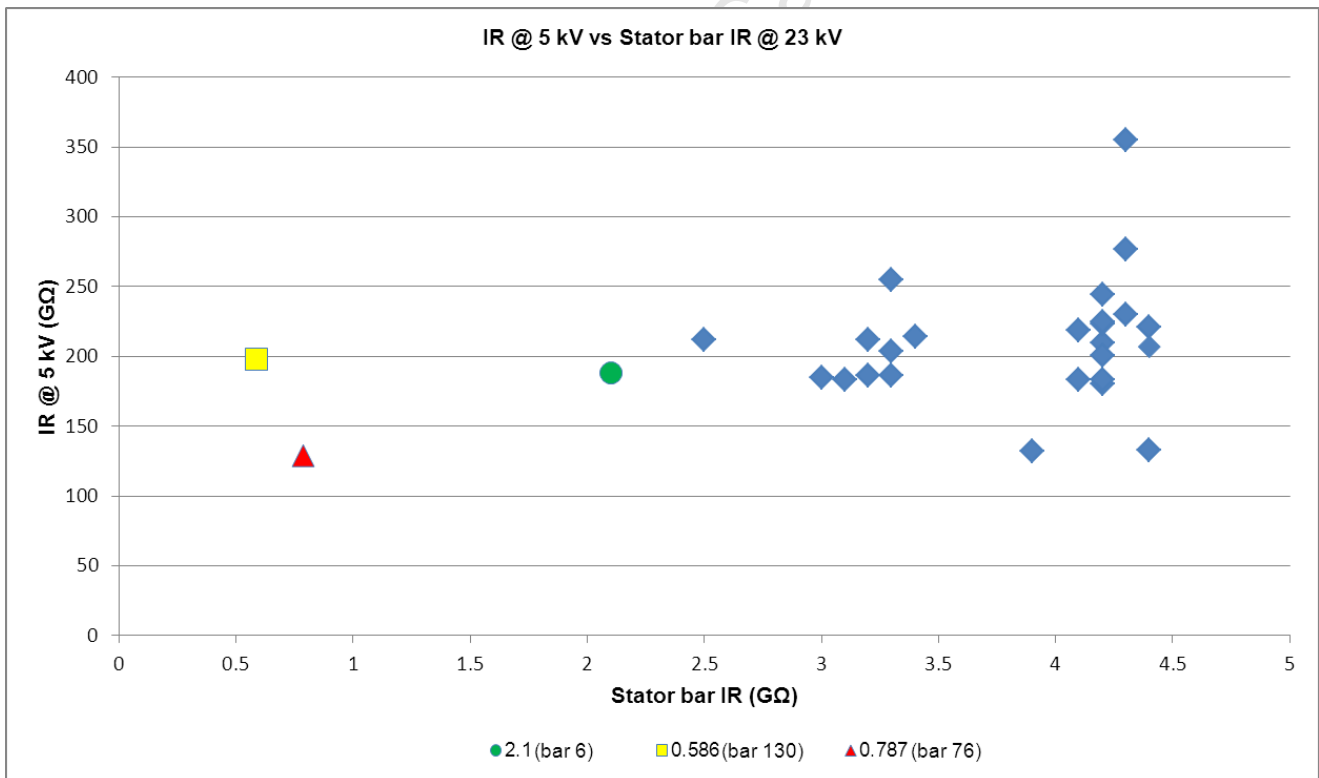
Comparing the stator bar insulation resistance @ 23 kV with operating voltage (bar position), TVA probe and IR (@ 5kV), the three (3) stator bars that failed had the lowest insulation resistance values. This shows that irrespective of the operating voltage, TVA probe value or IR (@ 5 kV) value the failure mechanism appears to be driven by the low bar insulation resistance @ 23 kV. It appears that the cut-off point is some value lower than 2.5 GΩ. This is demonstrated in Figures 8.4, 8.5 and 8.6. There is however no direct relationship between the breakdown voltage, operating voltage, insulation resistance @ 23 kV and TVA probe readings of these bars. Table 8.1 illustrates this.

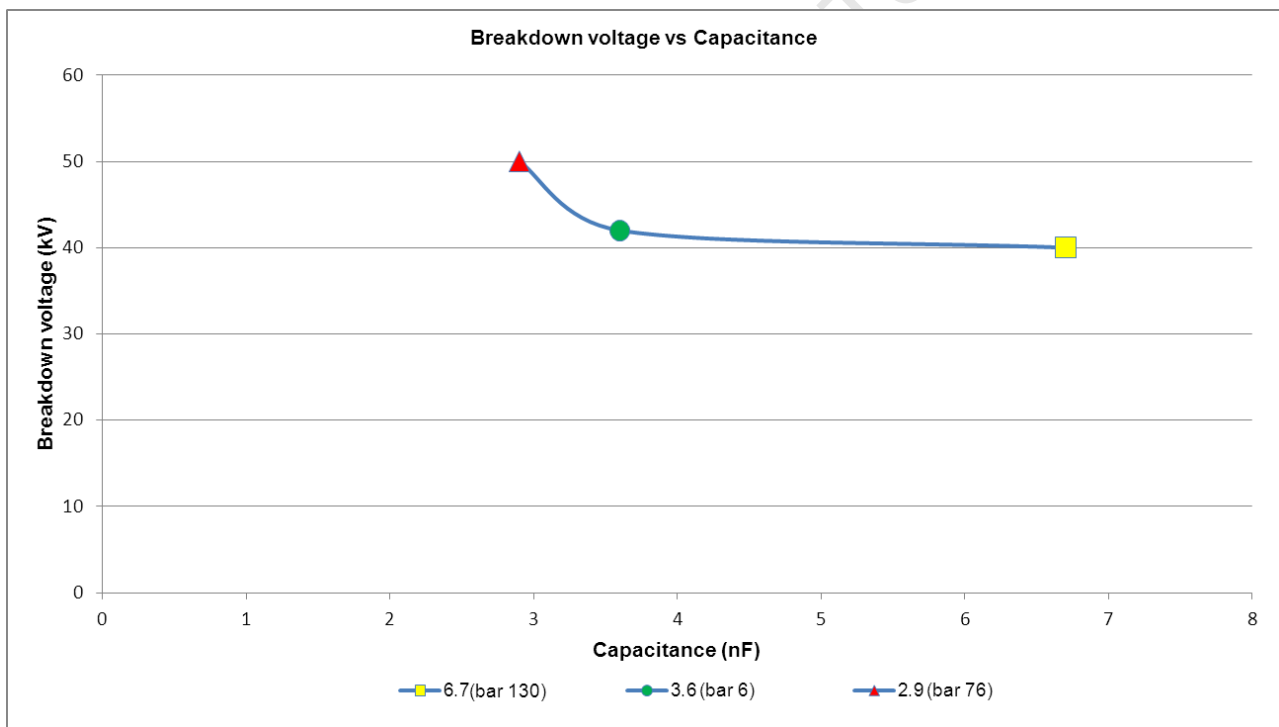
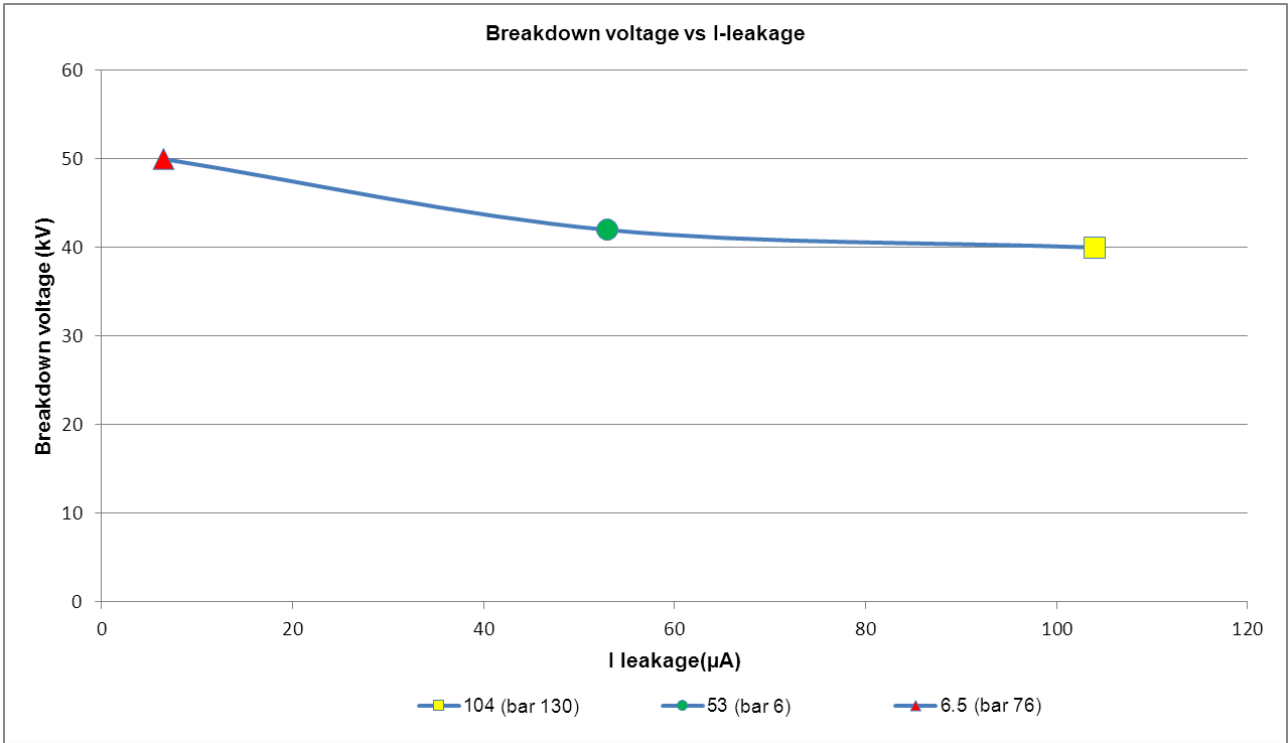
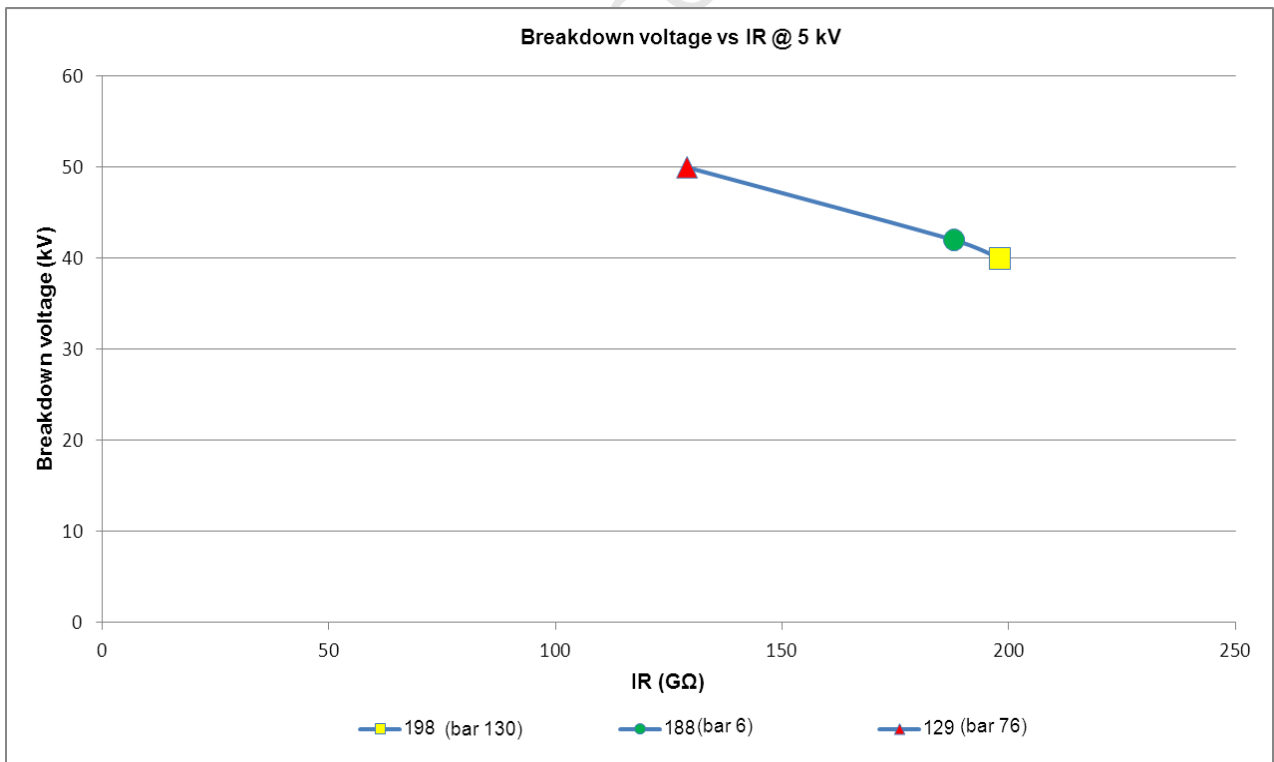
Further analysis of the graphs show an inverse relationship between the voltage breakdown and the following stator bar parameters: capacitance, I leakage and IR @ 5 kV. This can be seen from Figures 8.7, 8.8, 8.9 and Table 8.2.

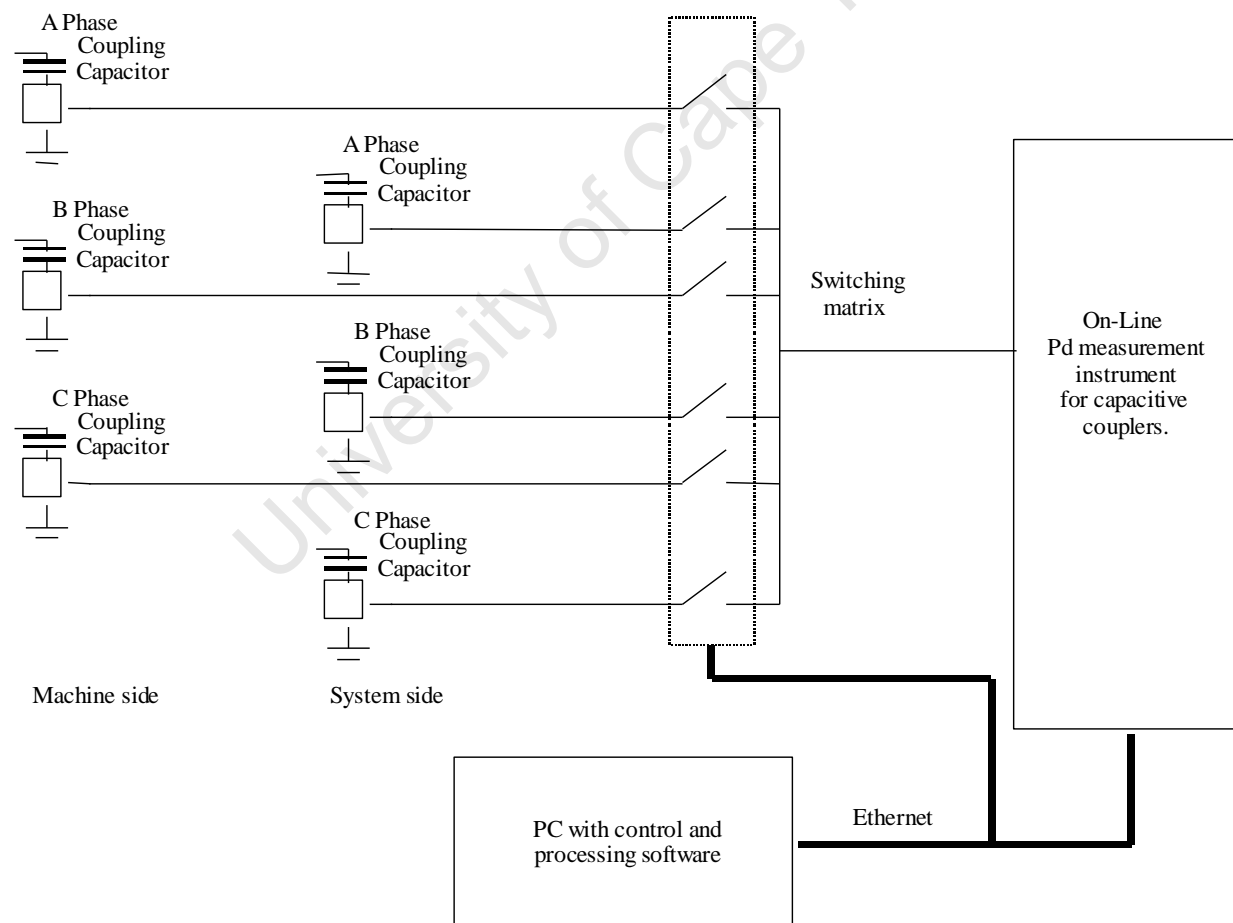
Figure 5. Block diagram of the on-line PD detection instrument

Digital instrumentation is used to gather process and display PD information. The instrumentation is attached to permanently mounted coupling capacitors via connections housed in a terminal box. Two sets of coupling capacitors are used on each phase. The first set is mounted at the phase output terminals of the machine. The second set is mounted at least two meters away from the first set toward the generator transformer. A capacitive/resistive divider is used to detect the signal and pass it to a switching matrix. A block diagram of the on-line detection method is shown in Figure 5.

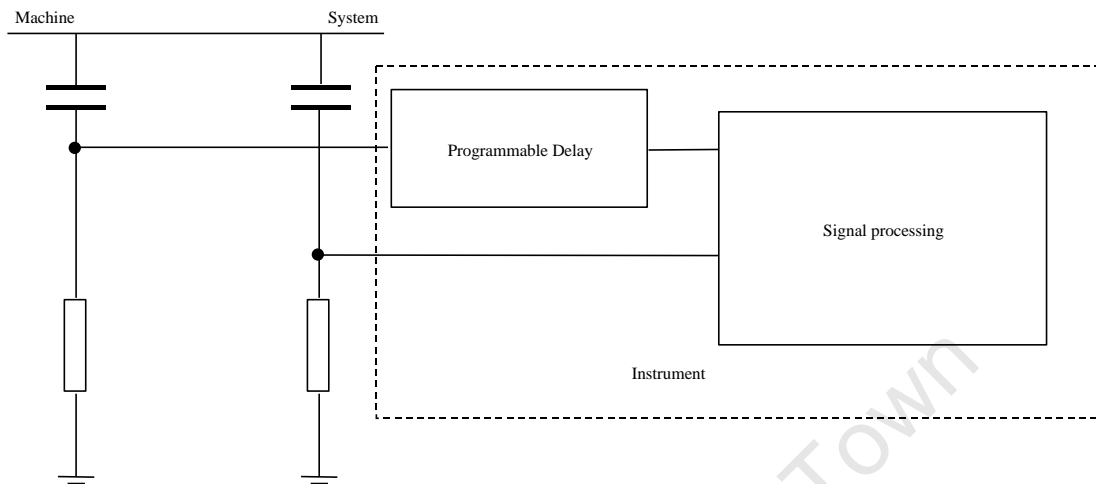
Once the switching matrix has selected the appropriate phase the signals are passed to the noise discrimination electronics. A programmable delay line, as illustrated below, delays the signal from the machine side:

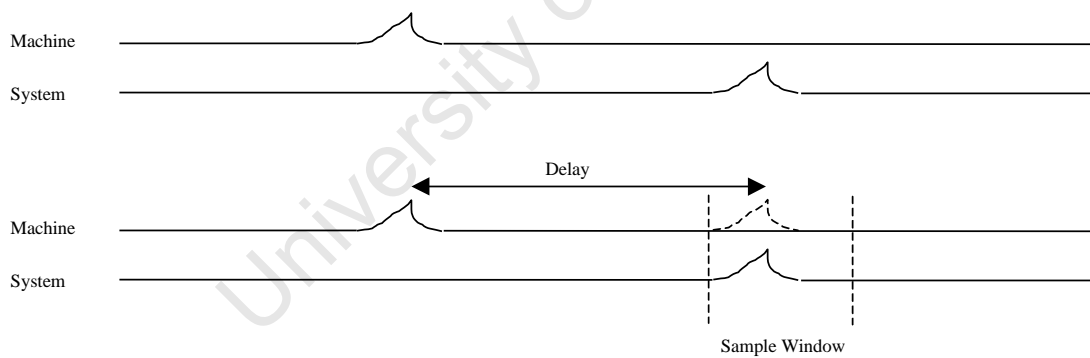
If the signal origin is from within the machine the two detected signals will fall into the same sample window as illustrated below:

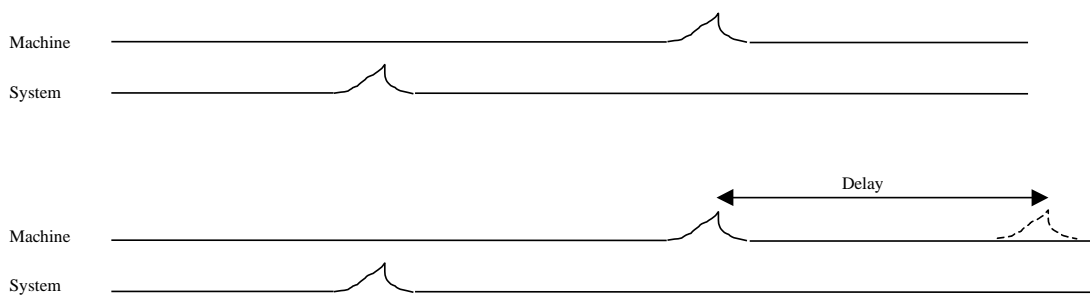
If the signal origin is from the system the two detected signals will not be congruent as illustrated below:

By using this technique signals from the machine can be discriminated from system noise.
