**EFFECT OF STRUCTURAL REPAIR AND STRENGTHENING ON
STIFFNESS AND ULTIMATE CAPACITY OF CORROSION-
DAMAGED RC BEAMS**

MOJABENG TIGELI

THESIS SUBMITTED IN PARTIAL FULFILMENT OF THE
REQUIREMENTS FOR THE DEGREE OF MASTER OF SCIENCE IN
CIVIL ENGINEERING

4th February 2010

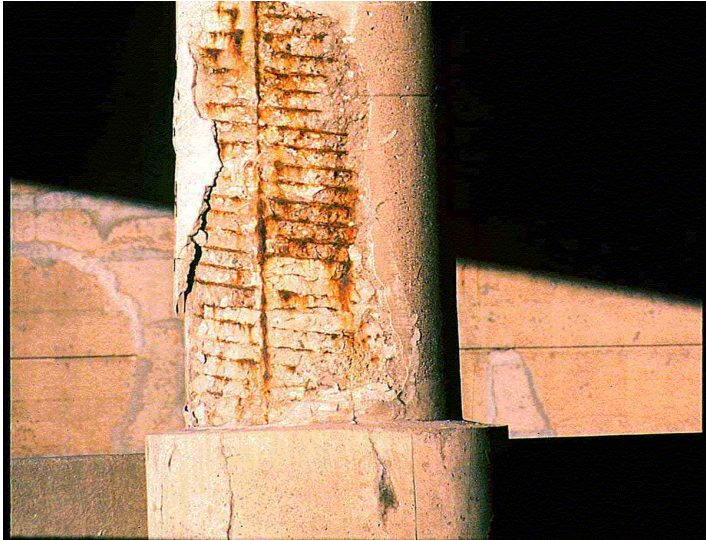
Figure 2.1: Corrosion of steel reinforcement (<http://irc.nrc-cnrc.gc.ca/ircpubs>, 2004)

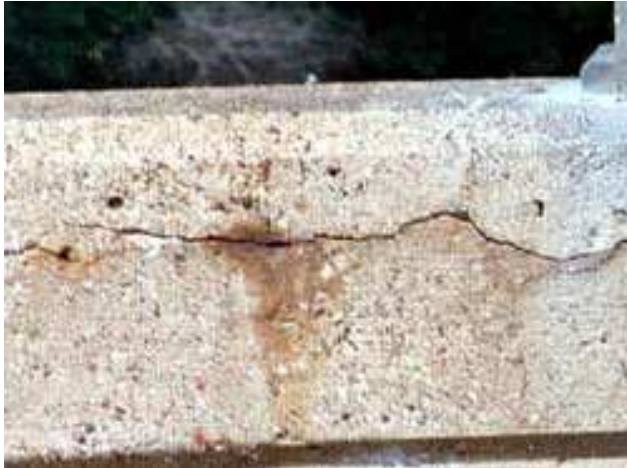
Corrosion cracks normally develop longitudinal to the direction of the reinforcement as shown in Figure 2.2. The compressed concrete around the corroded bars is consequently subjected to biaxial stresses and as a result of the transverse tensions, its longitudinal

Figure 2.2: Corrosion crack longitudinal to reinforcement direction
(www.cement.org/tech/faq_cracking.asp, 2009)

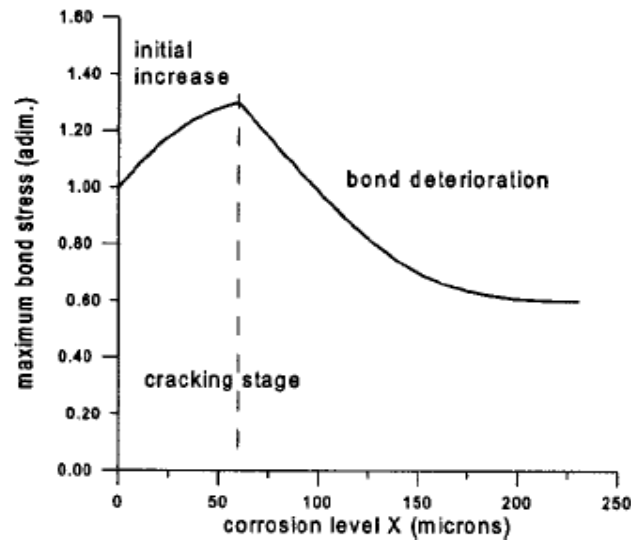
Studies devoted to understanding the effect of corrosion on the bond between reinforcement bar and concrete have led to the conclusion that there is a well defined relationship between the bond strength and corrosion level (Richardson, 1995; Capozucca, 1995; FIB, 2002, El Maaddawy et al, 2005). According to the FIB (2002), bond strength changes qualitatively as shown in Figure 2.3. El Maaddawy (2005) also illustrated that bond strength increases with the increase in corrosion prior to crack initiation, but a continuous loss of bond is observed after concrete cracks.

Figure 2.3: variation of bond strength with corrosion level (FIB 2002)

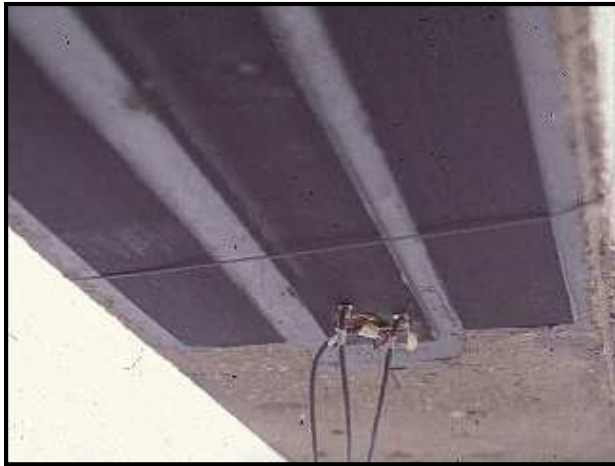
Figure 2.5 a: Concrete strengthened with steel plate (www-civ.eng.cam.ac.uk/cjb/cjbresearch1.html, 2008)

Externally bonding steel plates to RC members is one of the most common techniques used for upgrading RC members. This technique is cost-effective and efficient but has a number of drawbacks. It is prone to deterioration of the bond at the steel-concrete interface caused by the corrosion of steel (Banks et al, 2002). It has presented difficulty in manipulating the heavy steel plates at the construction site; especially in the case of flexural strengthening of long elements, therefore requiring scaffolding (Banks et al, 2002).

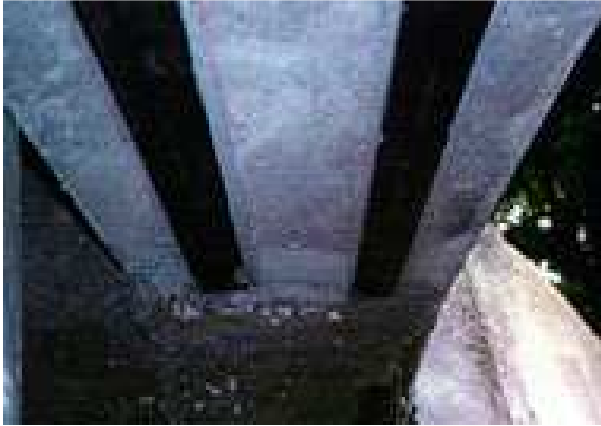
most suitable for flat surfaces such as beams, walls and slabs. Figure 2.5b shows the application of CFRP laminates to cater for increasing loads on a floor slab.

Figure 2.5 b: Concrete slab strengthened in bending (www.pulwellpultrusions.com/products5.htm)

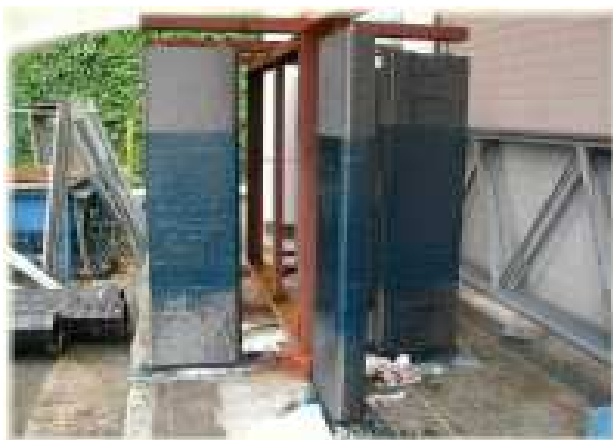
Figure 2.5 c: CFRP sheet system for columns (www.fos-ta.com/FRP-projects.html)

The sheet system consists of epoxy primer, putty, dry or pre-impregnated fibre and a resin system, which makes it a lengthier process than using the laminate system. This system often requires a post treatment such as painting, plastering or application of a thin layer polymer concrete (Taljsten, 2006). The sheet system is sensitive to irregularities on concrete surface and therefore requires pre-treatment. The sheet system is flexible and adapts to most surfaces as shown in Figure 2.5c where CFRP sheet is used to wrap columns. The system is most suitable for seismic retrofitting, strengthening of curved surfaces, strengthening of walls and slabs with openings.

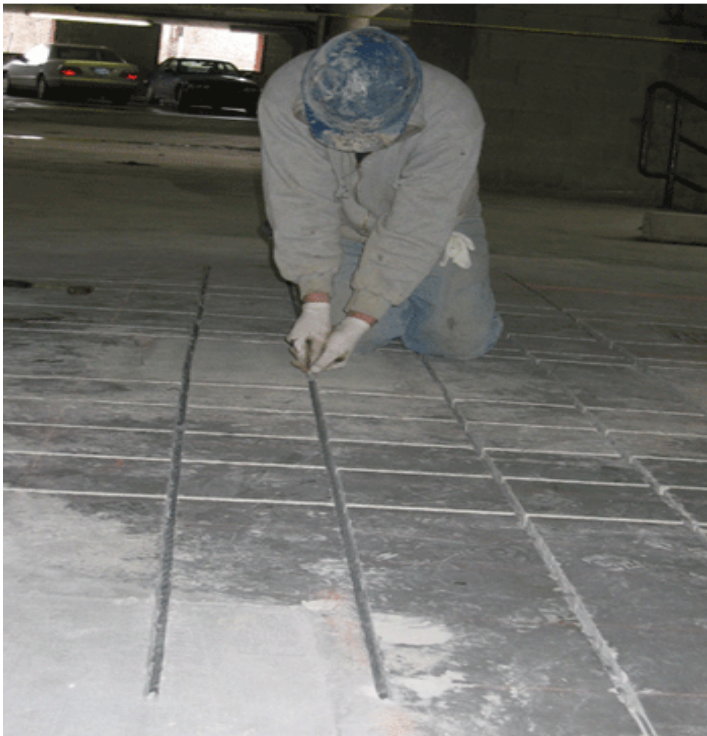
Near Surface Mounted Strengthening system is used mainly on surfaces that require protection from aggressive corrosion products. This system usually consists of circular or rectangular rods that are bonded in slots in the concrete cover of a structure, therefore requiring a concrete cover larger than 25 mm so that they can be fitted into the cover concrete. The pre-treatment of the surface consists of sawing slots in the concrete cover as shown in Figure 2.5d. The rods are then bonded in these slots with an epoxy adhesive or high quality cement grout (Taljsten, 2006).

Figure 2.5 d: NSMR strengthening. (www.hughesbros.com/aslan200/Aslan200_CFRP_bar)

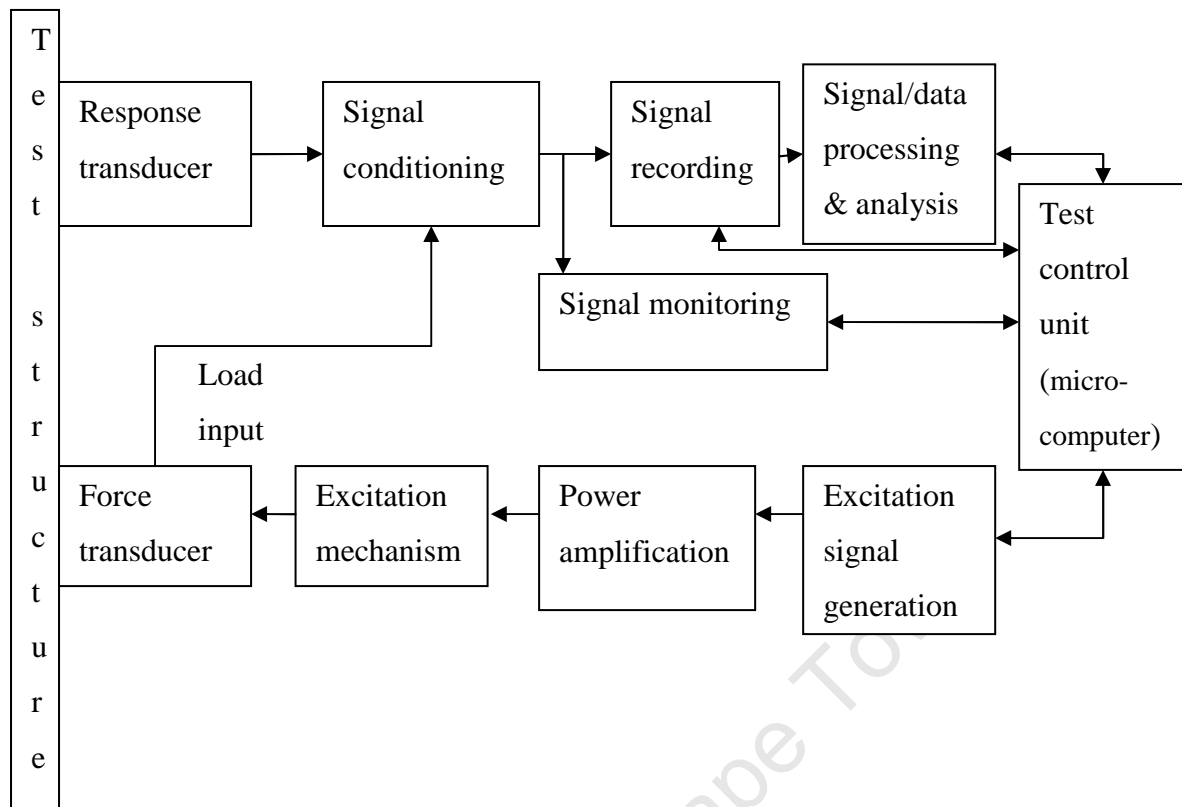
The basic steps involved in dynamic testing are illustrated in Figure 2.6. The test structure is provided with an excitation force which is generated from a computer system for regulation. The force is amplified to reach the structure. The response transducers are connected to the structure to capture the response of the structure to the applied force. The signal conditioner filters the signal that is recorded and processed; all these are captured into a computer system and analysed.

Figure 2.6: Stages involved in vibration testing (Salawu and Williams, 1995)

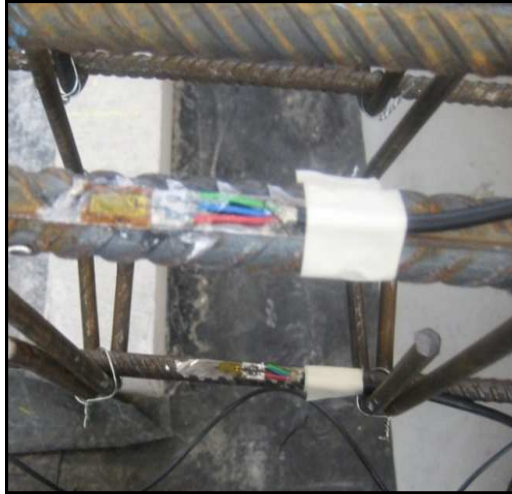
The reinforcement cages were fitted with the strain gauges for measuring the global strains in the beam during testing. Each beam is fitted with six strain gauges, three on both the tension and compression reinforcement. The strain gauges are very sensitive to dust, therefore require clean environment and skill. The reinforcement was ground for smoothing and cleaned before the gauges could be placed. The gauges were then glued to the smoothed surface and wires were soldered onto the gauges for connection to the data reading device as shown in Figure 3.2. The wires were extended such that they were long enough to connect after casting the beams.

Figure 3.2: strain gauges on the tension and compression reinforcement

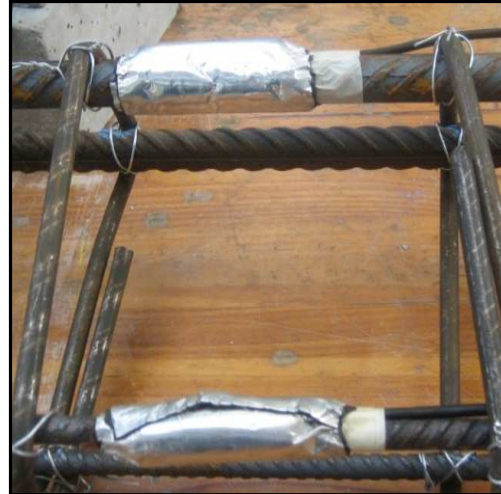
Figure 3.3: Strain gauges protected with an impermeable membrane

The strain gauges on the tension and compression bars have a resistance of 120Ω and 350Ω respectively. The gauges were placed at 1600 mm from both the left and right sides of the reinforcement cages and one at mid-span of the cage. The left side of the beam was marked by the wires soldered on the tension reinforcement for corrosion. The strain gauges were covered with clear silicon to prevent water damage, then covered with putty to prevent any direct impact that might damage the sensitive gauges, then wrapped with an impermeable membrane shown in Figure 3.3. Concrete was then cast over the reinforcement cages with the gauges to construct the beams.

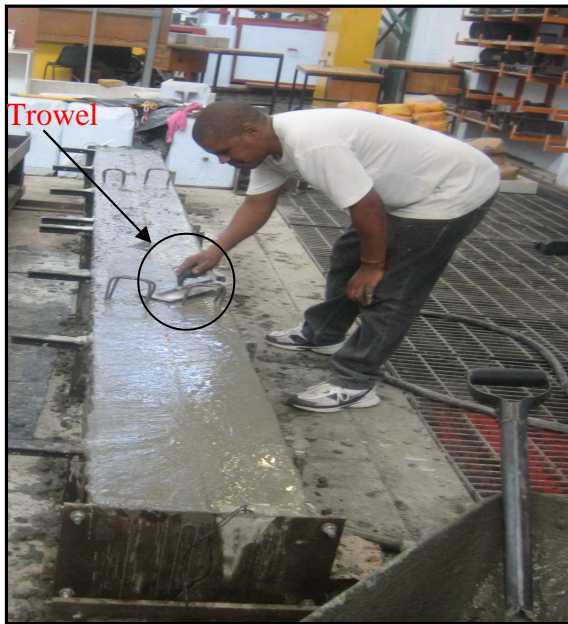
Figure 3.4: Concrete after casting

The beams were cast using ordinary Portland cement (OPC), with a w/b ratio of 0.55. 19 mm standard coarse aggregates were used as shown in Table 3.1. The average compressive strength of the concrete cubes after 28 days was 40 MPa, with a standard deviation of 2.8 MPa. Concrete was mixed in a concrete mixer and cast horizontally in the moulds, and then compacted with a poker vibrator and levelled with a trowel as shown in Figure 3.4. After casting, concrete was covered with plastic sheets for 48 hours, thereafter demoulded and cured by covering with a wet hessian cloth for 26 days as shown in Figure 3.5.

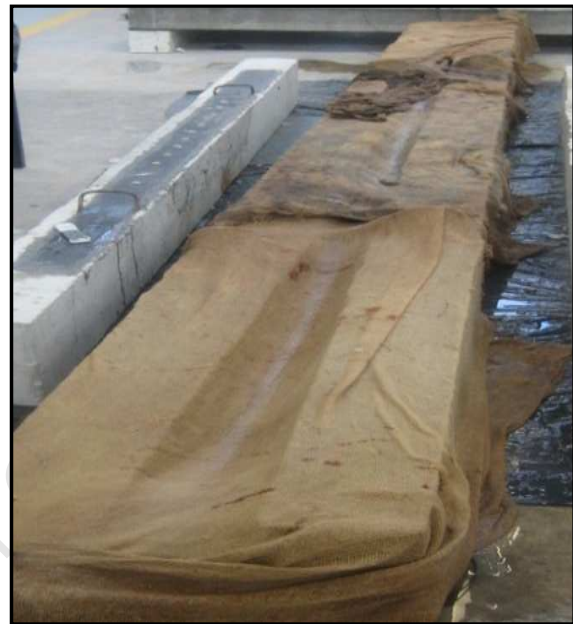
Figure 3.5: Curing with a Hessian cloth

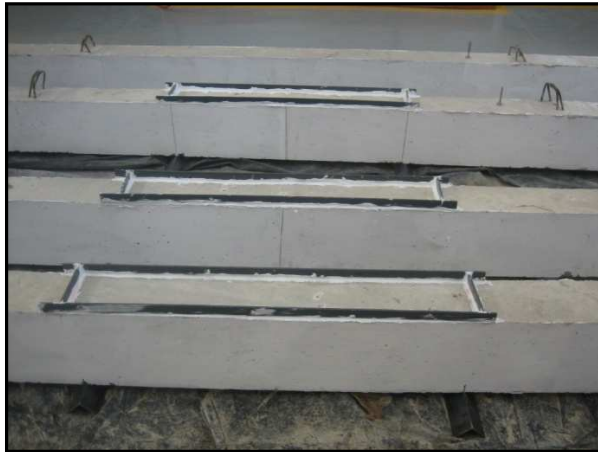
with shrink wrap to prevent moisture access. The tensile steel bars were connected to a positive terminal of the power supply to act as anode whilst the stainless steel bar was connected to the negative terminal of the power supply to act as a cathode. The stirrups around the tension reinforcement at the location of the pond were covered with an impermeable shrink wrap to avoid ingress of NaCl solution on the stirrups so as to prevent corrosion on them.

Figure 3.6: PVC corrosion ponds on concrete beams

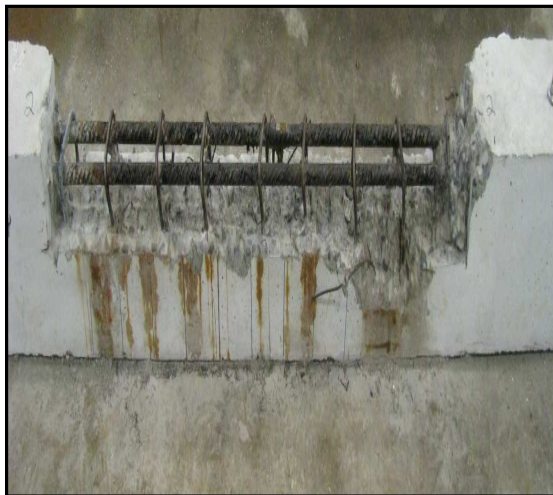
The corrosion damaged RC beams were prepared for repair by cutting-out the damaged area beyond the level of corroded steel, until sound concrete was reached. Damaged concrete was cut out with a grinder and broken out with a jack hammer to the level beyond the reinforcement to facilitate access to reinforcement when cleaning the corrosion products. The reinforcing bars were cleaned with a wire brush to remove the corrosion products before application of the patch repair mortars. Figures 3.7 and 3.8 show the section of the beam where damaged concrete was cut out and reinforcing bars after cleaning respectively. Durability repair in this work involves replacing the deteriorated concrete to restore its durability by providing adequate cover to the reinforcement.

Figure 3.7: Section through a beam where damaged concrete is cut out

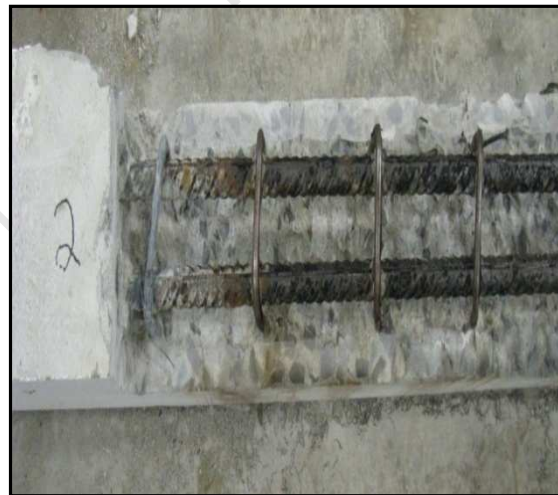
Figure 3.8: Reinforcing steel after cleaning corrosion products

The beam was cut up to 25 mm beyond the tensile reinforcement. The surface was cleaned such that it is free of all contaminants and all weak concrete removed. The loose material was removed mechanically by sand blasting. The reinforcement bars were cleaned, after which the exposed part of the beam was wetted overnight to ensure full saturation for preparation of the patch repair application.

Beams 2, 3 and 4 were patch repaired with a patch repair mortar. The grout was used to replace the damaged concrete within the beam. Formwork was provided around the cut area shown in Figure 3.8 and the repair mortar was placed to replace the damaged concrete. Figure 3.9 shows the repaired section of the beam. The beams were covered with a polythene sheet over night and then covered with a wet hessian cloth after demoulding for 28 days.

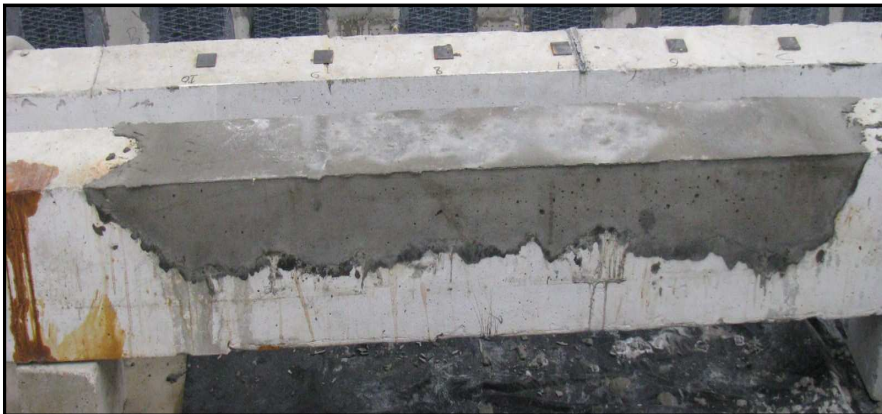
Figure 3.9: Patch repair section through the beam

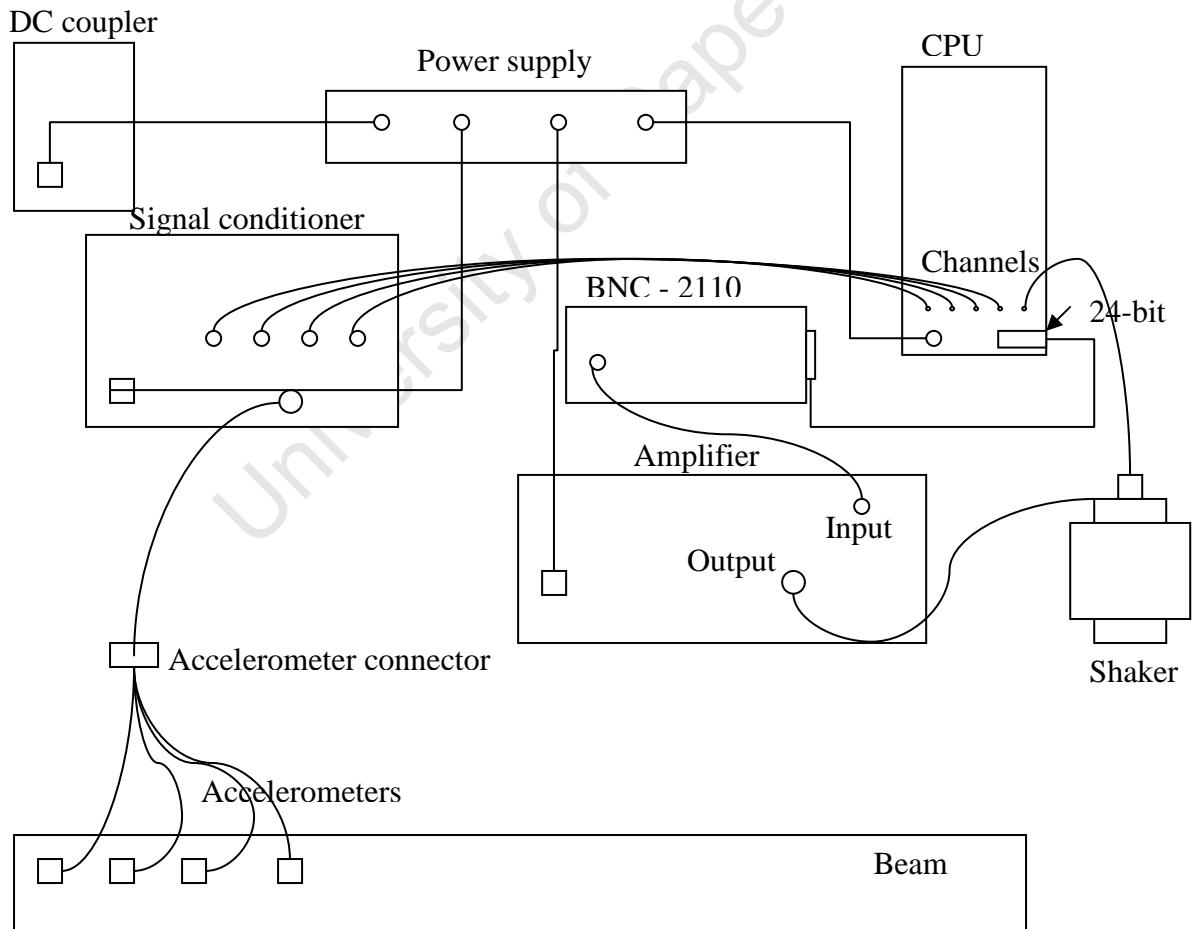
Figure 3.13: Instrument wiring diagram

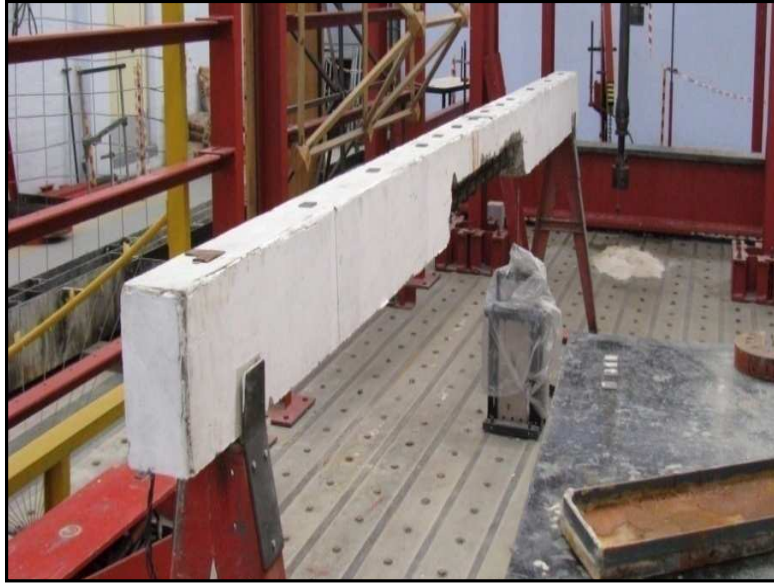
The same test was performed on the beam after it was corroded and after the corrosion damaged area was cut out as shown in Figure 3.15. This is to assess the change in dynamic stiffness of the beam with exposed reinforcement before repair. This is done in order to assess whether or not the stiffness is affected when preparing for repair. Dynamic testing still continued after the beam was repaired and cured and strengthened with FRP laminates.

Figure 3.15: Dynamic testing of the beam after the damaged concrete was removed, before repairing

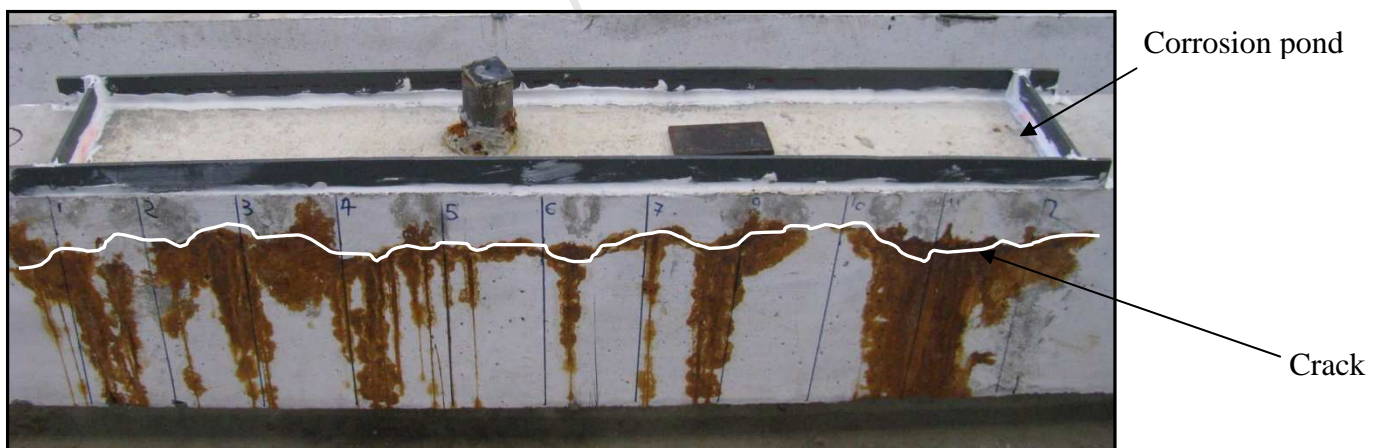
The crack pattern due to expansion of corrosion products was monitored for each beam during corrosion. Three different types of crack patterns were observed (Figures 4.2a to c). Beam 2 had one surface crack on each side of the beam parallel to the corroded reinforcing bar. Beam 2 had corrosion products leaching out of the side cracks. Beam 3 had two surface cracks, both of them were located at the top surface directly above the reinforcing bars inside the corrosion pond, crack 1 extended along the length of the corrosion pond whilst crack 2 converged to crack 1 at the beam mid-span, the corrosion products were leaching out of the cracks inside the pond. In Beam 4, two surface cracks were observed at the top surface directly above the reinforcing bars and both cracks extended along the length of the corrosion pond and the corrosion products were leaching out inside the pond. All the observed corrosion cracks were parallel to the steel reinforcement, yet all beams presented different crack locations. This shows that the crack locations are independent of the level of mass loss as all beams were corroded for the same duration. Beam 4 which was initially corroded to an estimated 10% mass loss maintained the same crack pattern when corroded further to an estimated 15% mass loss.

Figure 4.2a: Crack pattern for Beam 2.

Figure 4.2b: Crack pattern for Beam 3.

Figure 4.2c: Crack pattern for Beam 4.

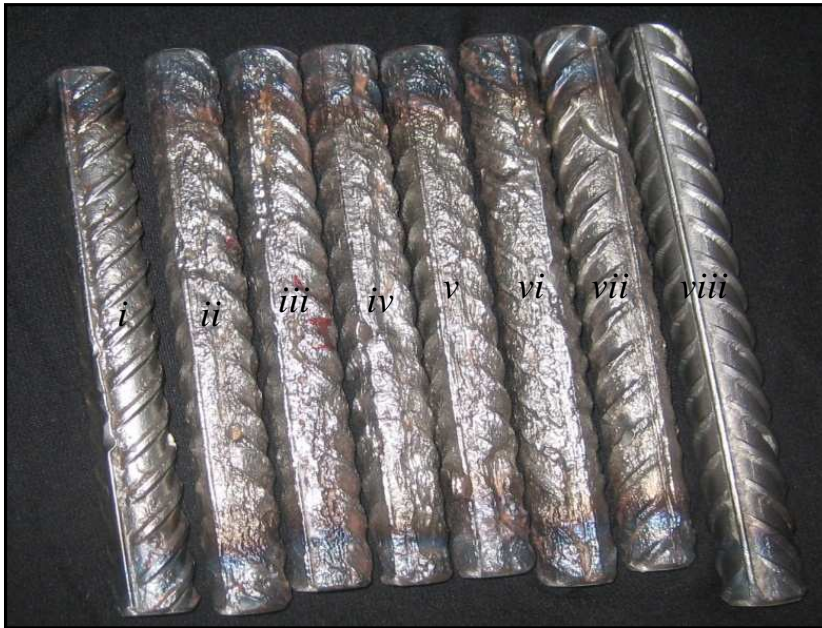
Figure 4.4: Corroded steel bars

According to Table 4.2, the bars were corroded 300 mm beyond the corrosion region on both sites. The bars around mid-span (iv and v in Figure 4.3) showed a comparable mass loss to the estimated. Mass loss beyond the corrosion region (i and viii in Figure 4.3) showed the least mass loss as mass loss seemed to decrease when moving away from the centre of the corrosion region. Figure 4.4 shows the corroded bars extracted from the beam. The bars showed pitting corrosion mainly concentrated around the centre of the corrosion region. The bars are arranged in the same order as in Table 4.2. Bars iv and v are the bars at the centre of the corroded region.

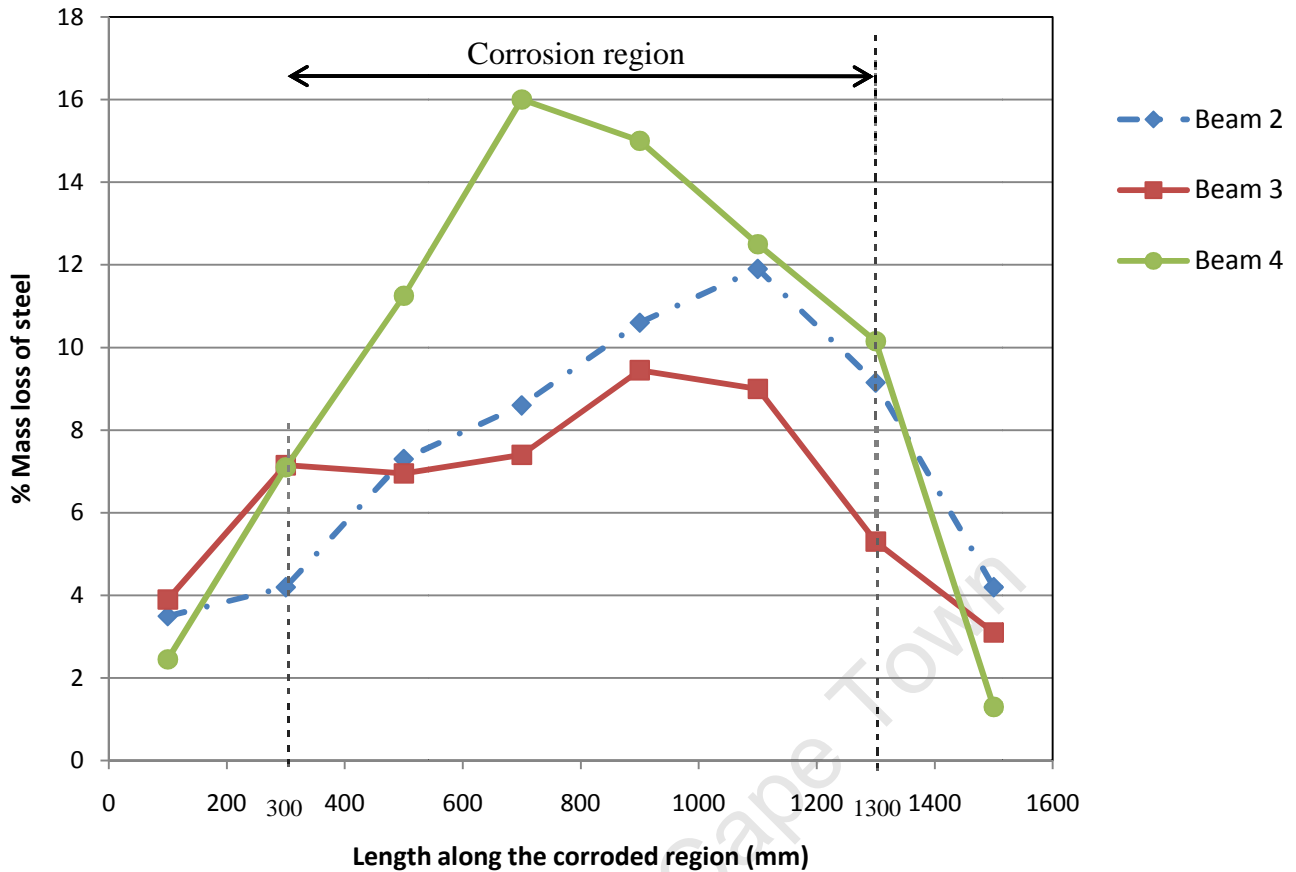
The measured average mass losses of steel on both bars for the three corroded beams are shown in Figure 4.5. Beam 4 which was corroded to an estimated 15 % mass loss had a maximum mass loss of 18.9 %; while beams 2 and 3 with an estimated mass loss of 10 % had maximum mass losses of 16.6 % and 12.4 % respectively. The maximum mass loss on all the beams occurred around the centre of the corroded bar. The mass loss of steel was different on the two bars at the same length along the beam as observed from Table 4.2.

Figure 4.5: Mass loss of steel along the corroded region

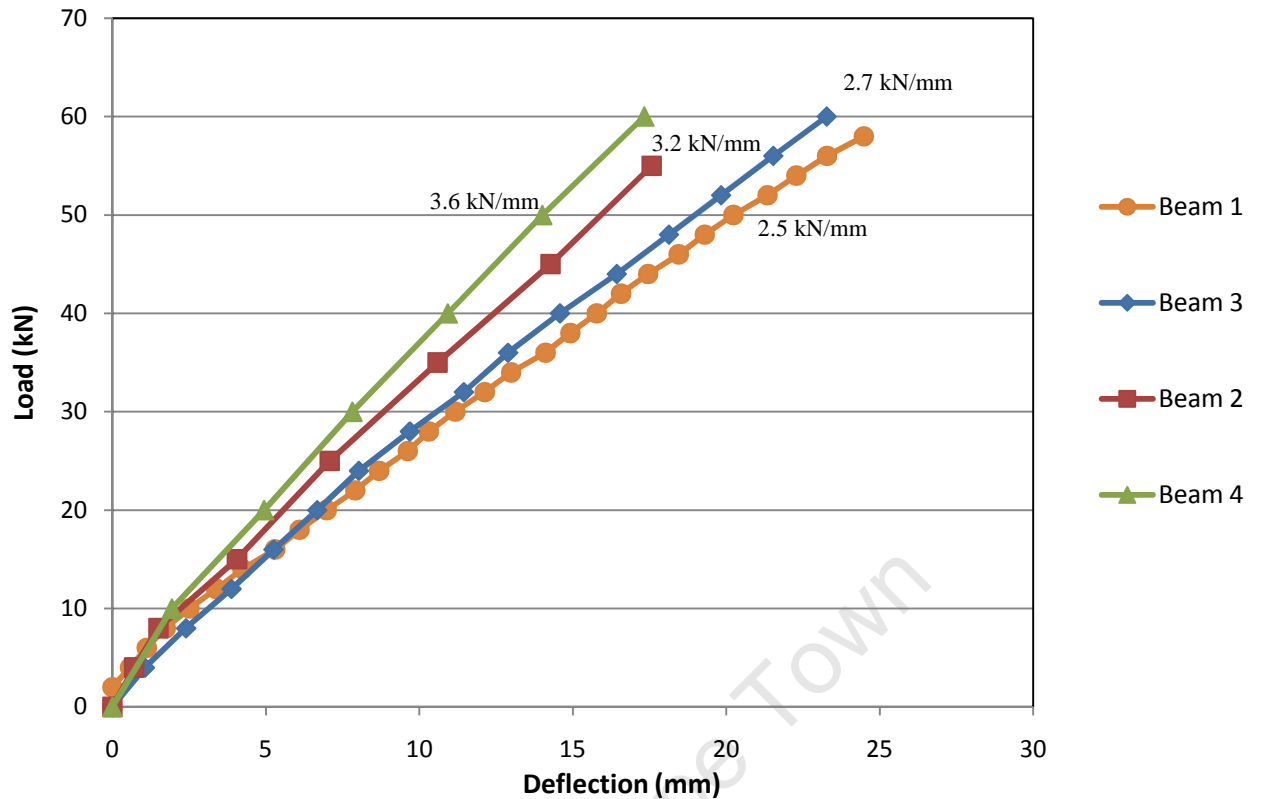
Figure 6.1: Deflection measurements of all beams

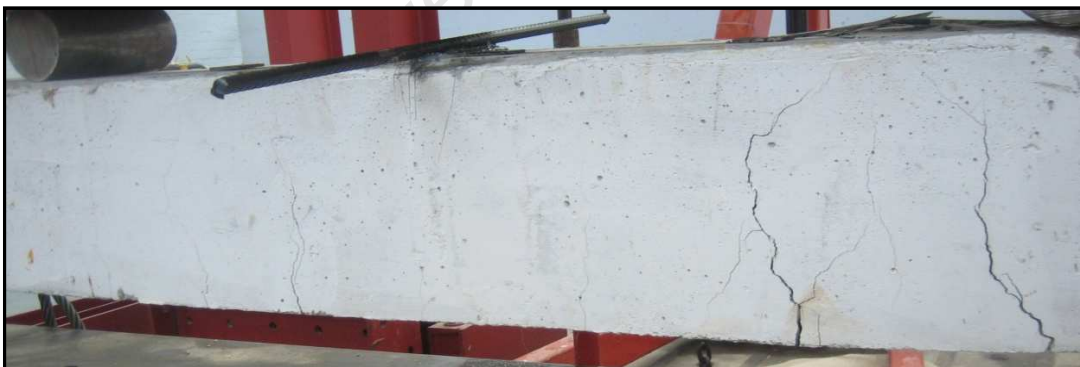
Different failure modes were observed when the beams were loaded. Figures 6.8 a-d show the failure modes of beams 1 to 4 respectively. Beam 1(control) developed vertical cracks along the length of the beam. The cracks were equality spaced, but at failure; when steel yielded cracks between the two loading points opened wider followed by crushing of concrete at the point where the load was applied.

Figure 6.8a: Crack pattern on Beam 1 during failure

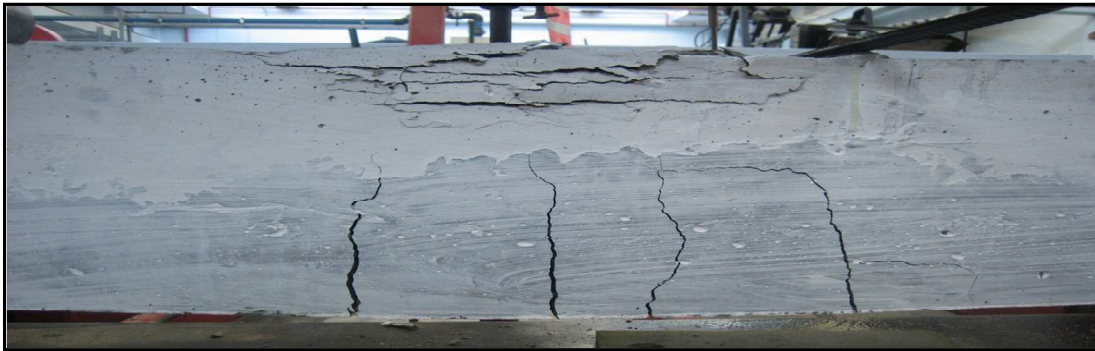
Beam 3 (patch repaired) showed a different failure mode. Vertical cracks developed along the length of the beam. Beam 3 failed first by yielding of steel then followed by opening up of cracks on the

tension side at mid-span, thereafter followed by crushing of concrete on the compression face at mid-span. There was no debonding between the patch repair and the substrate at failure, the cracks extended from the patch repair through the substrate.

Figure 6.8b: Crack pattern on Beam 3 during failure

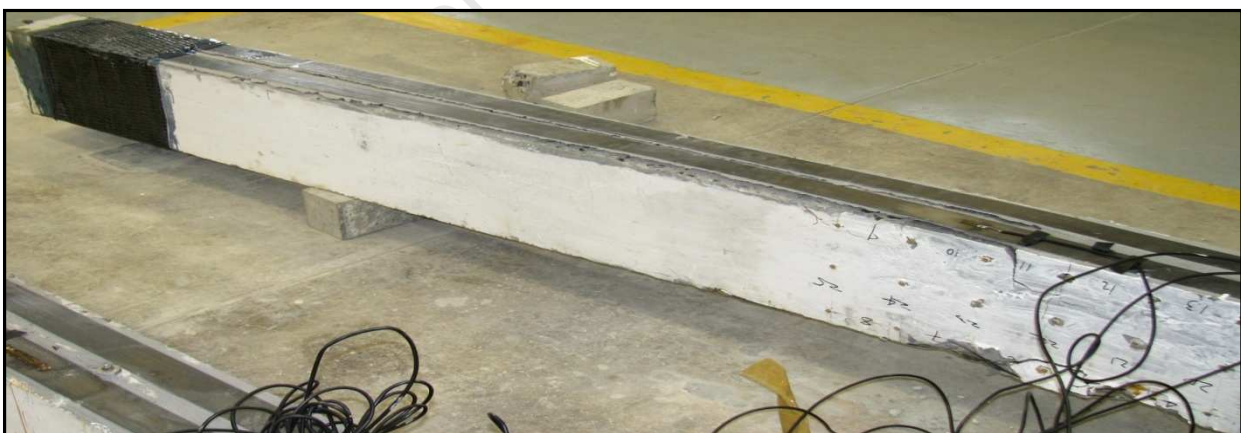
Beams 2 and 4 (with patch repair and CFRP) showed similar failure modes as show in Figures 6.8 c and d. The vertical cracks opened wider at the point of load application, followed by debonding of the CFRP laminates. Immediately as the laminates debonded, the beam failed. Debonding of CFRP commenced from the crack to one end of the beam where the laminates were anchored while the other side of the laminates remained intact.

Figure 6.8c: Crack pattern on Beam 2 during failure

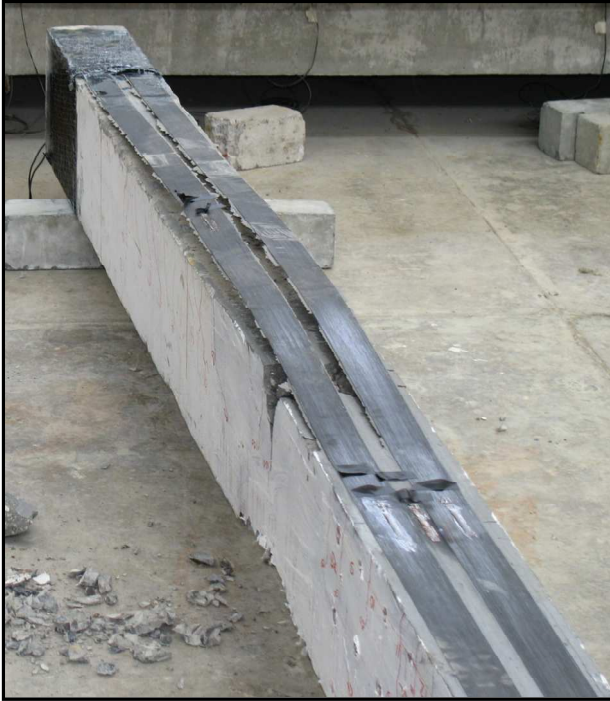
Figure 6.8d: Crack pattern on Beam 4 during failure
