THE WEAR OF MATERIALS IN AN ASH CONDITIONER

A Dissertation submitted to the Faculty of Engineering, of the University of Cape Town, in fulfilment of the requirements for the Degree of Master of Science in Engineering.

Department of Materials Engineering  
University of Cape Town  
January 1989

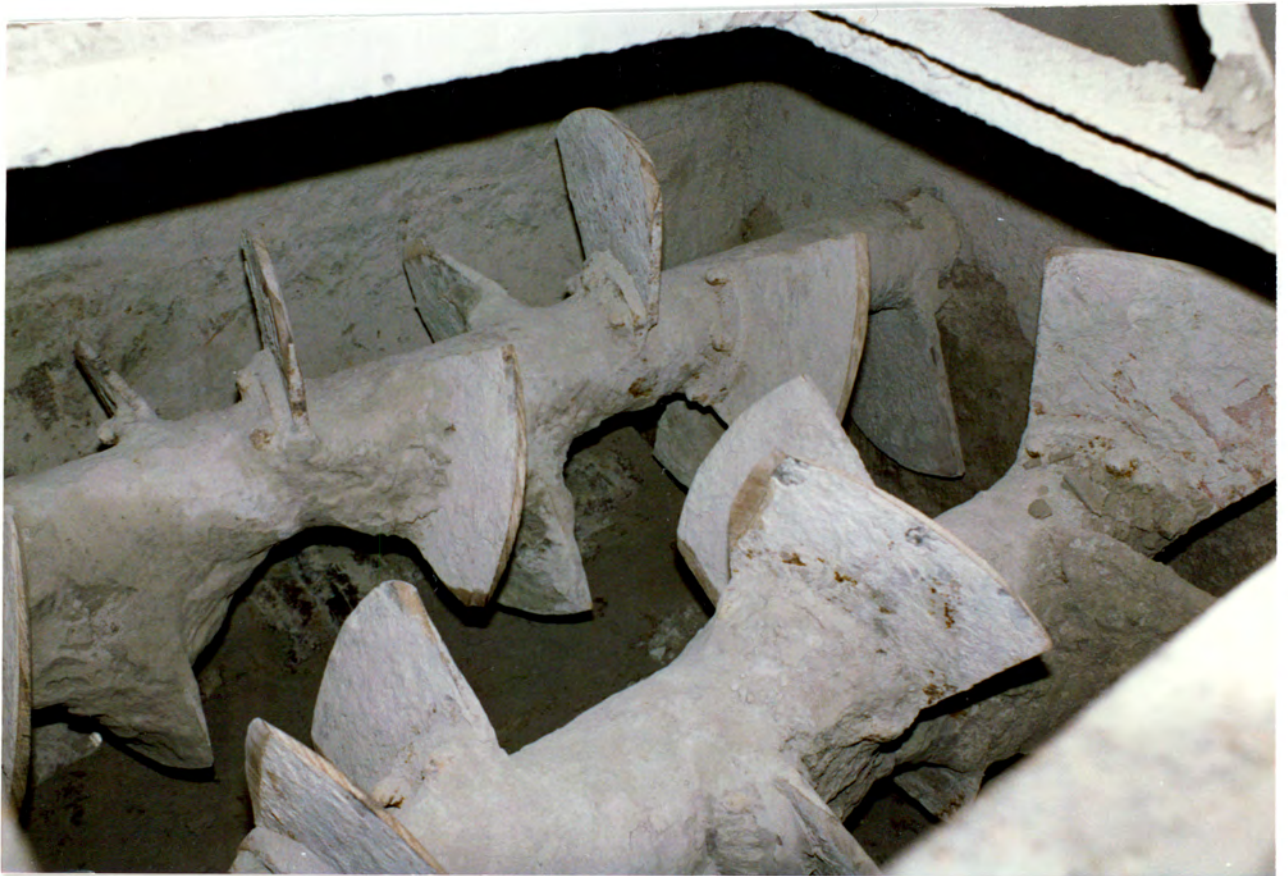
Figure 1.2 Ash conditioner showing positioning of mixing blades located on counter rotating shafts.

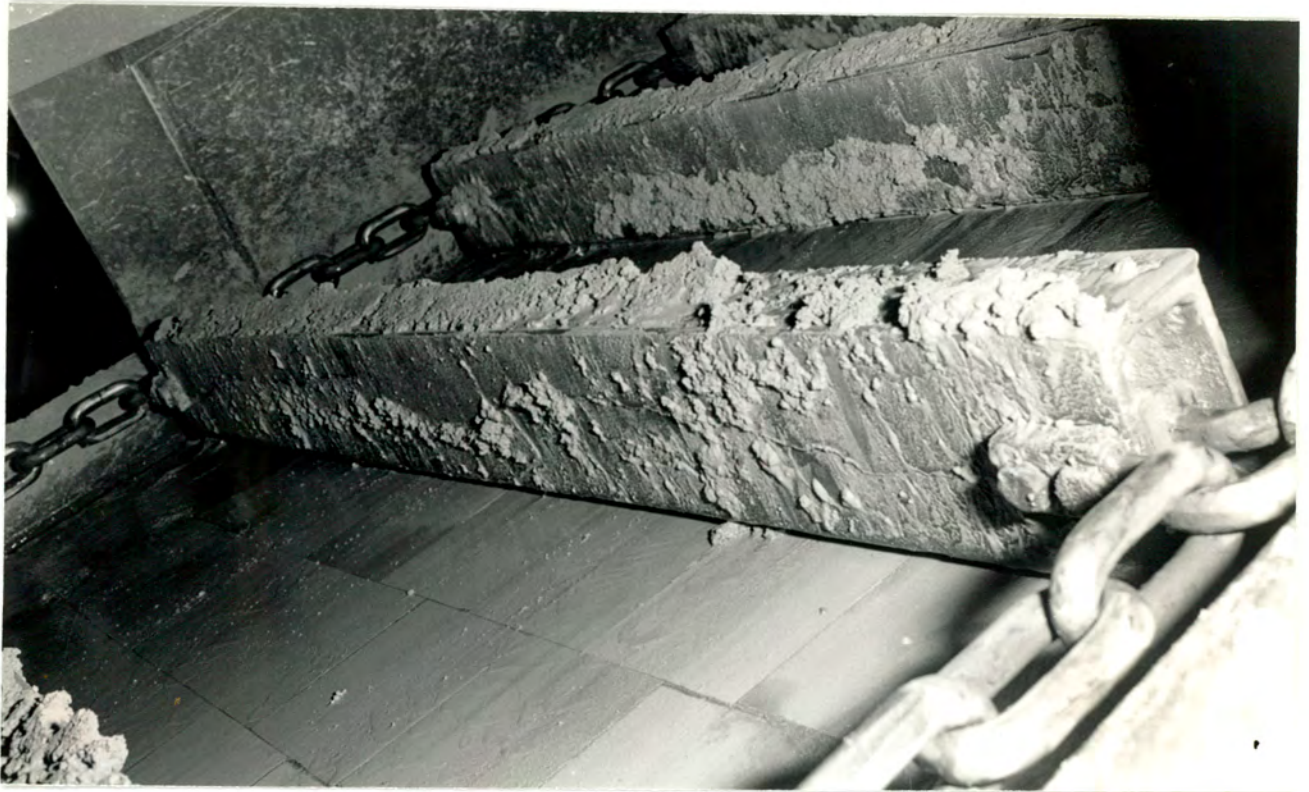
Figure 1.3 Return side of the drainage deck of a submerged scraper conveyor. Flights are suspended between two parallel running chains. Flights are seen moving over a surface lined with alumina tiles.

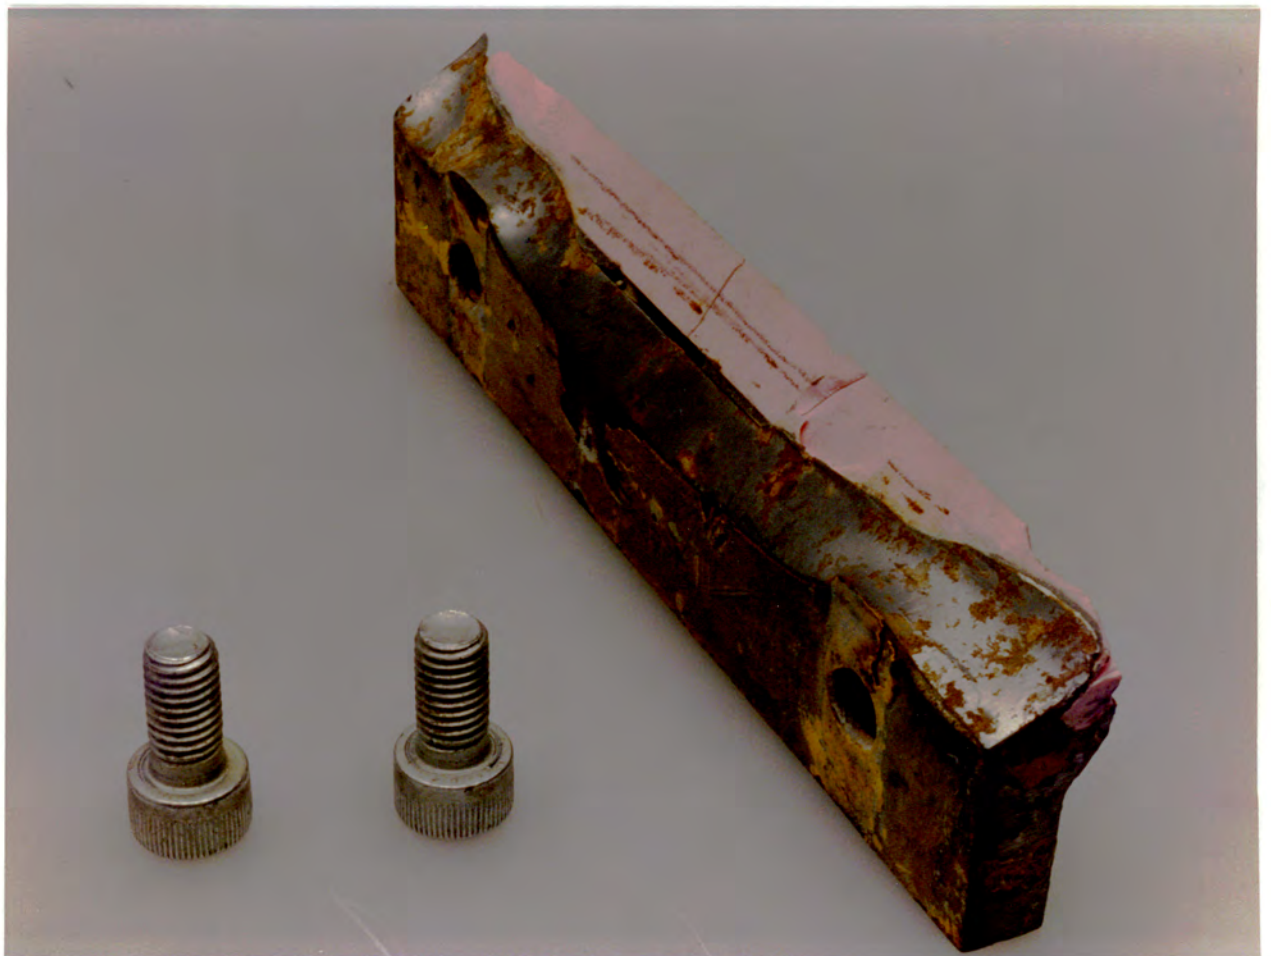
Figure 1.5 (a) Belt cleaning scraper, on a sprung arm held tangential to a conveyor belt.

(b) Scraper blade

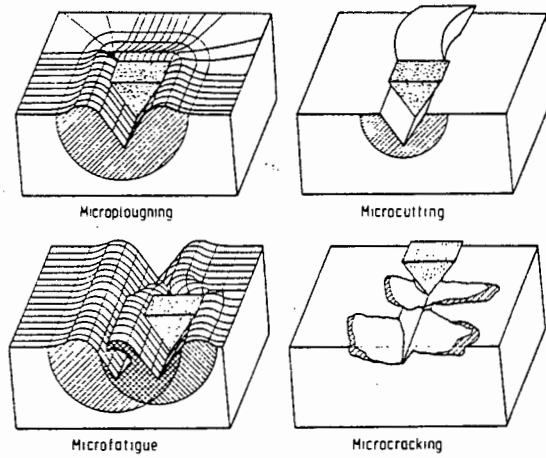
Figure 2.3 Schematic illustration of abrasion mechanisms resulting from physical interactions between abrasive particles and the surface of materials. [11]

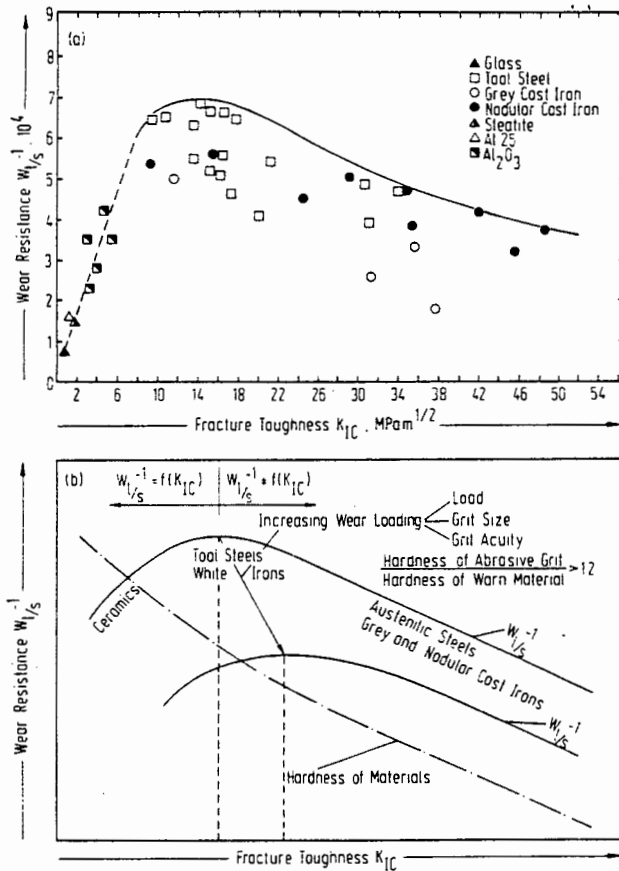
Figure 2.4 Relation between fracture toughness and abrasive wear resistance of different metallic and ceramic materials: (a) experimental data (b) schematic illustration [11].

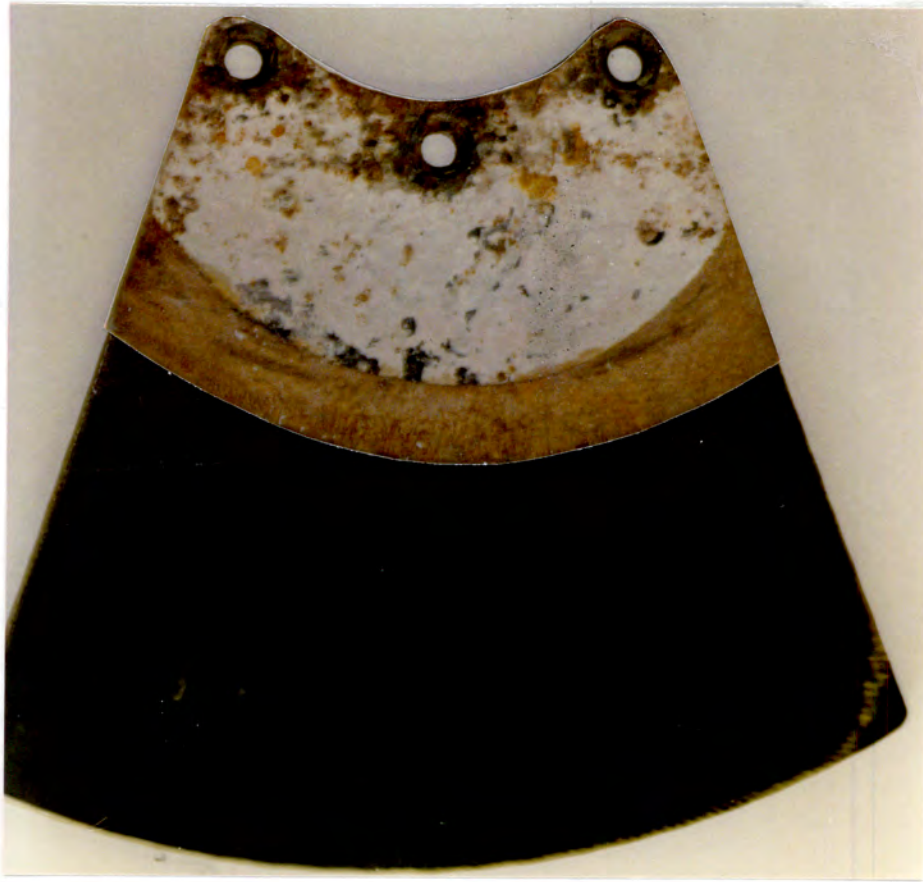
Figure 3.4 Extent of mixer blade wear after 2000 hours in service.

The reason for this variation in blade wear is considered to be due to the abrasion stress levels to which the metal is subjected. Near the inlet position there is little compaction of the loose ash-water mixture against the bin wall, with the result that the contact stress between the abrasive particles and the moving blade tip is low. However as the ash advances through the conditioner, it becomes more compacted and encrusted on the sides of the bin, resulting in progressively greater contact stresses between the blades and the ash mixture, with consequent higher wear rates. The fall in wear rate from the mid-section to the bin exit can be attributed to a lowering of the back pressure on the blades as the mixture moves more freely. At the exit point little wear is experienced.

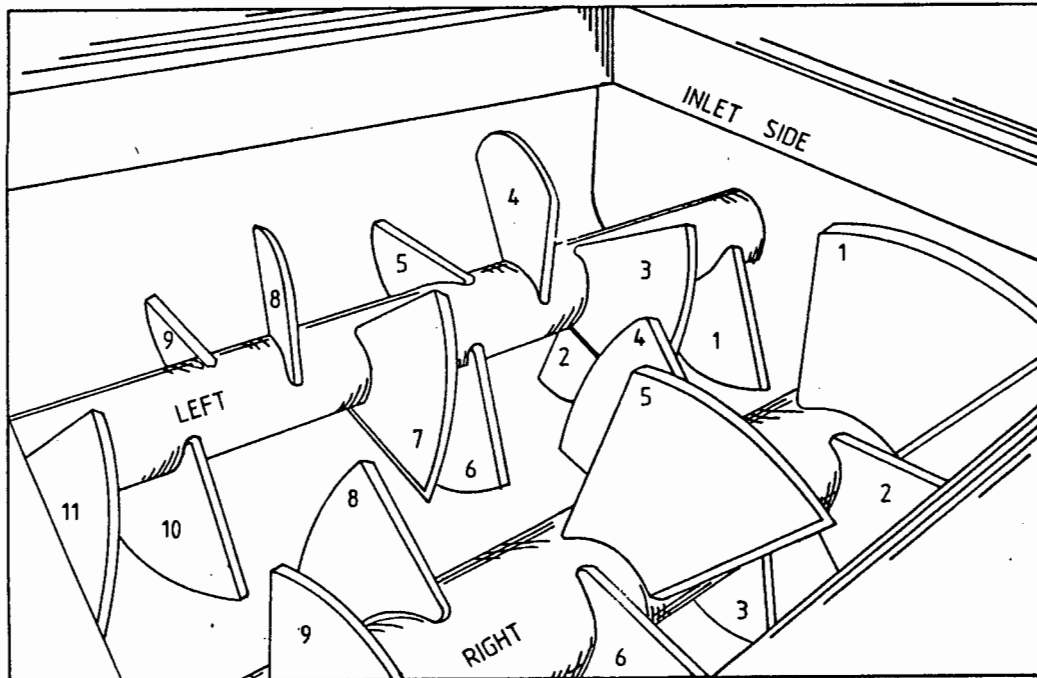
Figure 3.7 Schematic diagram of ash conditioner showing positioning of test and reference blades.

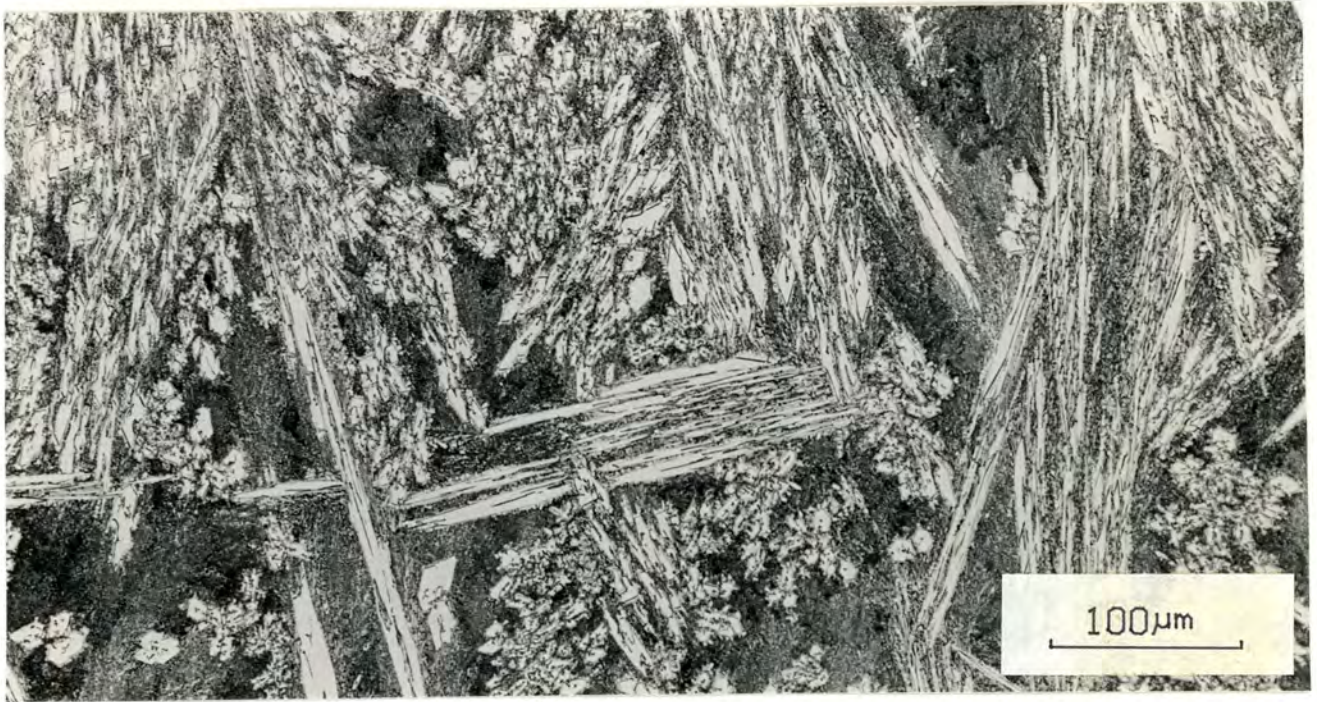
Figure 3.14 Microstructure of Alloy G. Similar to alloy F but somewhat finer.

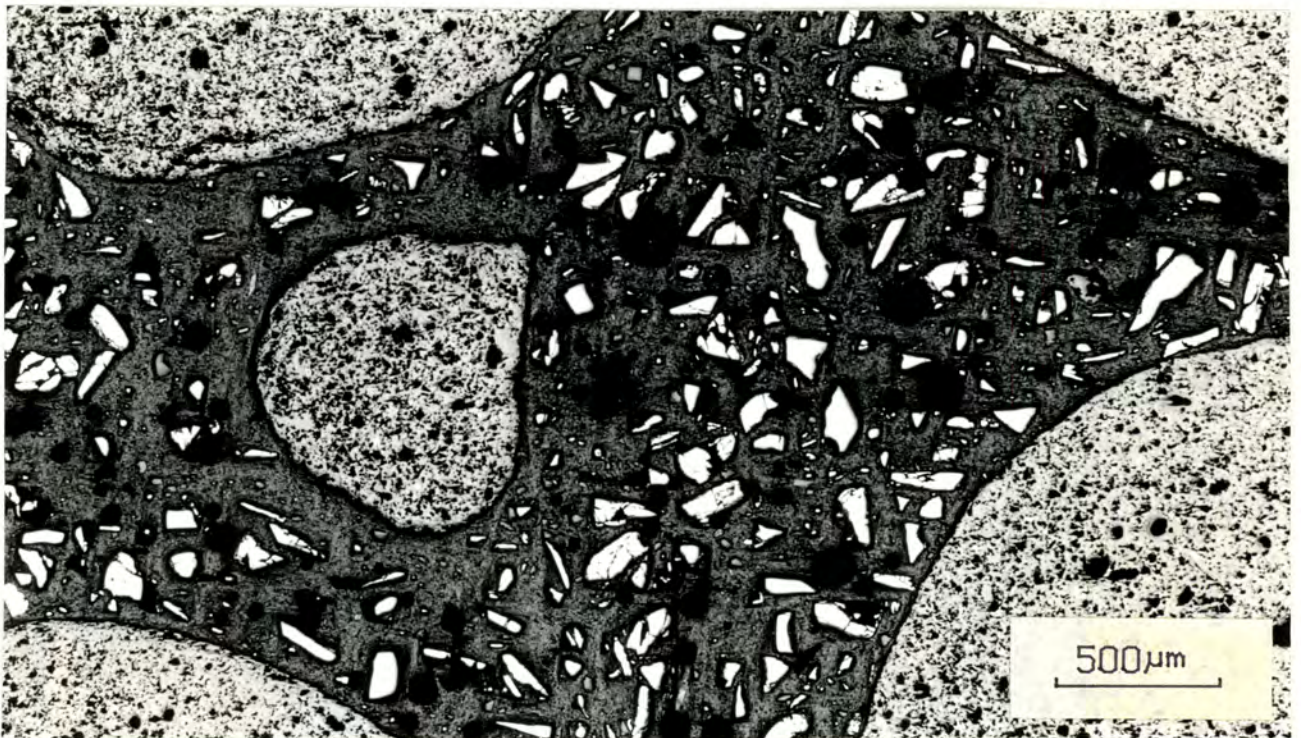
Figure 3.15 Structure of ceramic (white spheres) bead impregnated epoxy. Note the presence of silicon carbide crystals in the epoxy.

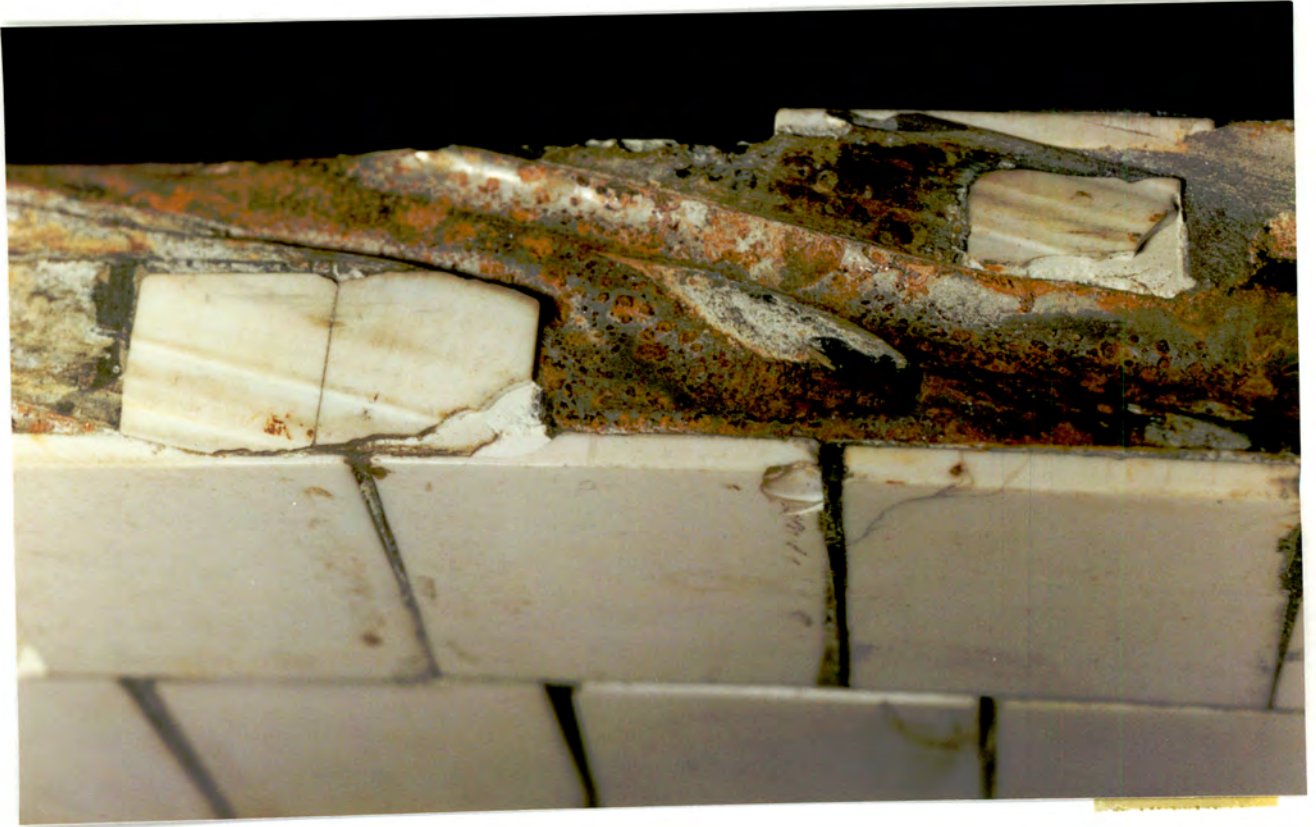
**Figure 3.18** Comparison of the presence of wear tracks on alumina ceramic and steel on a blade tip.

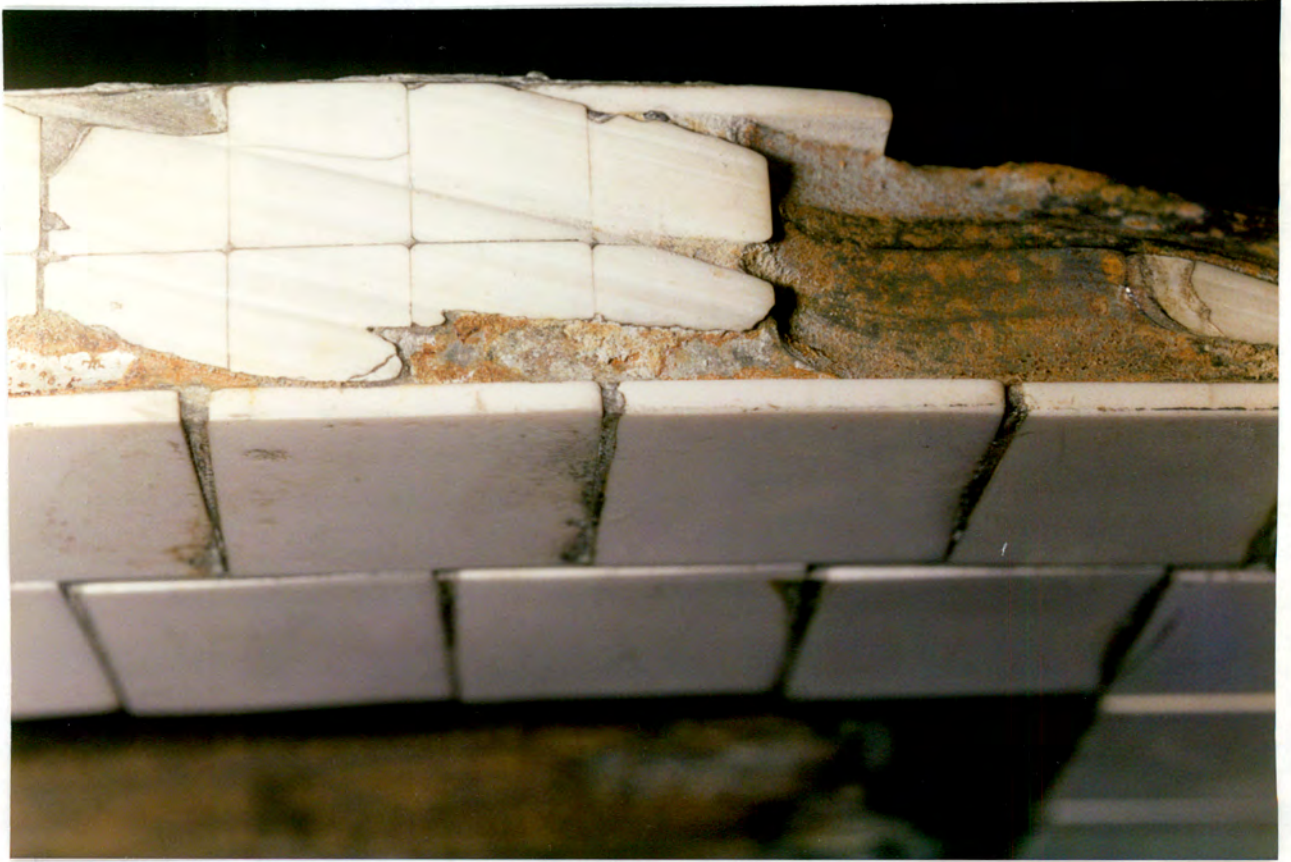
Figure 3.22 Degradation of underlying metal once protection by ceramic tiles is lost.

However a disadvantage found with the use of ceramic tiles was that the method of application was not altogether satisfactory, leading to tile loss and impaired performance as indicated in Figure 3.22. Hence design and method of application should also be given attention.

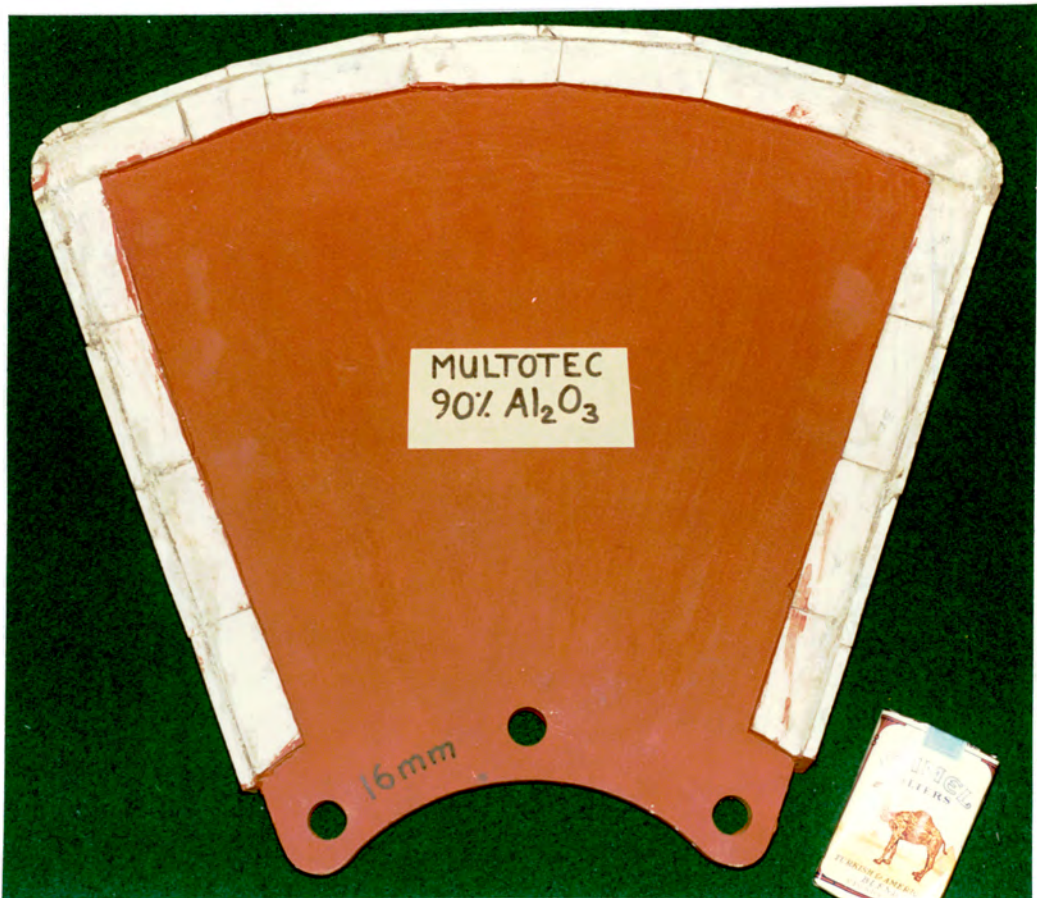
Figure 4.2 Ceramic tiles attached to areas of the blade exposed to significant wear.

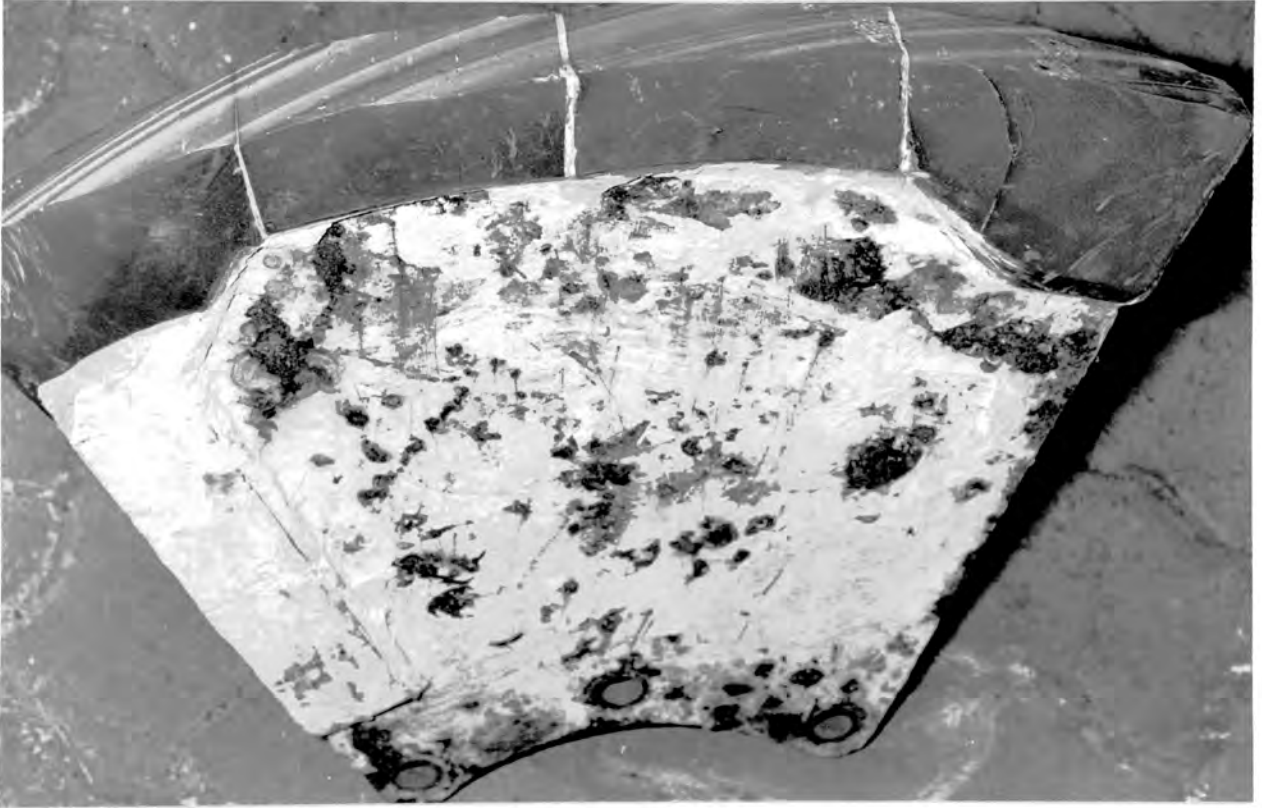
**Figure 4.7** A crack which has arrested at the joint between two tiles illustrating the benefit of tile joints.

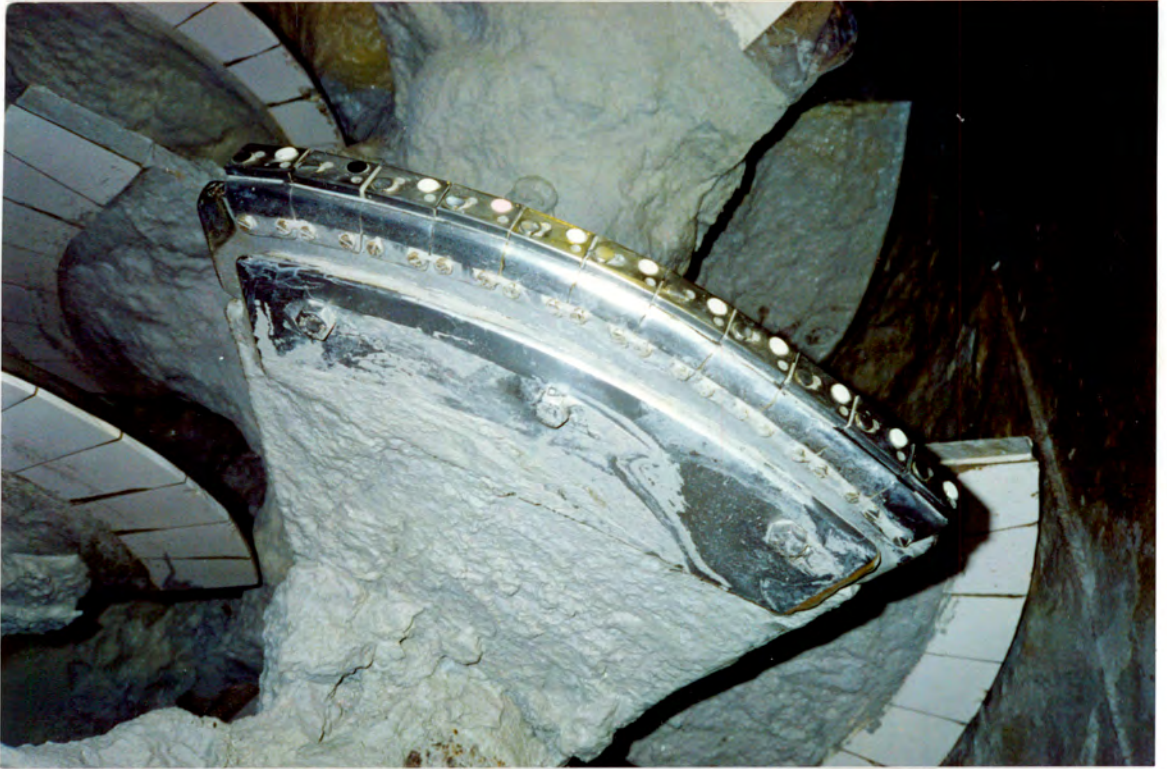
Figure 6.1 Layout of ceramic test pieces and medium carbon steel references.

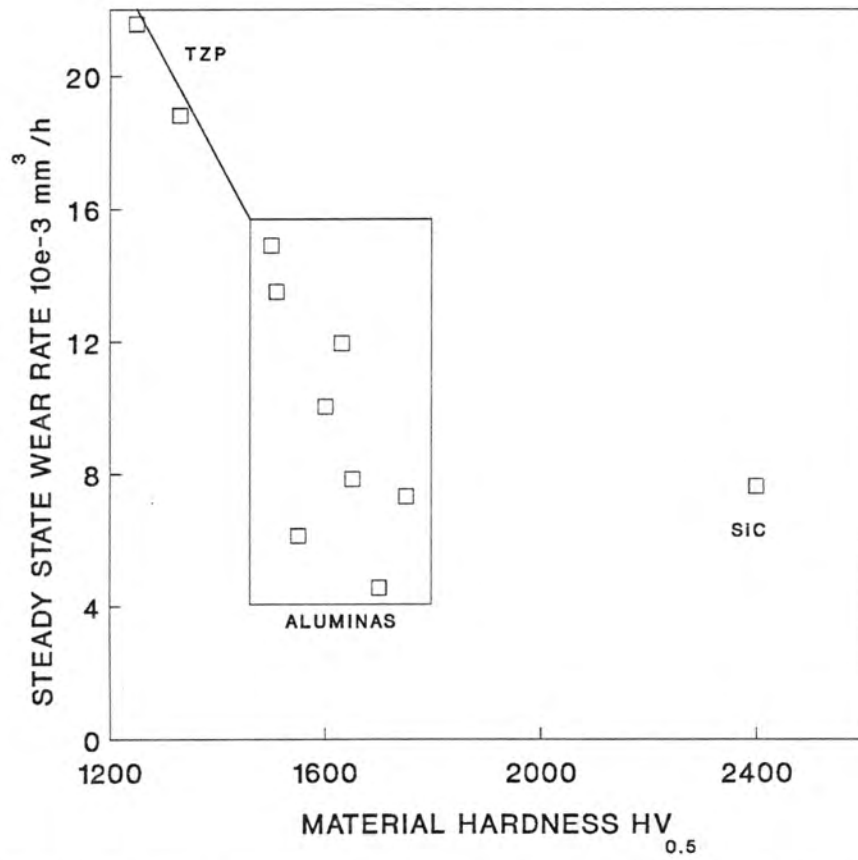
Figure 6.4 Relation between bulk material hardness and steady state wear rate.
