**ASSESSMENT OF ALKALI AGGREGATE REACTION AVOIDANCE MEASURES  
AND ALKALI AGGREGATE REACTION TESTS WORLDWIDE**

**MASTER OF ENGINEERING IN CIVIL INFRASTRUCTURE MANAGEMENT AND  
MAINTENANCE**

**MARTHA NDINELAO MWATILE**

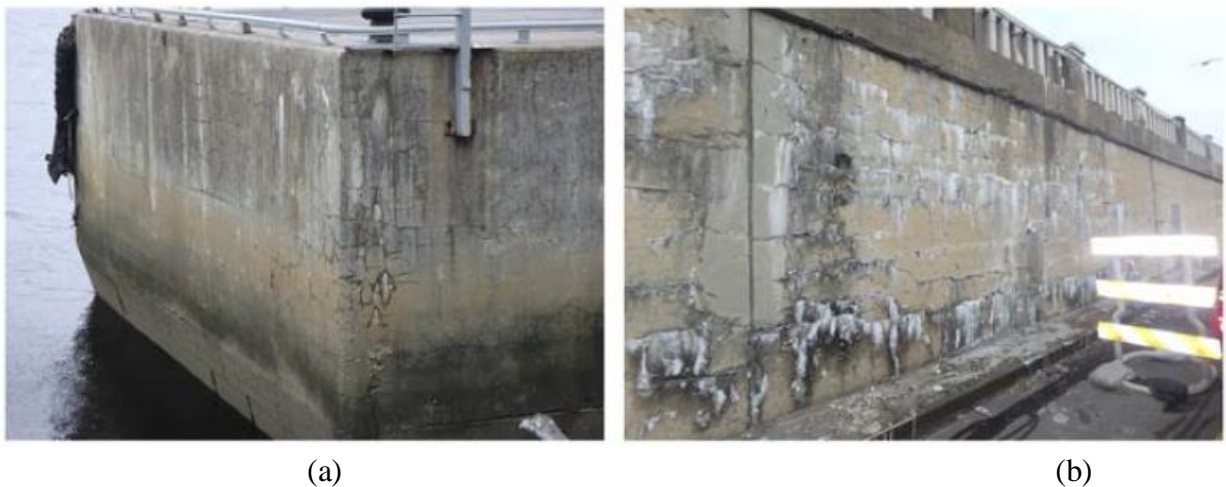
Figure 2: (a) Moderate AAR cracking in cope wall and (b) More severe AAR cracking gel discharge in retaining wall (Alexander, 2019)

The most typical manifestation of AAR is concrete cracking. AAR and more particularly ASR results in the formation of gel, which swells and causes expansion within the concrete when there is a presence of water. These internal expansions exceed the tensile capacity of the concrete and result in cracking (Alexander, 2019). The effects of AAR can appear as very unsightly and at other times alarming cracks that can be centimetres wide. AAR may also result in external features such as a gel being discharged from cracks, unsightly straining as well as random or map cracking. Figure 2 (Alexander, 2019) shows such cracking in two different structures – one where the cracking is moderate and random and the other where the cracking is severe.

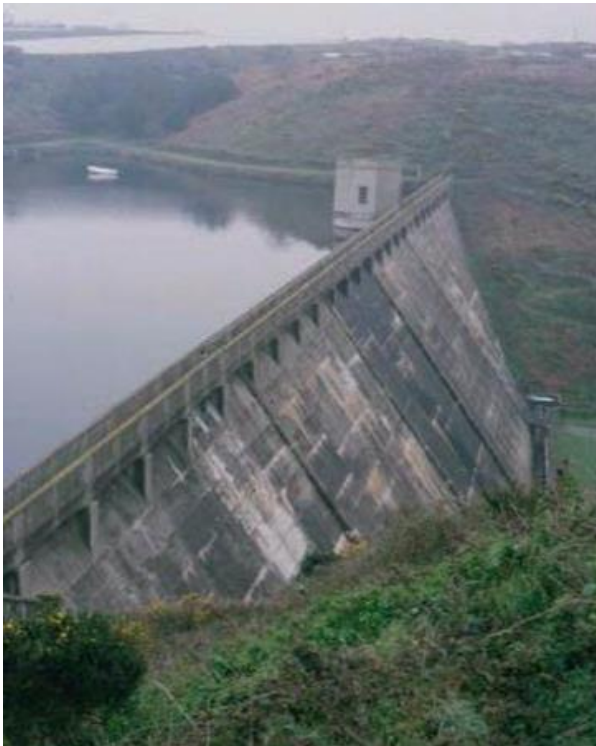
*Figure 3: The Val de la Mare Dam in the United Kingdom in April 1989 (Sims, 2017)*

The Val de la Mare Dam is a mass concrete gravity dam located in St Ouen's in Jersey in the United Kingdom. It was constructed from 1957 to 1961, with the dimensions of 29 m height and 168 m length, as shown in Figure 3 (Sims, 2017). The coarse aggregate used in the construction was mainly crushed diorite and granodiorite, combined with Jersey shale, chert and some igneous rocks. The fine aggregate used was a fossil beach sand that consisted of quartzite, quartz and feldspar as well as small contents of chert, shell and igneous rocks.

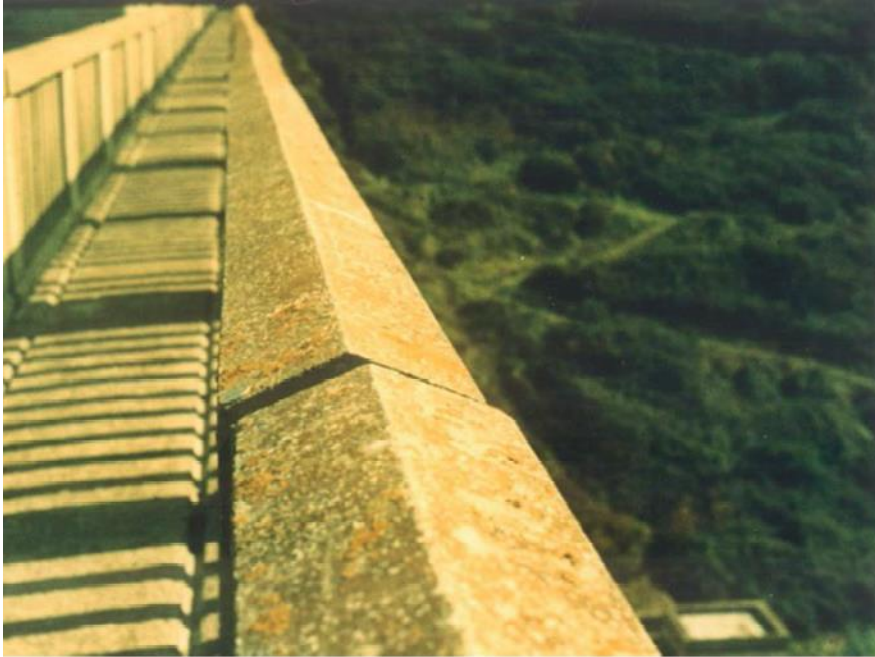
*Figure 4: Concrete parapet of the Val de la Mare Dam in the United Kingdom with a displacement of up to 13mm (Sims, 2017)*

In 1971 – about 10 years after construction - four of the concrete sections exhibited discoloration, dampening and cracking, and there was a displacement of up to 13 mm in some sections, as can be seen in Figure 4 (Sims, 2017). Over the 13 years that followed, the dam was monitored and a continued expansion of 50-75 microstrain per year due to ASR was observed.

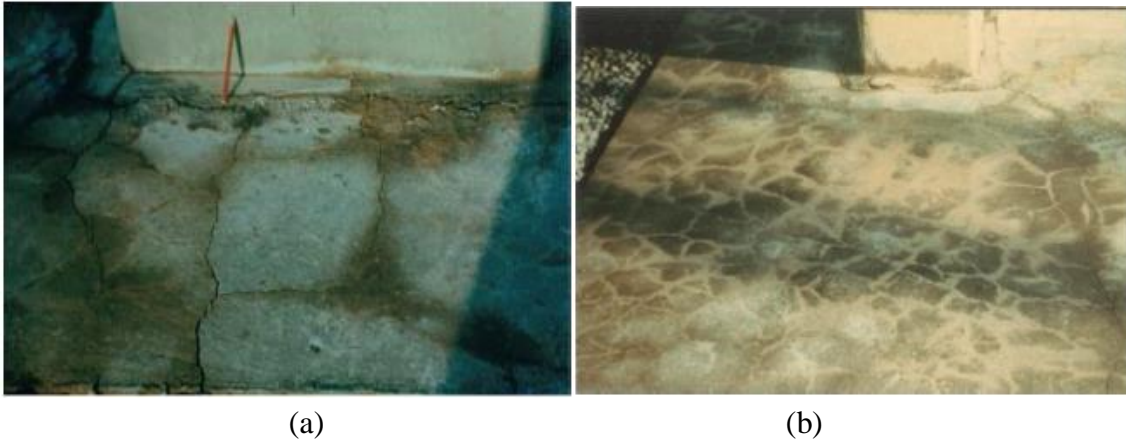
Figure 5:(a) and (b) Map cracking on concrete bases at Milehouse electricity substation in Plymouth in 1977 (Sims, 2017)

The ASR could be observed through brown and white chert particles, as well as reaction rims which formed in the concrete. Gel deposits were also observed. The surfaces of the bases were exposed to wetting and drying, and this was a necessary condition in promoting the occurrence of ASR (Sims, 2017).

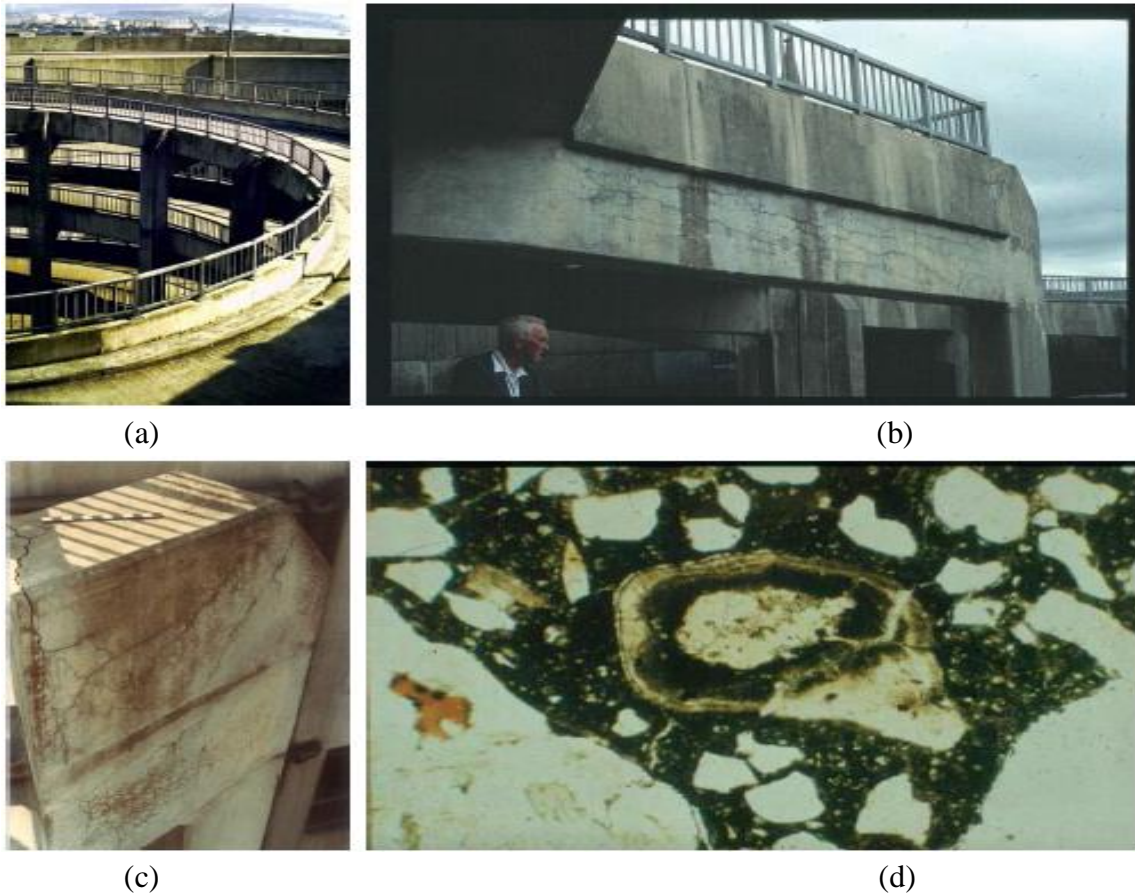
*Figure 6: (a) The spiral ramp of the Charles Cross Car Park in Plymouth; (b) Severely cracked beam; (c) Cracked column head; (d) Photomicrograph of a thin section of concrete from the car park (Sims, 2017)*

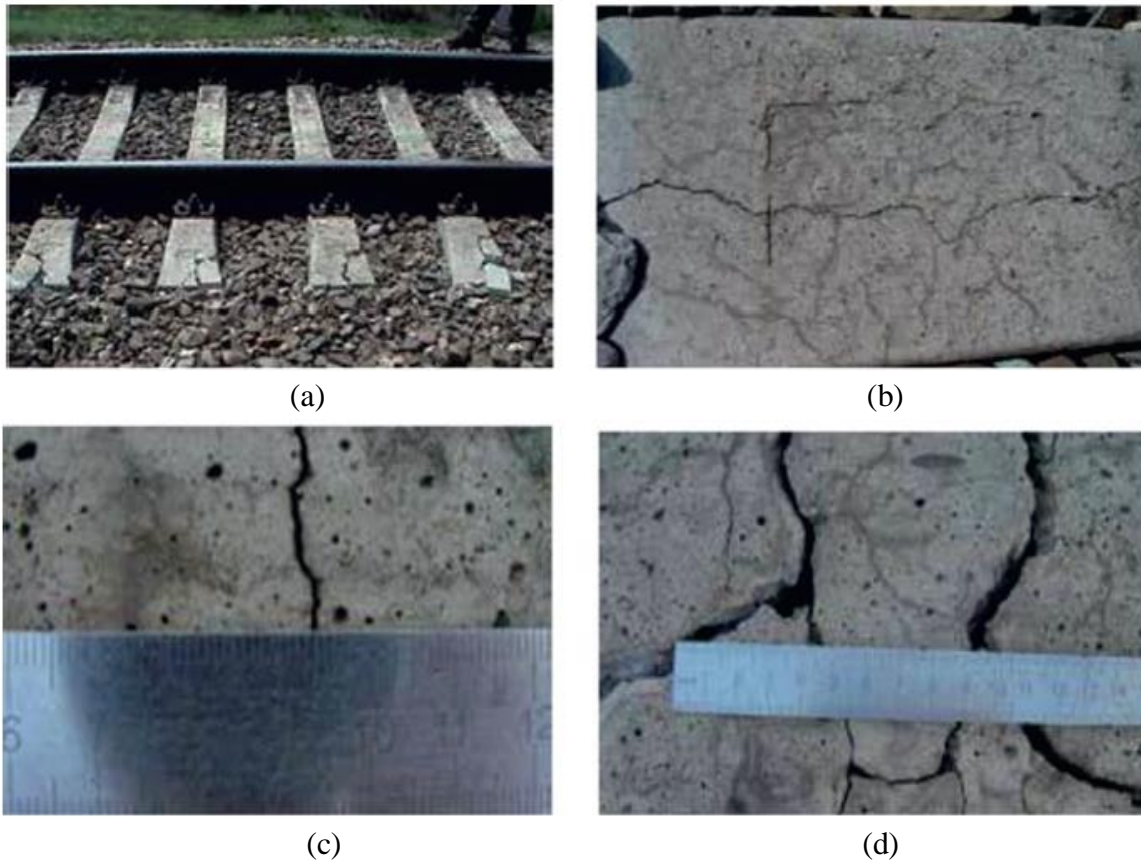
Figure 7: (a) and (b) General view of the deteriorated railway sleepers; (c) and (d) Close up view of the cracks in the railway sleepers (Falikman & Rozentahl, 2017)

Many cases of alkali silica reaction damage have been recorded in Russia. The most notable signs of concrete damage due to ASR includes crack networks and white jelly-like extrusions from the concrete. The commonly used aggregates are flint, sandstone and andesites. The most well-known cases are of house footing structures, railway sleepers, port facilities as well as concrete elements in public and industrial buildings and structures (Falikman & Rozentahl, 2017). It was reported in the year 2004 that there was large-scale deterioration of precast concrete railway sleepers which were produced in 2001. This deterioration manifested through cracks with varying widths as can be seen in Figure 7. Core samples were extracted from the damaged sleepers and it could be seen that the deteriorated coarse aggregate grains released a gel, which is one of the characteristics of alkali-silica reaction (Falikman & Rozentahl, 2017). Similar cases of ASR damage reported in Russia included the failure of footings of a transmission tower of the USSR railway overhead system, which took place 3 years after construction (Falikman & Rozentahl, 2017).

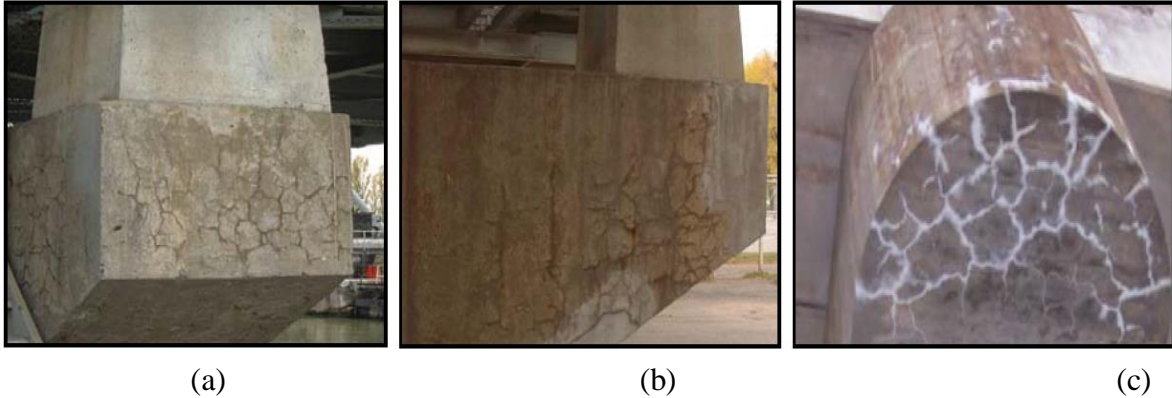
Figure 8: (a) and (b) show AAR induced map cracking in the bridge component at the St. Lambert Lock in Montreal. (c) is the train-bridge beam in Sherbrooke. Both bridges are in Canada (Kabir, 2006)

bridges in the St Lambert Lock Bridge in Montreal and a train bridge located in Sherbrooke. AAR results in swelling and eventual cracking in concrete, and the level of swelling gives an indication of the concrete deterioration, loss of rigidity and decreased mechanical properties. Components obtained from the St. Lambert Lock Bridge were severely affected by AAR, and exhibited various rates of concrete swelling. Components retrieved from bridges in Sherbrooke, including the train-bridge, all exhibited varying degrees of concrete deterioration.

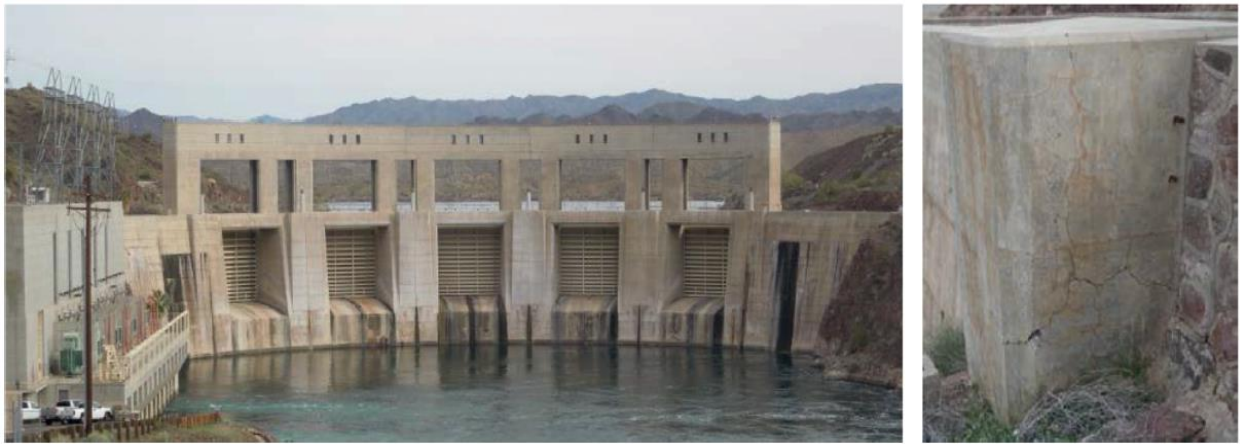
Figure 9: (a) Parker Dam in the USA exhibiting map cracking in 2013; (b) Visible cracking on elements of the Parker Dam (Thomas, Folliard, et al., 2017)

The Parker Dam between Arizona and California was constructed between 1934 and 1938. In 1940, the United States Bureau made a diagnosis that the expansion and cracking which were observed in the dam were the result of ASR (Thomas, Folliard, & Ideker, 2017). The dam was one of the first large structures in the world to have been diagnosed with ASR and remains in service to date. Two to three years after construction of the dam came to an end, cracks were observed on the dam and they were said to be due to the reaction between the cement and aggregate, which was andesitic aggregate (Thomas et al., 2017). The Parker Dam can be seen in Figure 9.

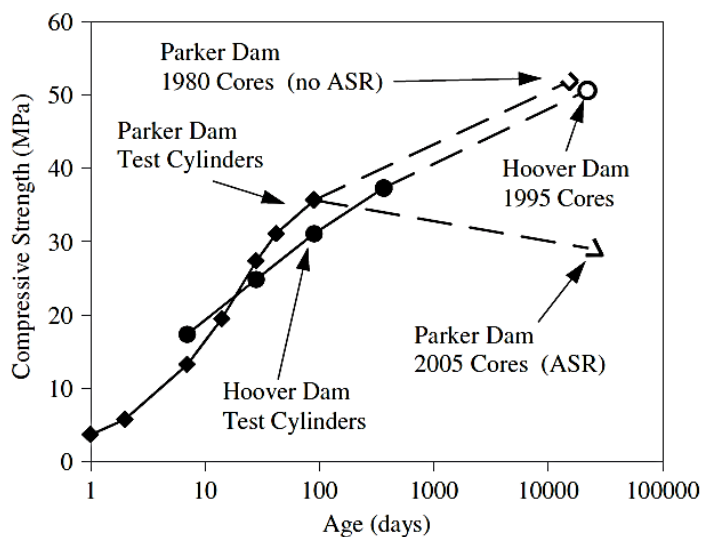
Figure 10: Effect of ASR on the strength of cores extracted from Parker Dam (Thomas, Folliard, et al., 2017)

Cores taken from ASR-affected (where high-alkali cement was used in the construction) areas of the Parker Dam as well as cores taken from non ASR-affected (where low-alkali cement was used in the construction) areas of the same dam were compared to cores and cylinders from the Hoover Dam, also in the United States of America. Cylinders were cast during the construction, while cores were taken at 60 years or later after construction. The results of strength tests performed on these cores are shown in Figure 10 (Thomas et al., 2017).

The results in Figure 10 show that the cores taken from the parts of the Parker Dam constructed with low-alkali cement showed no ASR and their strength development was similar to that of the Hoover Dam. The cores taken from the ASR-affected parts of the Parker Dam, which were constructed with high-alkali cement showed a reduction in concrete strength (Thomas et al., 2017).

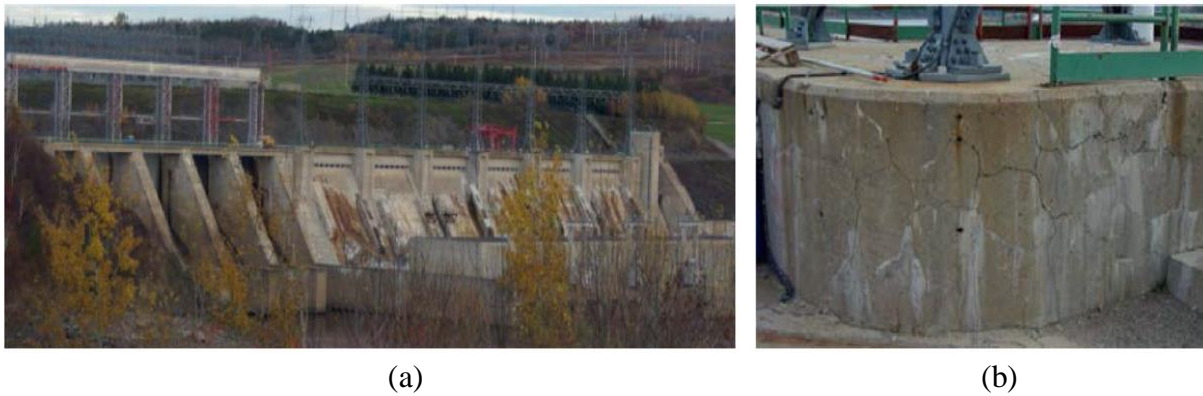
Figure 11: (a) Mactaquac Dam in Canada exhibiting map cracking in 2008; (b) Cracking on dam elements (Thomas, Folliard, et al., 2017)

this was attributed to alkali silica reaction and the expected life of the dam was reduced significantly. The aggregate used in the concrete was greywacke/argillite rock. The dam is shown in Figure 11. Since its construction, the height of the intake structure is said to have increased by more than 175mm (Thomas et al., 2017). Additionally, the unrestrained expansion of the concrete is currently estimated to be in the range of 120 – 150 microstrain per year and there is no indication of a decrease in this rate of expansion. Due to the continued problems in the operations as well as increasing maintenance costs, partially due to ASR damage, the concrete structures are projected to be replaced by the year 2030, at which point they will be in service for 60 years (Thomas et al., 2017).

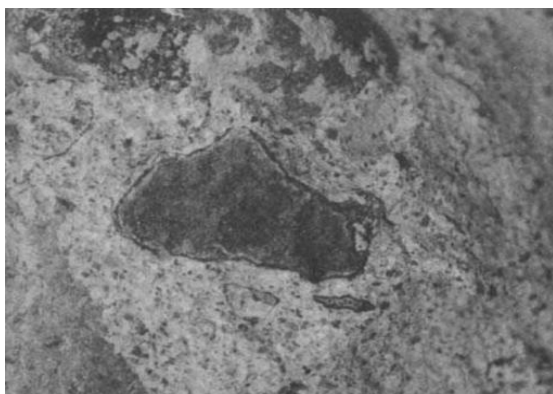
*Figure 12: Concrete core sample extracted from the Hirakud dam spillway in India showing a dark reaction rim around aggregates and ASR gel (Mullick, 2017)*

The Hirakud dam is one of the longest earth dams in the world, at a length of 4.8 km and is composed of earth, concrete and masonry. Investigations were done on spillways in the Hirakud dam 27 years after its construction (Mullick, 2017). The spillways were found to be extensively cracked. Map cracking, superimposed with longitudinal horizontal cracks were observed on the spillways. It was also noted that the extent of the cracks had been increasing with time (Mullick, 2017). Samples retrieved from the structure showed that there was indeed presence of ASR, which manifested through off-white, translucent-to-opaque agglomeration of fluffy gel-type deposits in the voids on the borders with aggregates as well as on the aggregates as can be seen in Figure 12 (Mullick, 2017). The petrographic examination identified that the three coarse aggregates present in the concrete were quartzite river shingles, granitic rocks and diorites (Mullick, 2017).

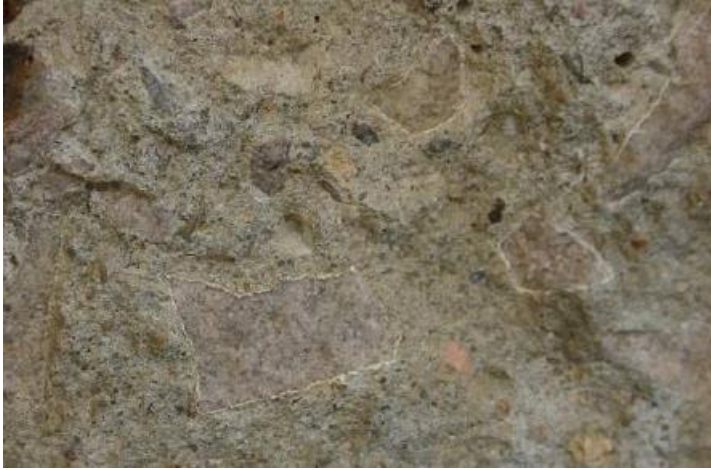
*Figure 13: White reaction rim around aggregates in the Mile 7 Square Reservoir in Namibia (Beushausen, 2011c)*

The Mile 7 Round Reservoir is an old decommissioned round reservoir located close to Dune 7 just outside the coastal town of Walvis Bay. A visual assessment was performed on the structure and there was excessive random cracking indicated the possibility of ASR damage (Beushausen, 2011b). The Rooibank Reservoir is a 40 year old rectangular reservoir made up of columns and beams which support arched walls and is located in the Namib Desert just past Rooibank approximately 25km from the shoreline and at times is subjected to mist from the ocean. The structure showed a significant amount of random cracking on all the walls, beams and columns which is consistent with ASR (Beushausen, 2011d).

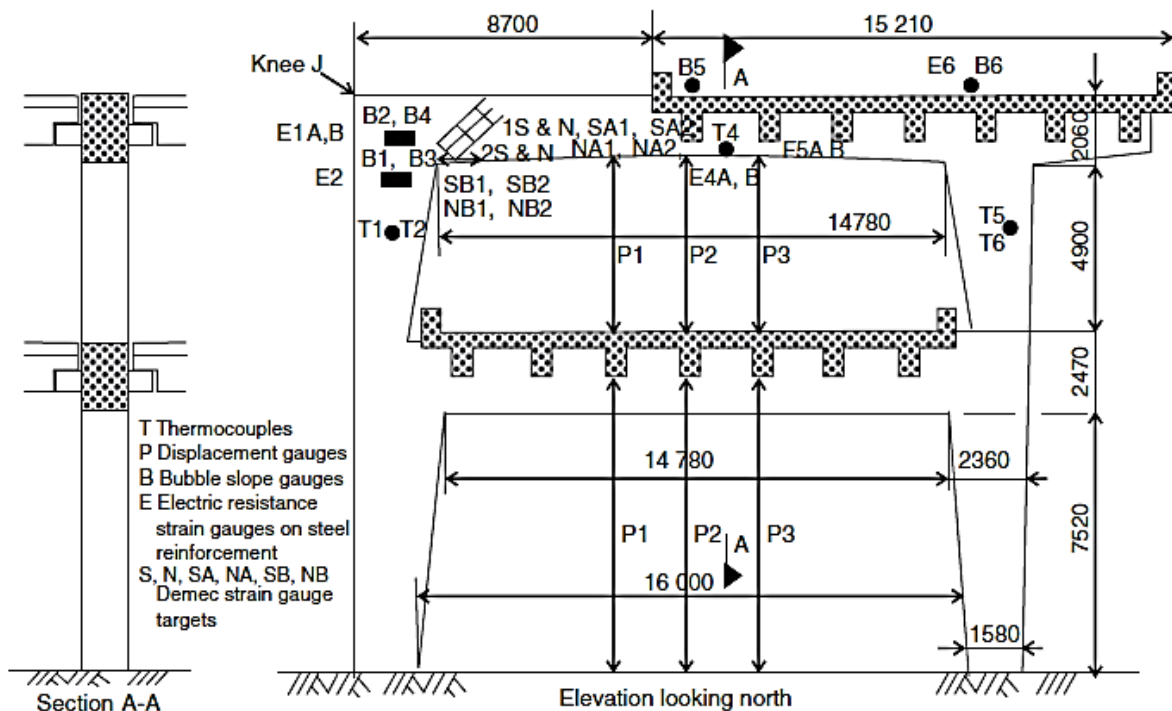
Figure 15: Layout of motorway portal frame in Johannesburg, where loading tests were performed in 1992 and 1998, and subsequent repairs were done. (Dimensions in mm)(Alexander and Blight, 2017)

The reinforced concrete motorway portal frame is part of a series which supports a doubled-decker stretch of urban freeway in Johannesburg, the layout of which is as shown in Figure 15. The structure was designed in 1963 and was reported to exhibit signs of severe AAR deterioration (Alexander & Blight, 2017). In 1982 and then again in 1988, full-scale loading tests were performed on the portal frame. Despite the severe damage, the portal frame continued to behave as if the concrete was not cracked (Alexander & Blight, 2017). Overall, it was concluded from the loading tests that the portal frame's strength was adequate for it to continue service, but cosmetic repairs were required to improve visual outward appearance and prevent further widening of existing cracks.

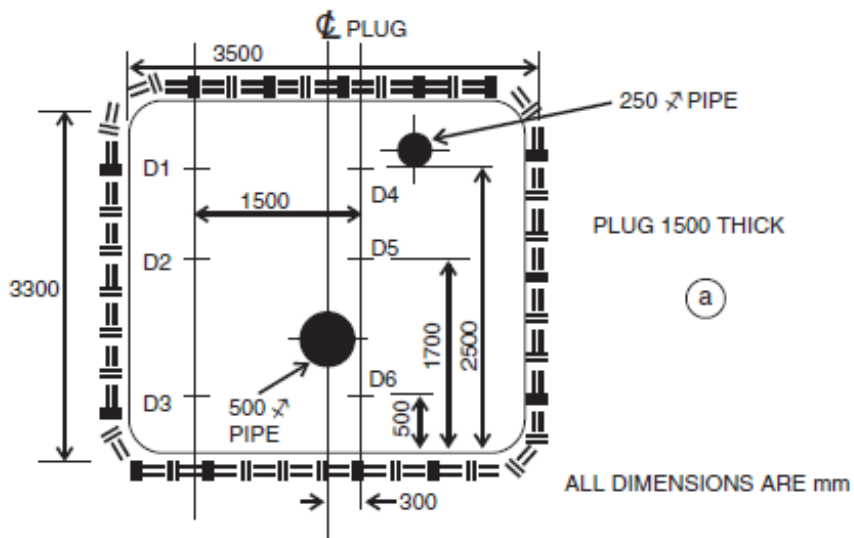
Positions of dial gauges (D1, D2, D3, D4, D5, D6 and LVDTs (D3 and D5)

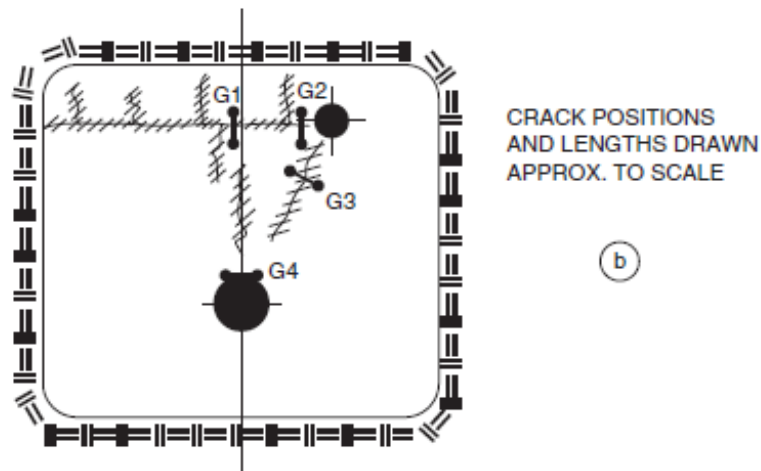
Positions of Demec targets across cracks (G1 to G4)

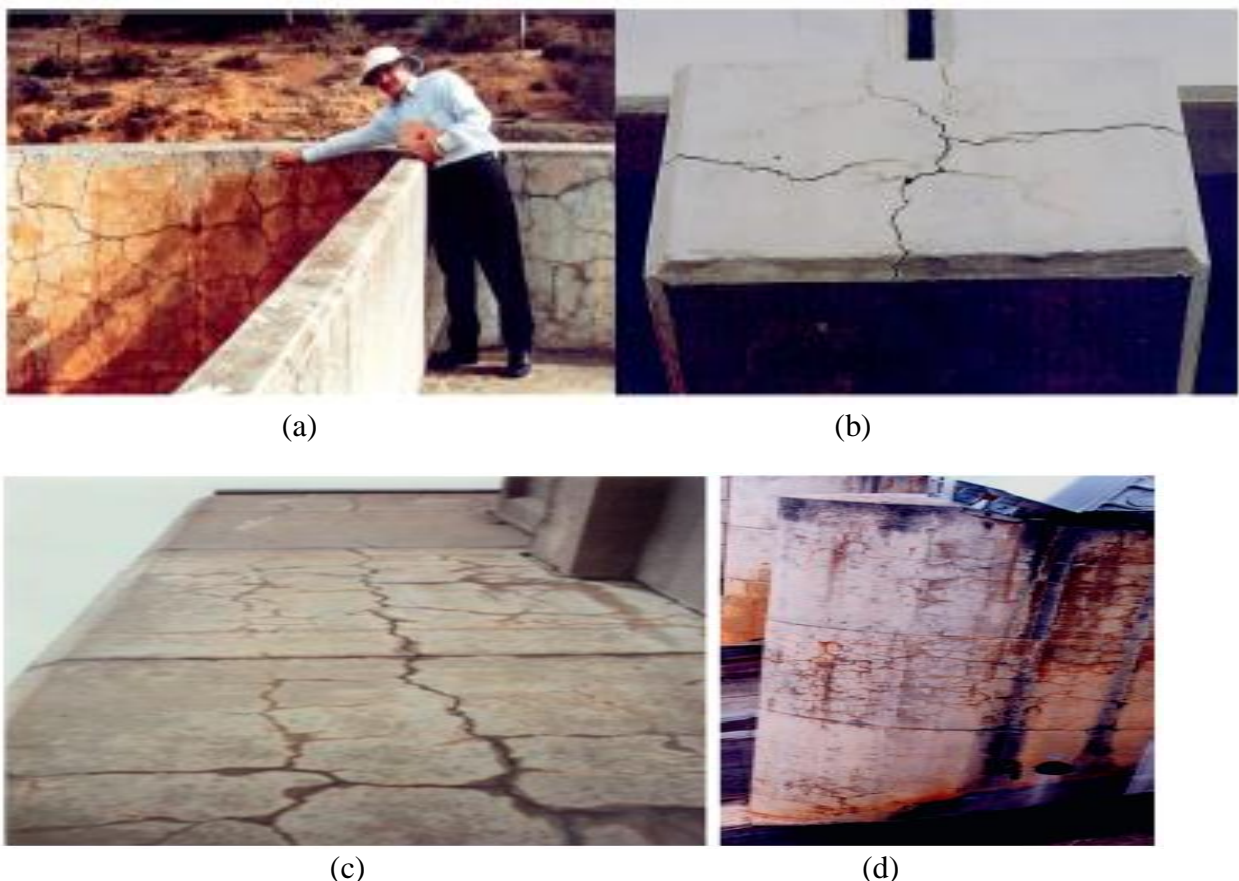
*Figure 17: (a) AAR induces map cracking in retaining wall of a dam; (b) ASR cracking at the end of a crosshead beam in a bridge; (c) cracking due to ASR in a bridge pylon, (d) a cracked bridge pier in dam spillway, all in Australia (Shayan & Freitag, 2017)*

Some other visual manifestations of AAR observed in dams in Australia include the distortion, misalignment and rotation of the AAR-affected elements relative to other elements next to them. Figure 18 shows a concrete block in a dam wall which was displaced and rotated relative to the concrete block next to it (Shayan & Freitag, 2017). The cause of this was the significant amount of expansion and cracking in the one concrete block due to AAR damage.

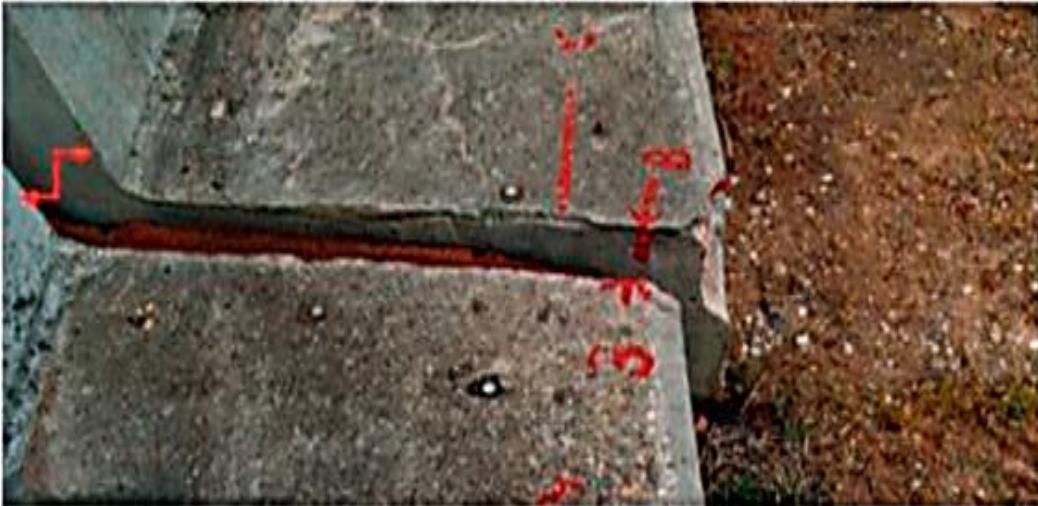
Figure 18: Large concrete block in a dam in Australia displaced (Shayan & Freitag, 2017)

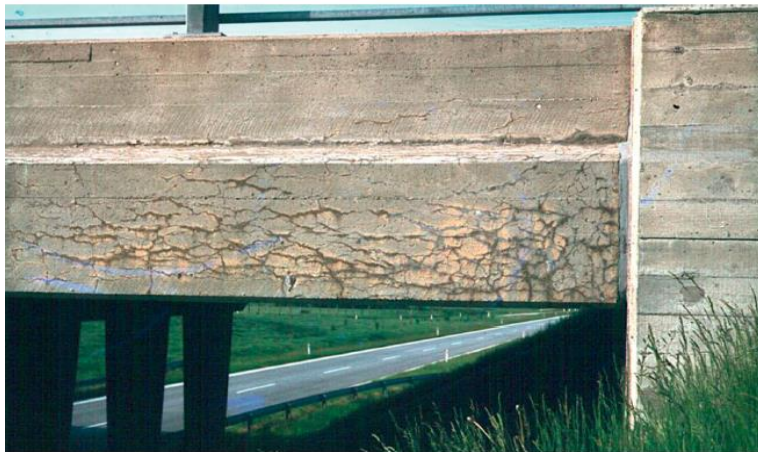
*Figure 19: Cracking due to ASR on a bridge in Ølstykke in Denmark (Lindgard et al., 2017)*

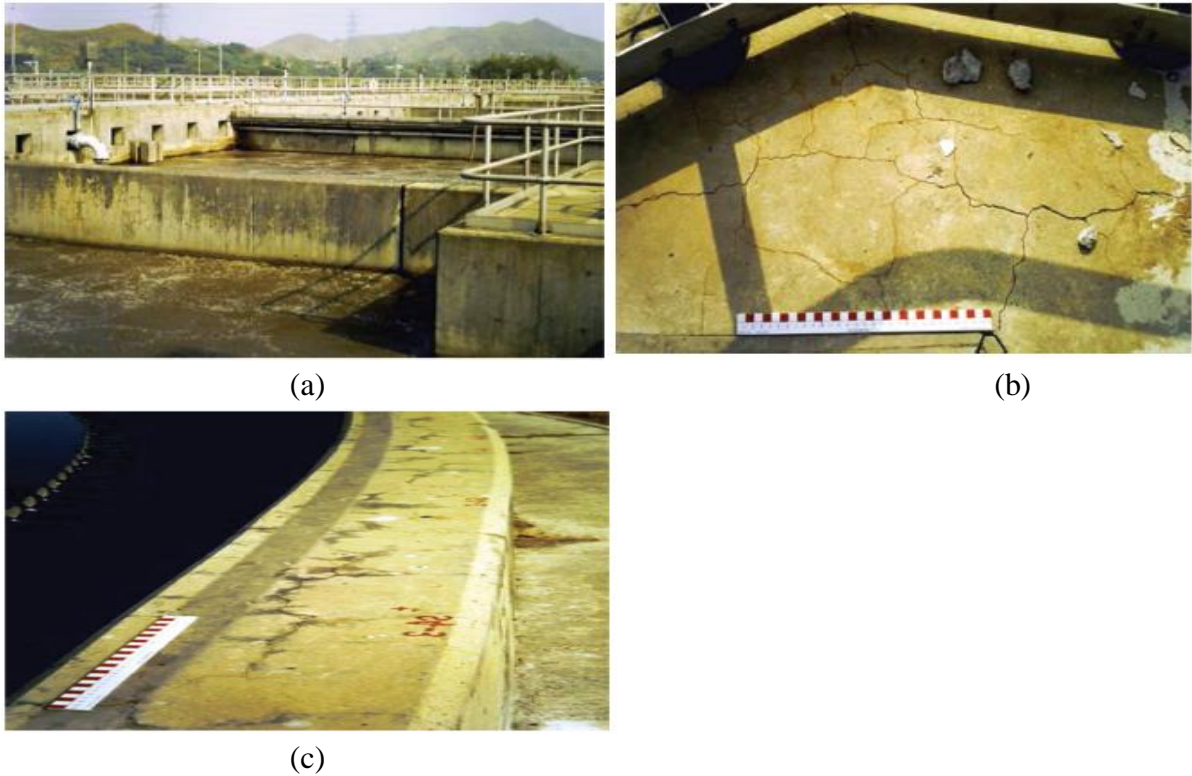
*Figure 20: ASR damaged sewage works in Hong Kong. (a) General view; (b) Map cracking in concrete tank wall; (c) Cracking along the top of the surface of concrete wall (Yamada & Miyagawa, 2017)*

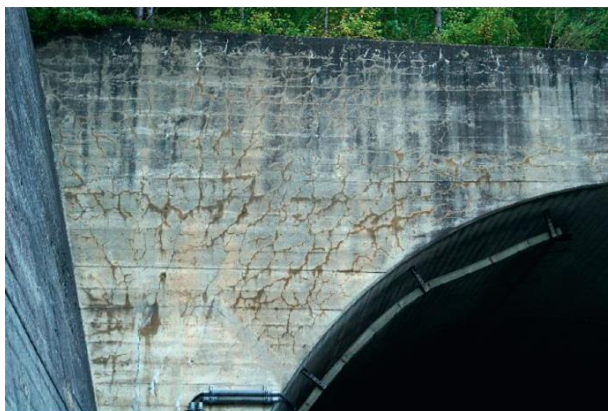
*Figure 21: Tunnel showing dense cracking pattern in Switzerland (Fernandes et al., 2017)*

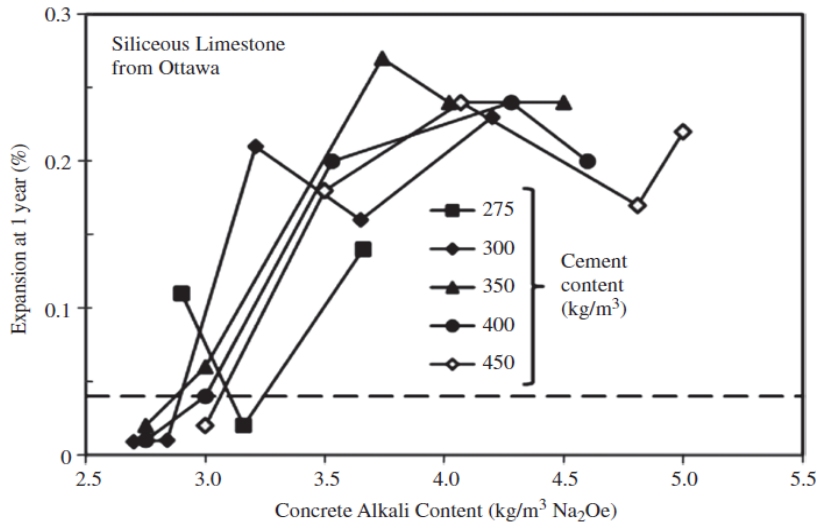
Figure 22: Expansion of concrete prisms as a function of alkali content. The dashed line represents the critical 1 year expansion limit (Sims & Poole, 2017)

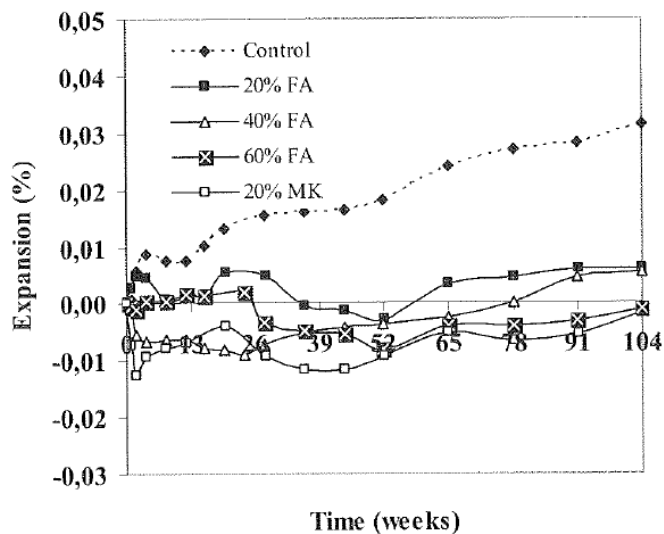
Figure 26: Expansion of concretes in accordance with the RILEM AAR-3 method (Silva et al., 2006)

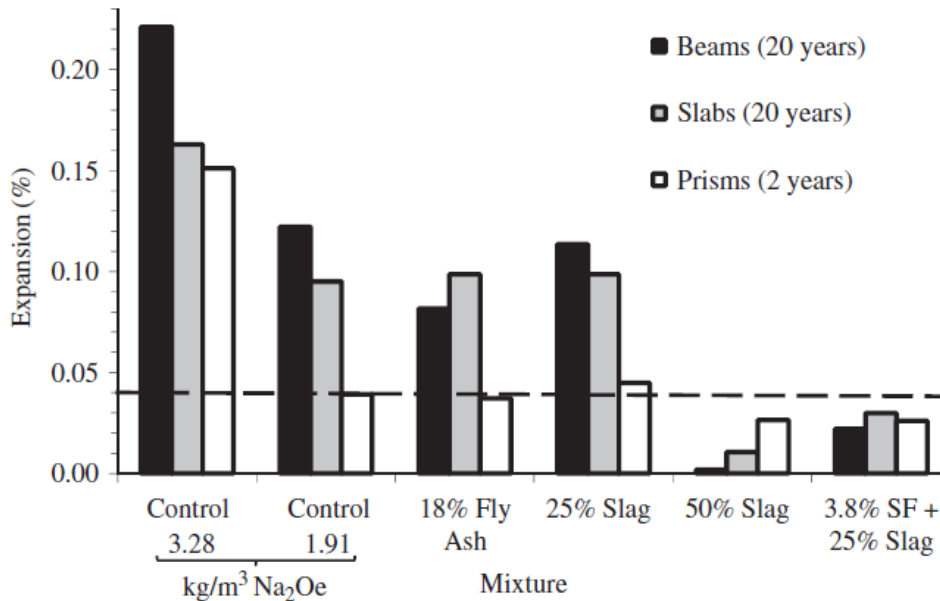
Figure 27: Expansion of concrete prisms in the laboratory and concrete blocks and slabs on the Kingston exposure site (Thomas et al., 2017)

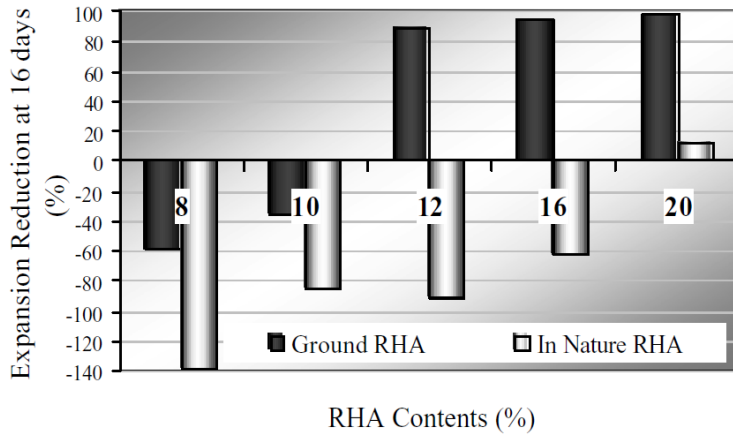
Figure 28: Reduction in expansions of the reference sample, with respect to different contents of RHA at 16 days of testing (Hasparyk et al., 2004)

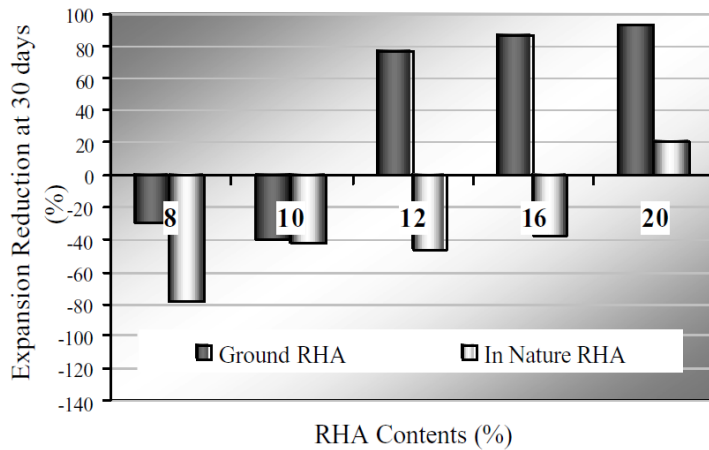
Figure 29: Reduction in expansions of the reference sample, with respect to different contents of RHA at 30 days of testing (Hasparyk et al., 2004)

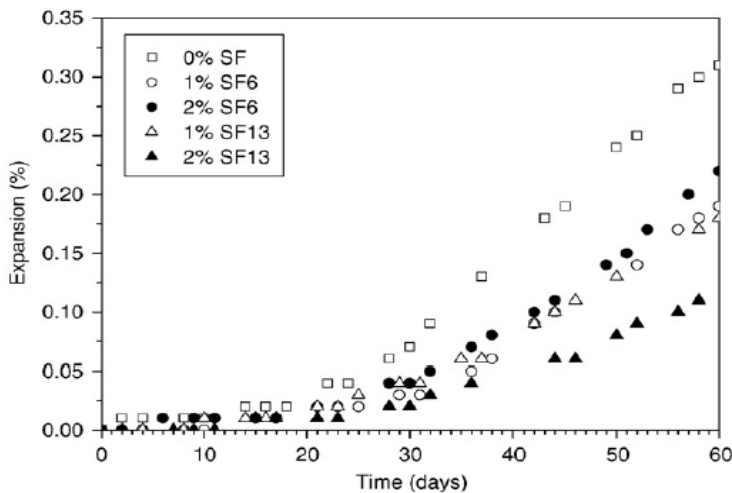
Figure 30: Expansion due to AAR (de Carvalho et al., 2010)

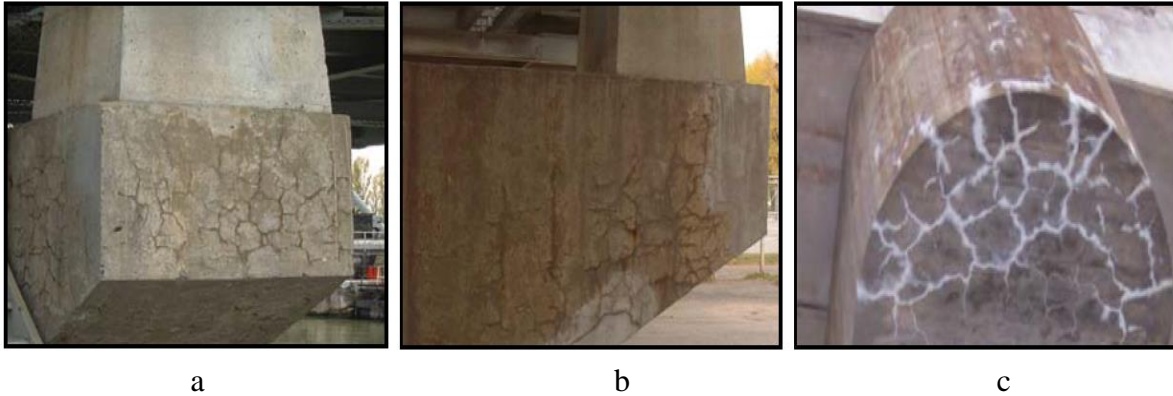
Figure 33: (a) and (b) show AAR induced map cracking in the bridge component at the St. Lambert Lock in Montreal. (c) is the train-bridge beam in Sherbrooke (Kabir, 2006)

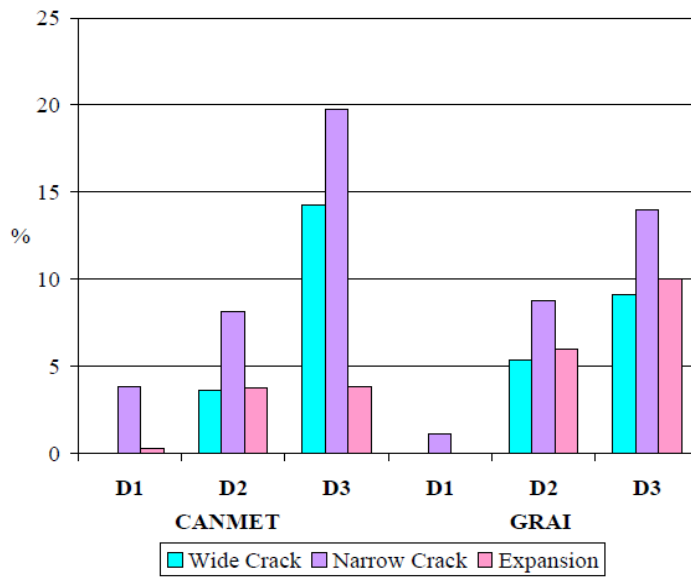
Figure 34: Comparison of concrete crack damage and expansion levels (shown in percentage on the vertical axis) among the CANMET specimens and the GRAI specimens (Kabir, 2006)

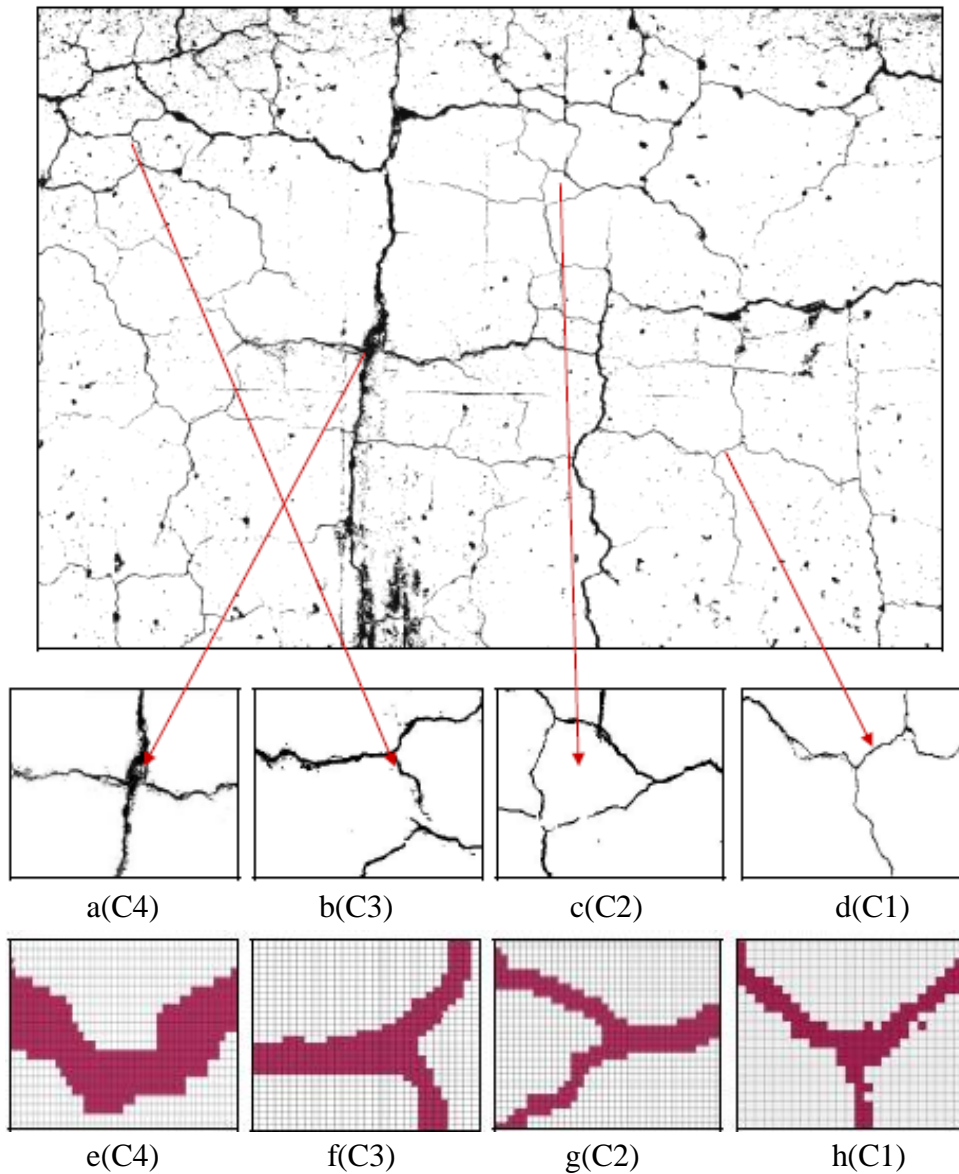
Figure 35: Different ranges of crack widths from binary image of Joffre Bridge. (a)-(d) zoomed to  $1x$  and (e)-(h) zoomed of 20 times with a grid of 1 pixel per square (Kabir, 2006)

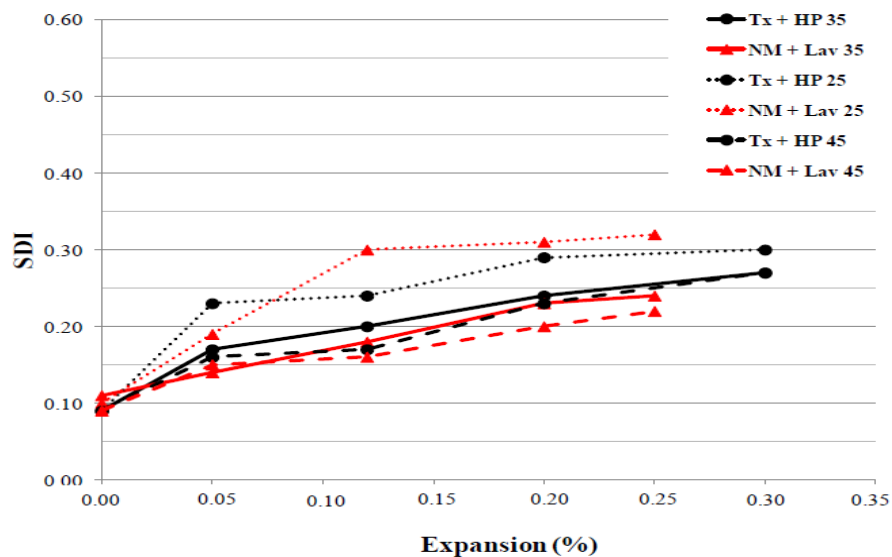
Figure 36: Stiffness damage indices for 25, 35 and 45 MPa concrete mixes - SDI results (Sanchez et al., 2016)

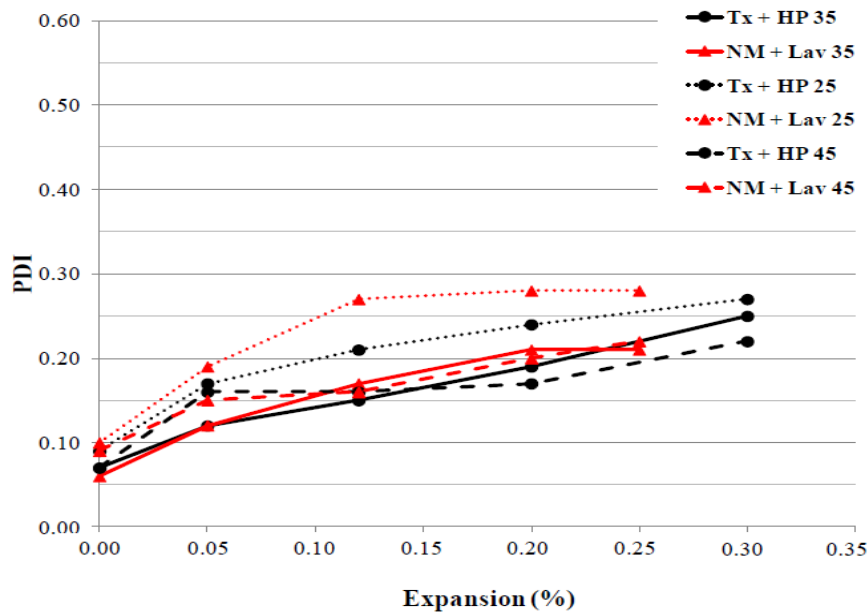
Figure 37: Stiffness damage indices for 25, 35 and 45 MPa concrete mixes - PDI results (Sanchez et al., 2016)

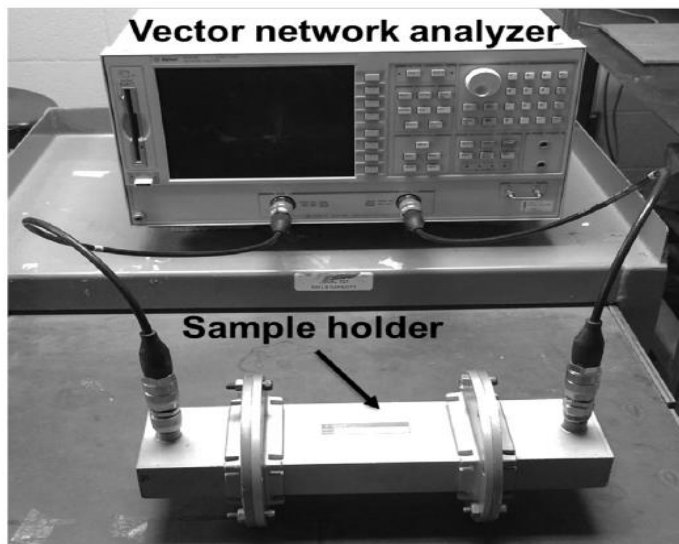
*Figure 39: Test setup for the microwave measurements (Rashidi et al., 2016)*

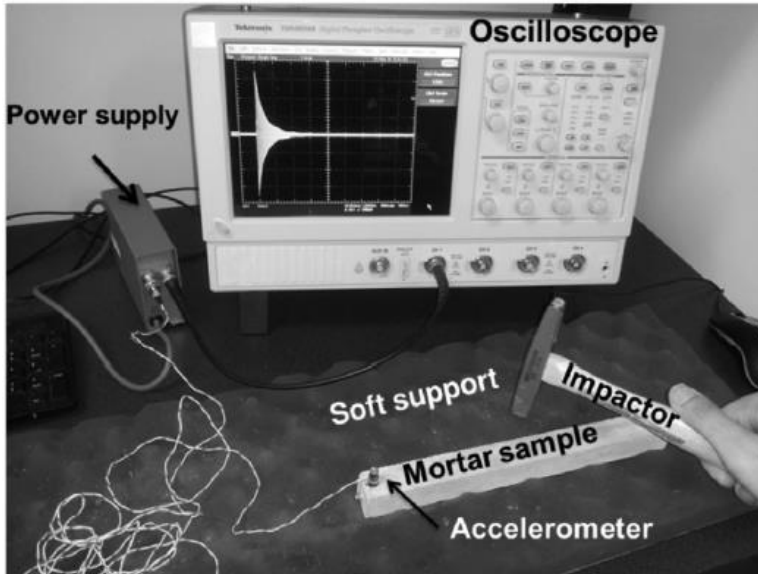
Figure 40: NIRAS test setup (Rashidi et al., 2016)

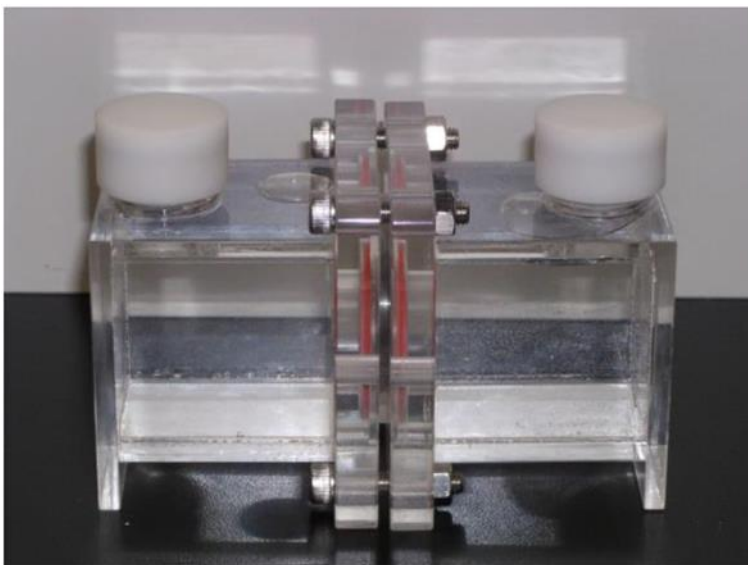
Figure 41: Diffusion cell unit (Prasetia & Torii, 2013)

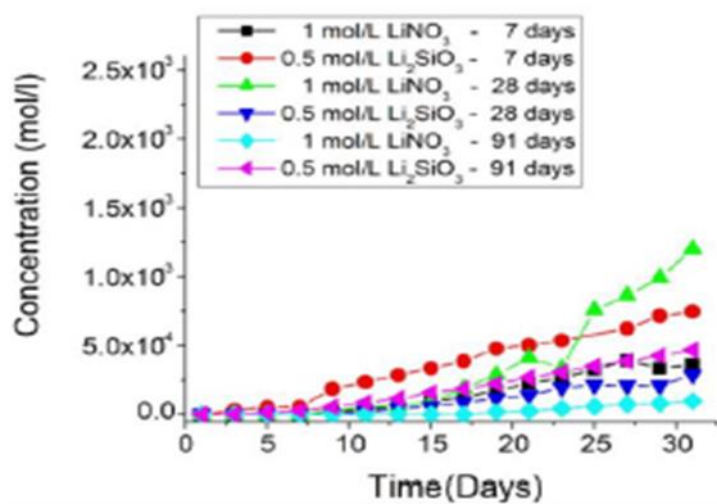
Figure 42: Diffusion profiles of Li<sup>+</sup> from LiNO<sub>3</sub> and Li<sub>2</sub>SiO<sub>3</sub> solution (curing time: 7, 28 and 91 days) (Prasetia & Torii, 2013)

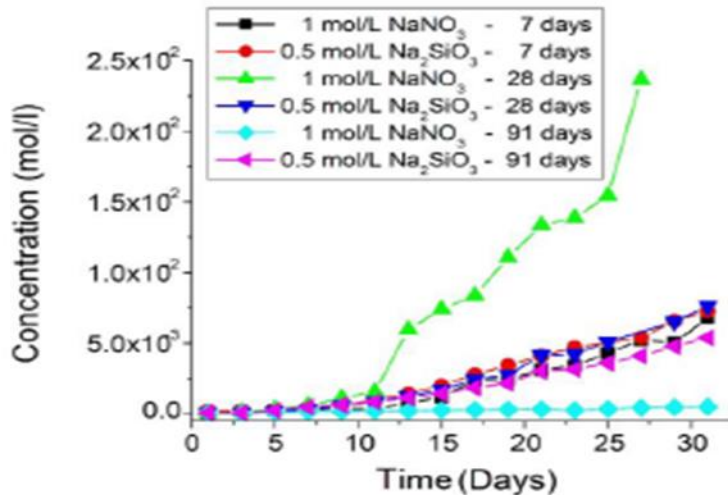
Figure 43: Diffusion profiles of  $\text{Na}^+$  from  $\text{NaNO}_3$  and  $\text{Na}_2\text{SiO}_3$  solution (curing time: 7, 28 and 91 days) (Prasetia & Torii, 2013)

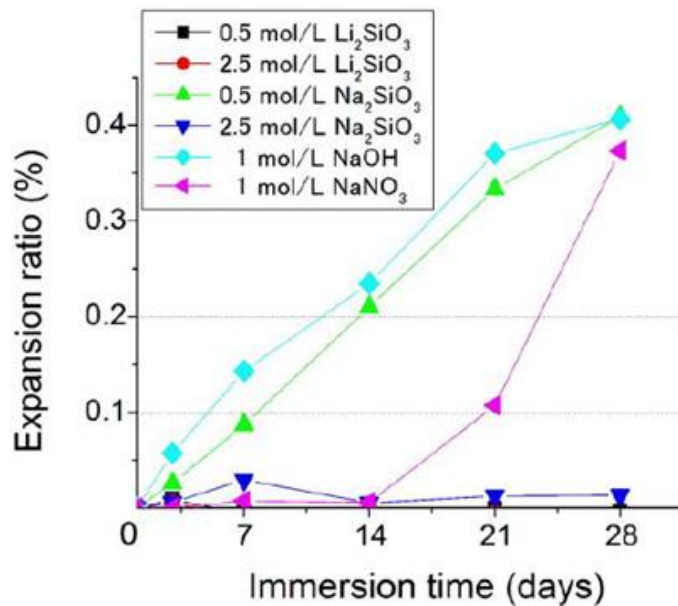
Figure 44: Expansion ratio of accelerated mortar bars immersed in various lithium and sodium compounds in accordance with ASTM C1260 (Prasetia & Torii, 2013)
