**ASSESSMENT OF ALKALI AGGREGATE REACTION AVOIDANCE MEASURES  
AND ALKALI AGGREGATE REACTION TESTS WORLDWIDE**

**MASTER OF ENGINEERING IN CIVIL INFRASTRUCTURE MANAGEMENT AND  
MAINTENANCE**

**MARTHA NDINELAO MWATILE**

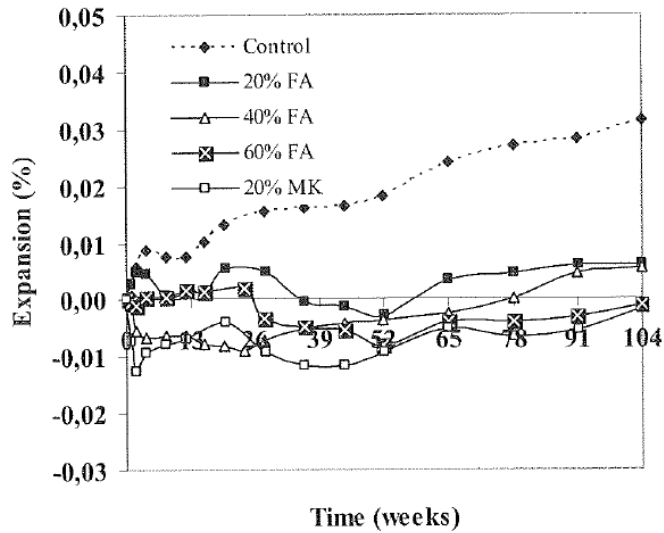
Figure 47: Expansion of concretes in accordance with the RILEM AAR-3 method (Silva et al., 2006)

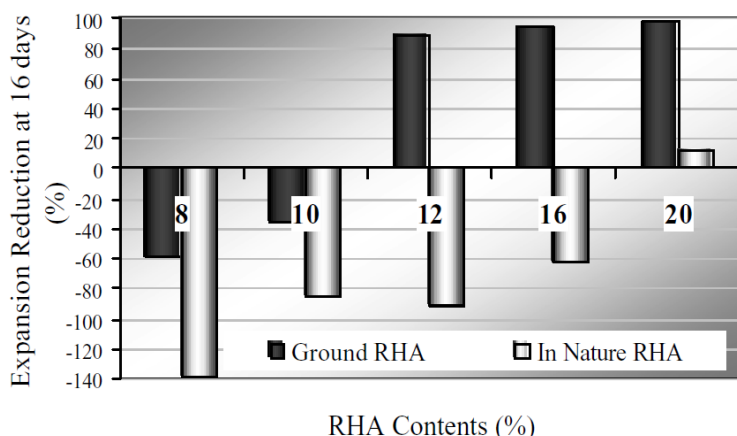
Figure 48: Reduction in expansions at 16 days of testing (Hasparyk et al., 2004)

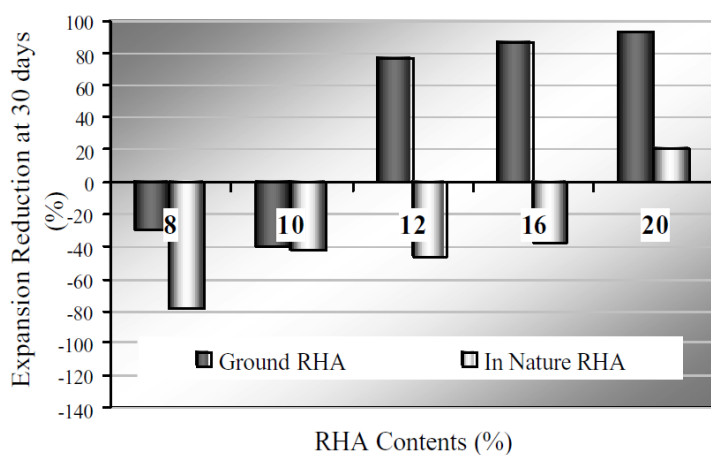
Figure 49: Reduction in expansions at 30 days of testing (Hasparyk et al., 2004)

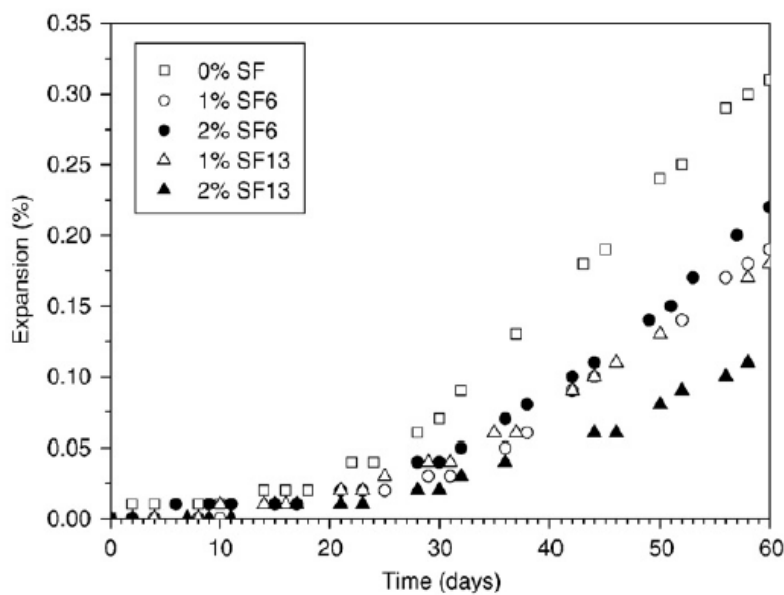
Figure 50: Expansion due to AAR (de Carvalho et al., 2010)

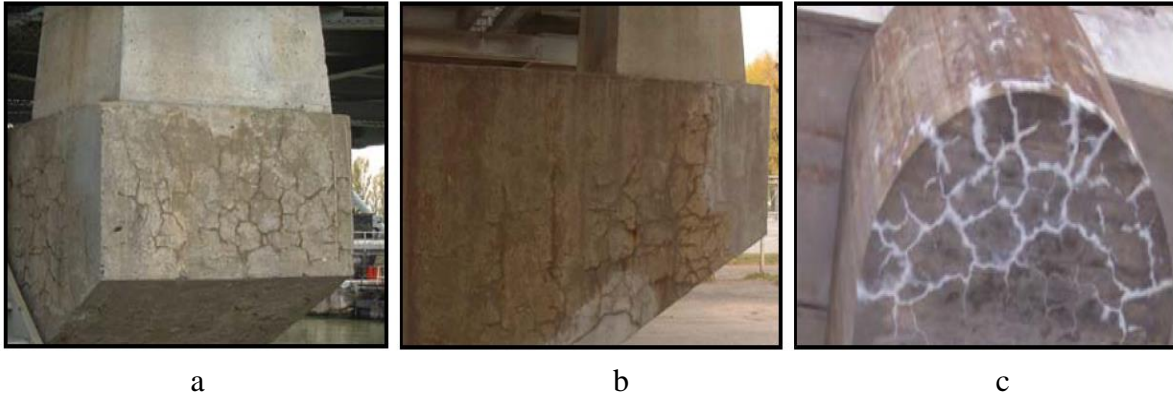
Figure 51: (a) and (b) show AAR induced map cracking in the bridge component at the St. Lambert Lock in Montreal. (c) is the train-bridge beam in Sherbrooke (Kabir, 2006)

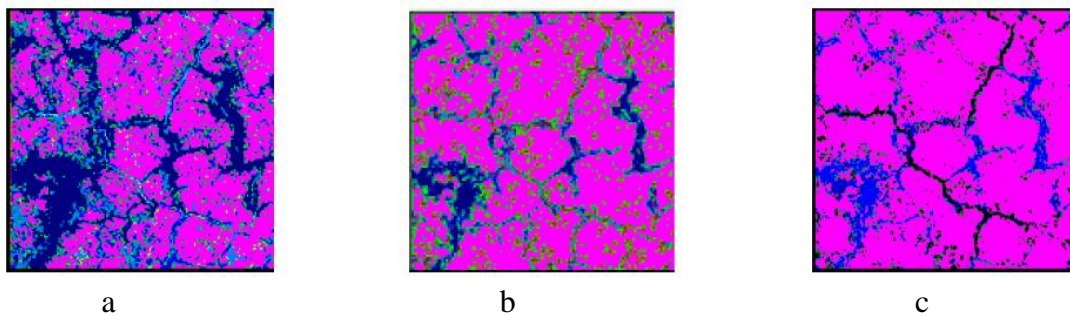
*Figure 52: Classified images of CANMET-D3 (a) greyscale, (b) colour and (c) thermographic (Kabir, 2006)*

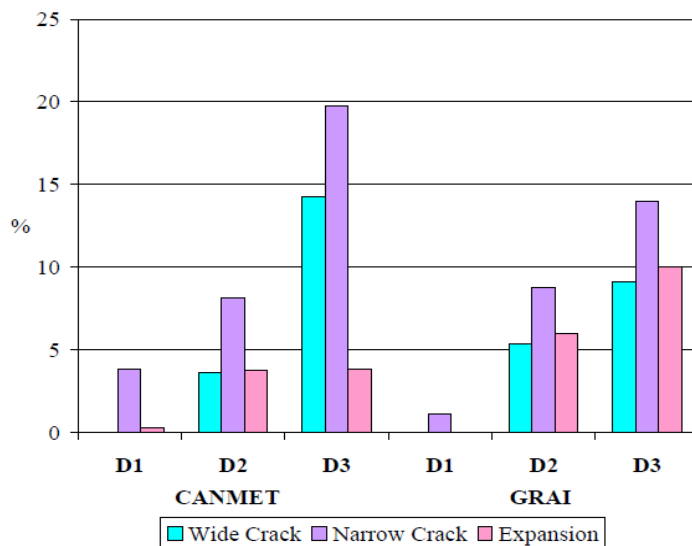
*Figure 53: Comparison of concrete crack damage and expansion levels among the CANMET specimens and the GRAI specimens (Kabir, 2006)*
