**Repair and Rehabilitation of Reinforced Concrete
Harbour Structures**

Andrew George Rowan

February 2007

A thesis submitted to the University of Cape Town in partial fulfilment of
the requirements for the degree of Master of Science in Engineering.

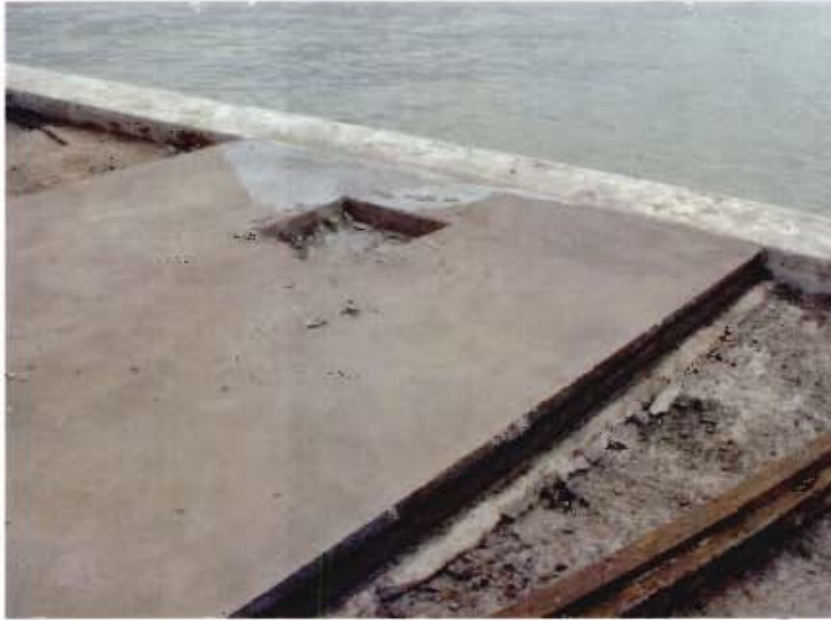
Figure 5-6: Use of new and existing elements

Another point that was observed during the investigations was the combination of new structural elements, such as the slab shown in Figure 5-6, with existing elements, in this case the pile capping beam. The difficulty with which certain elements can be repaired or replaced is clearly an important factor in the repair methodology. The long quay wall was being repaired on a patch basis, where the worst locations of damage were being identified and treated. With the slabs, however, a decision was taken to replace all of them as this would most likely have been the more cost-effective option for repair.

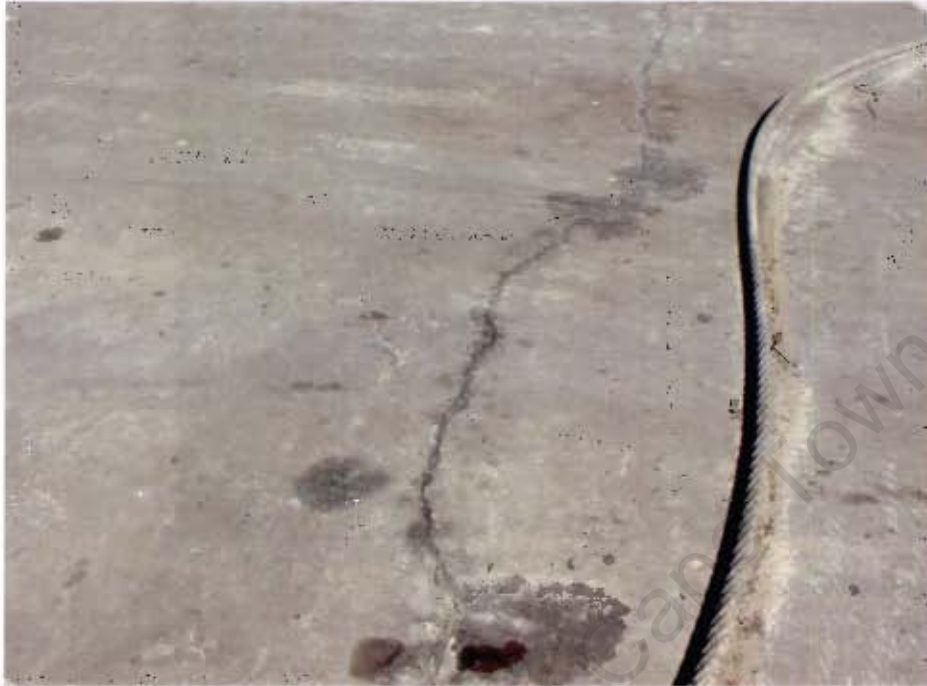
Figure 5-13: Crack sealing and crack grouting

The use of crack sealing and grouting with mortar and/or epoxy is evident in Figure 5-13.

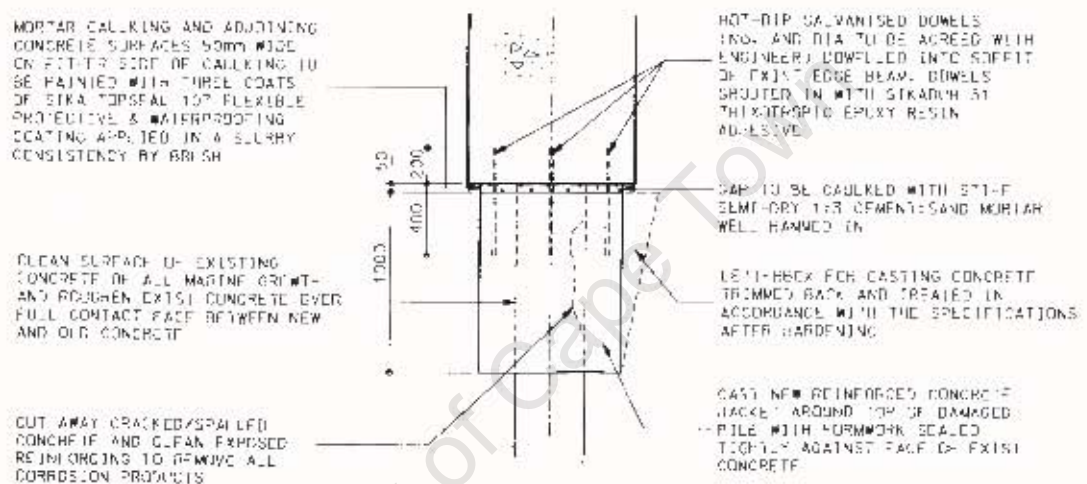
Figure 5-16: Repairs to damaged piles

Many of these piles had been damaged either due to mechanical impact or corrosion and spalling. These were to be repaired as shown in Figure 5-16, with the damaged concrete being removed and new jackets cast around the top of the piles.

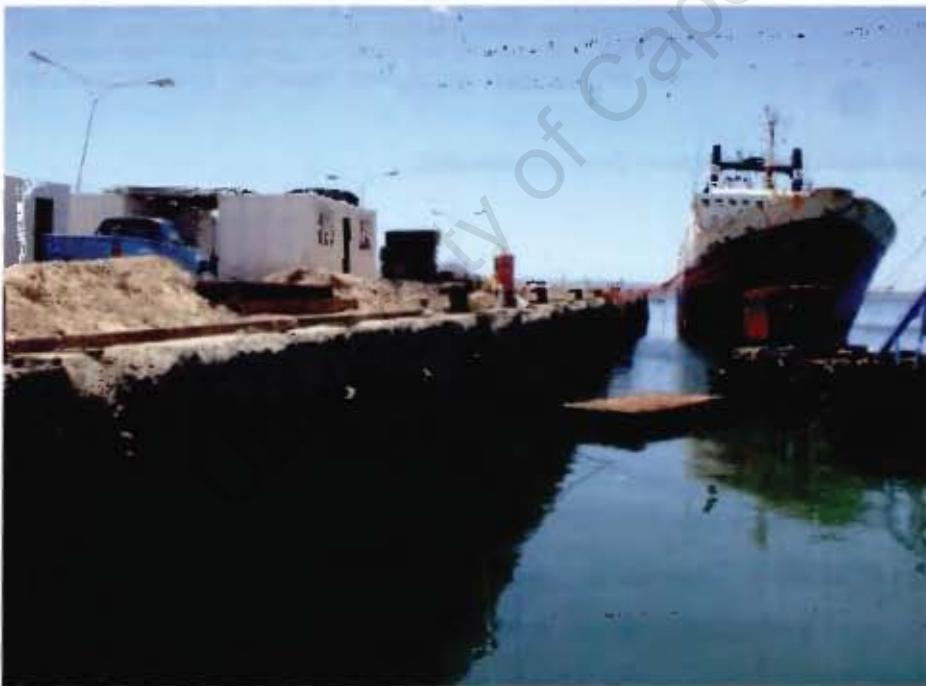
Figure 5-18: Edge beam of Government Jetty

There had been much mechanical damage along the edge coping beam of the jetty, and the adopted repair method involved cutting back the concrete to beyond the level of the steel, and recasting the edge beam. While the damage may have been attributed to mechanical impact of ships docking at the jetty, the removal of the surface concrete clearly showed the presence of steel corrosion. Also noticeable in the photo on the right is the presence of previously performed repair works, showing at least three different concretes in one edge beam.

Figure 5-18 and the following diagram (Figure 5-19) show the superstructure of the Government jetty, to which surface treatment of barrier coatings and penetrating corrosion inhibitors was applied. This repair method will be given more focus at a

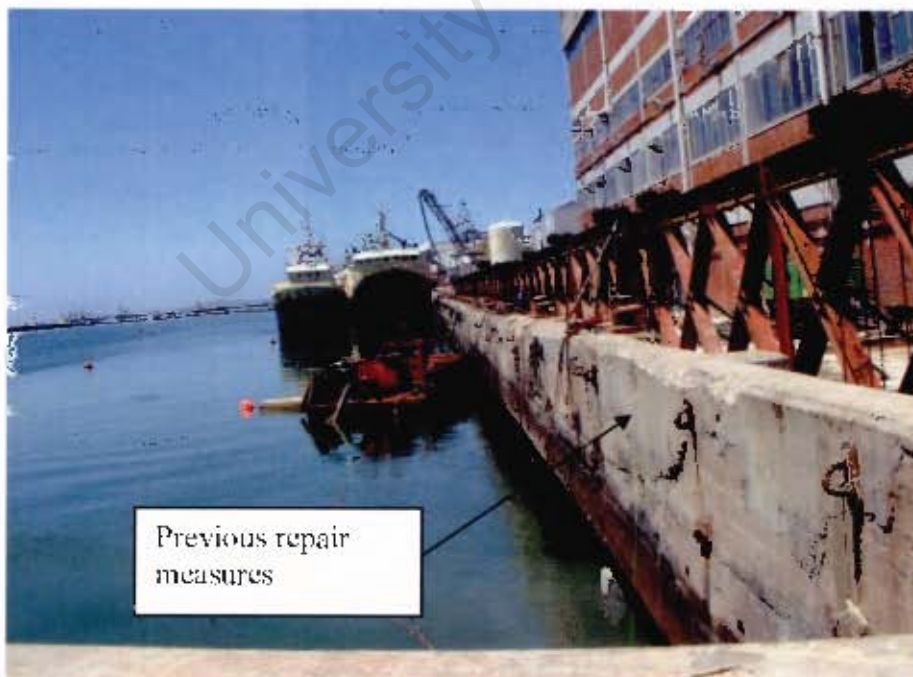
Figure 5-22: Trawler Quay showing 'strongback' girder

The photo above shows clearly the deflection that had occurred along the edge of the Trawler Quay, and the strong-back girder that was being used for temporary support. Also noticeable is the presence of previous repair measures.

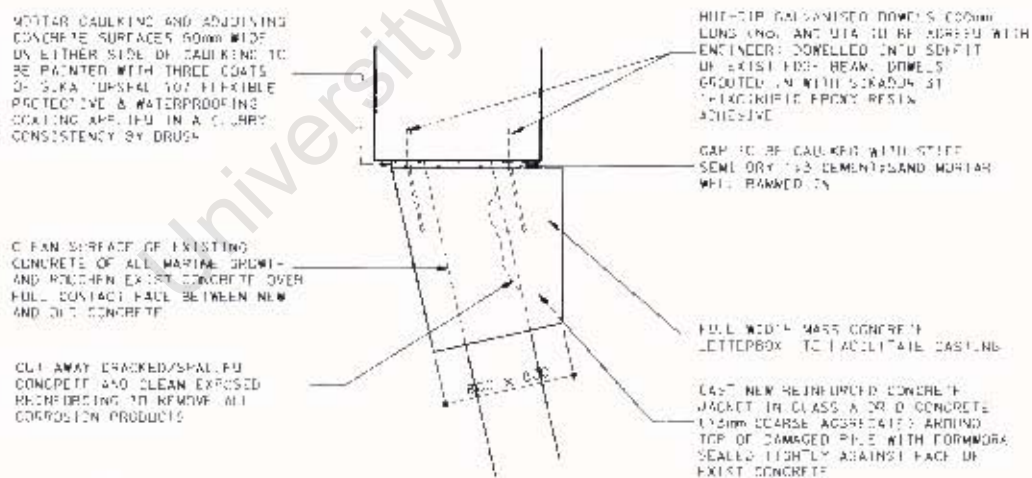
Figure 5-23: Cracked pile repair detail

The Repair Jetty is a beam and slab superstructure supported on reinforced concrete piles, and it is likely that its original construction date was sometime between 1960 and 1970. At the top of the piles there was longitudinal cracking evident, and according to the contract is likely that the damage has been caused by reinforcement corrosion. Rehabilitation required the removal of cracked and spalled concrete and the casting of a new jacket around the top of the piles, as is shown in Figure 5-23.

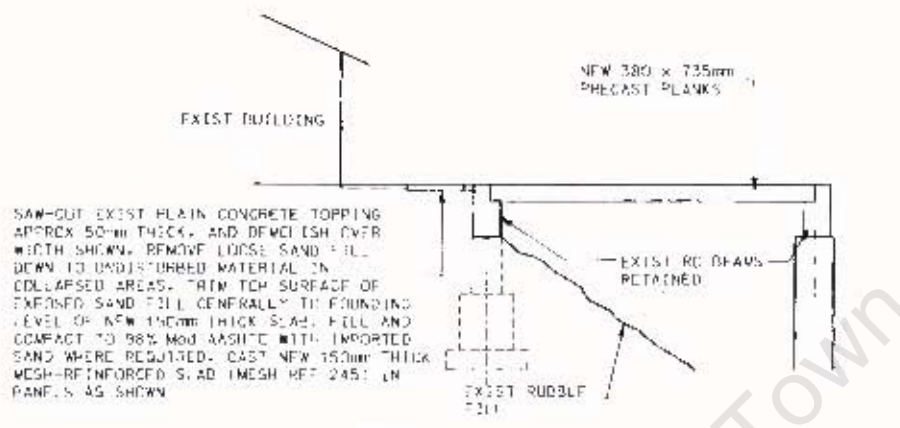
Figure 5-24: Pepper Bay repair details

concrete piles. It is estimated that it was constructed in the late 1960's. Severe spalling had occurred on the precast planks and the decision was made that the deck would be replaced in its entirety, due to the impracticality of repairing the spalled concrete.

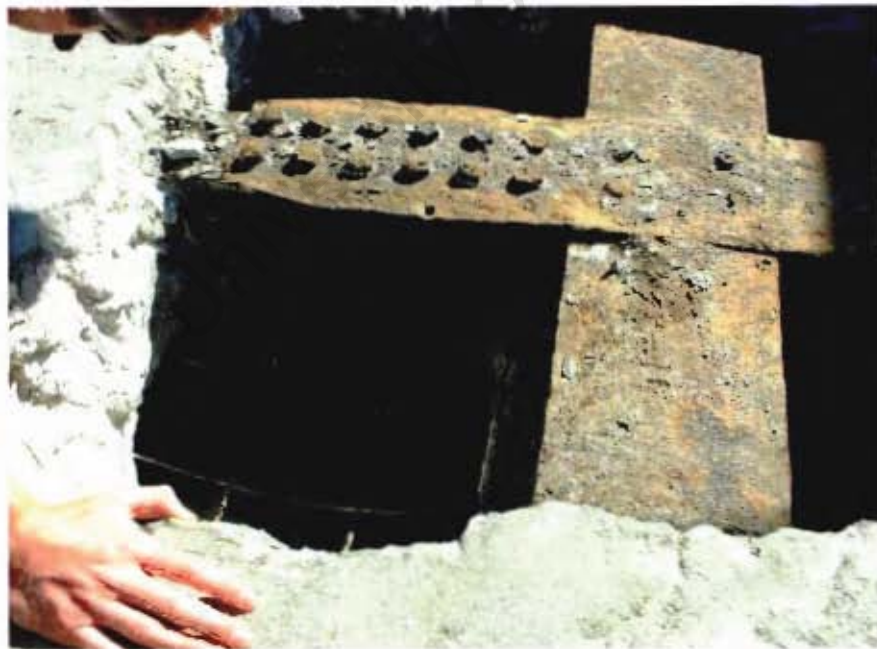
Figure 5-29: Typical reinforcement at St Helena Bay Jetty 2

Jetty 2 is a lead-in jetty for the main slipway at St Helena Bay. It comprises a deck supported on transverse and longitudinal beams, which are in turn supported on concrete piles. The reinforcement in the piles and beams are Rolled Steel Joist beams, and in the beams especially, major spalling had occurred exposing the bottom flange of these beams. The method adopted in the repair of these elements was to remove the damaged concrete and shotblast the corroded steel to rid it of corrosion products. An anti-corrosive coating was then applied to the steel before the member was gunited to a minimum cover of 75 mm, as is shown in Figure 5-30 below.

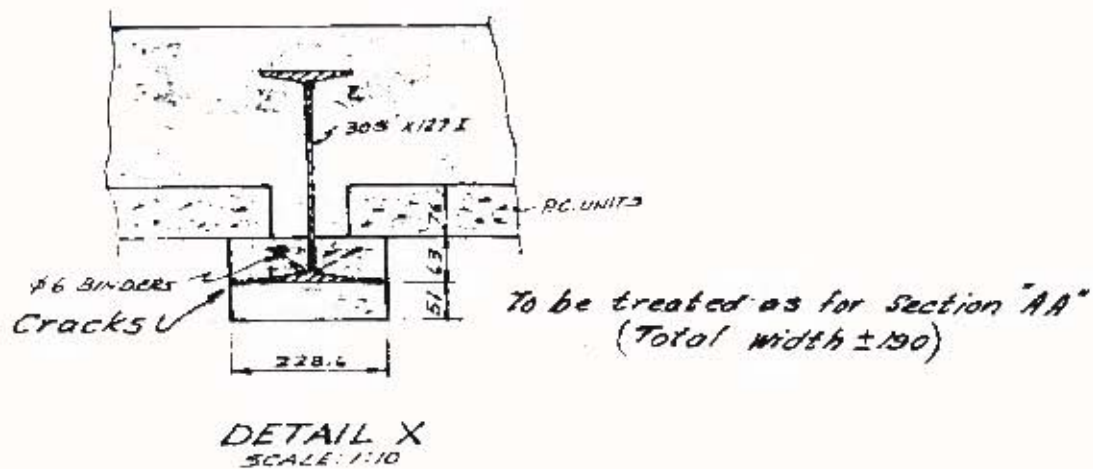
Figure 5-31: Details of previously performed repair methods to Jetty 2

It should be noted that previous repair measures were also present in these elements. Details of these are shown in the following drawing, noting the date (1977), and the similarity between this method and the current method of repair.

The major difference is the level of cover provided, and it is likely that the failure of the previous method of repair contributed to this increased cover specification.

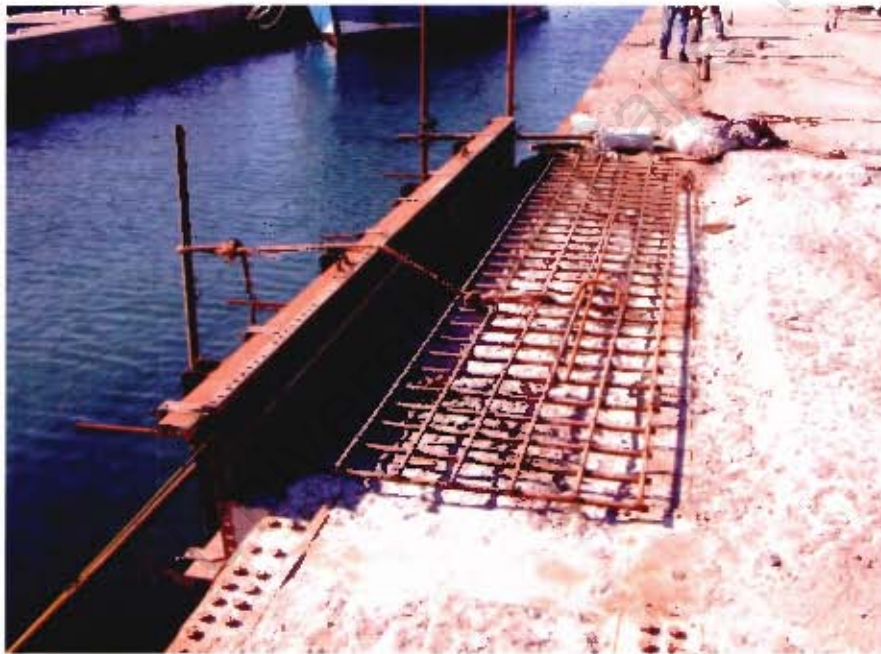
Figure 5-32: New reinforcement to Jetty 2 at St Helena bay

Major repairs were being performed along the surface of the deck, ranging from areas such as shown below where breaking out and recasting is required to crack injection and sealing.

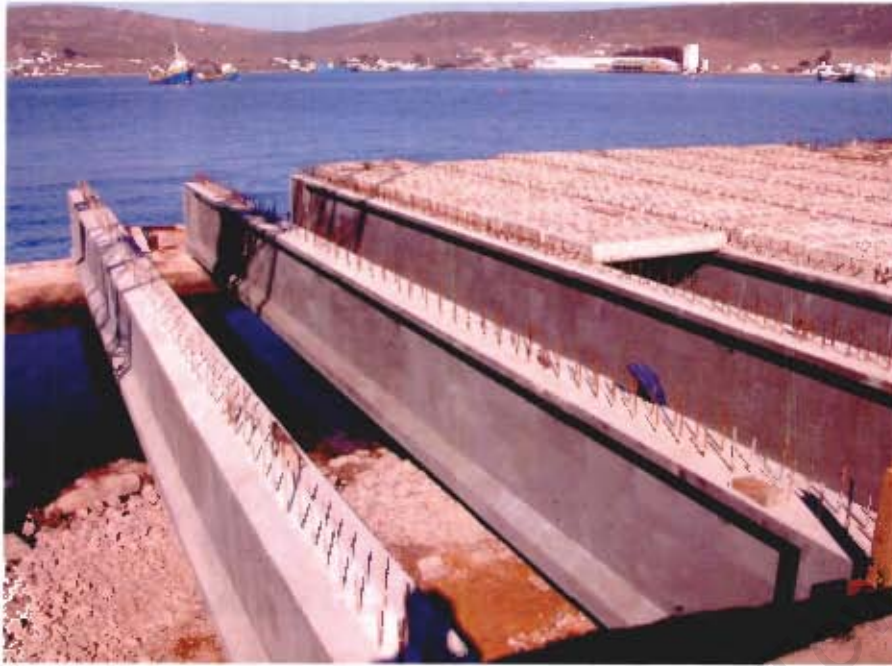
Figure 5-33: New transverse beams for Quay 3, St Helena Bay

The deck of the quay was found to be in very poor condition with most of the post-tensioned transverse beams having spalled so severely that the structure had been condemned. The piles and the pile cap beam, however, were in good condition and were retained for the new construction. Shown in Figure 5-33 are the new prestressed transverse beams sitting on the original pile cap beam.

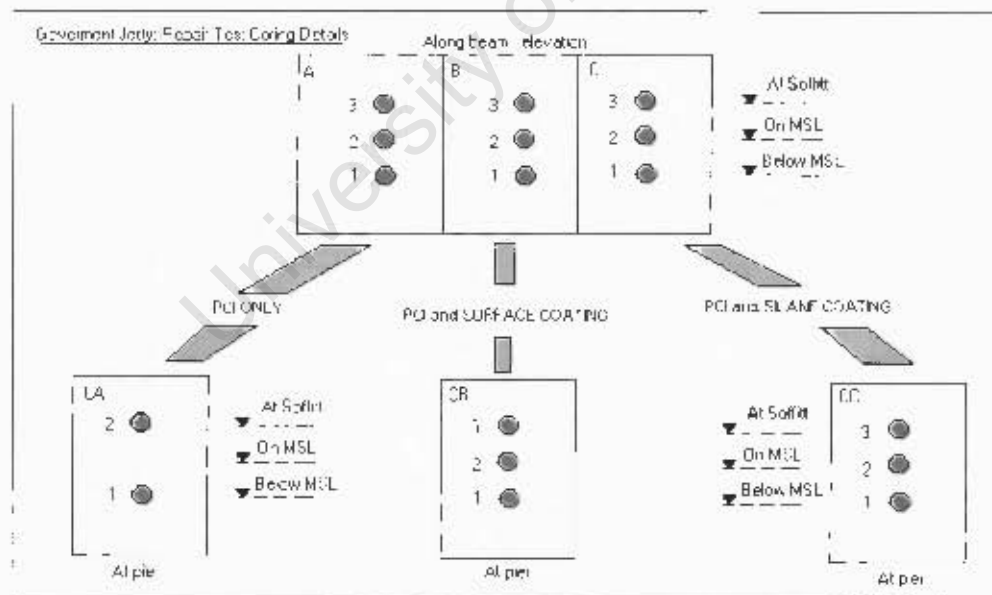
Figure 6-3: Locations of Cores extracted from Government Jetty for Inhibitor Testing

Seventeen cores in total were extracted, and Figure 6-3 shows the locations of each:

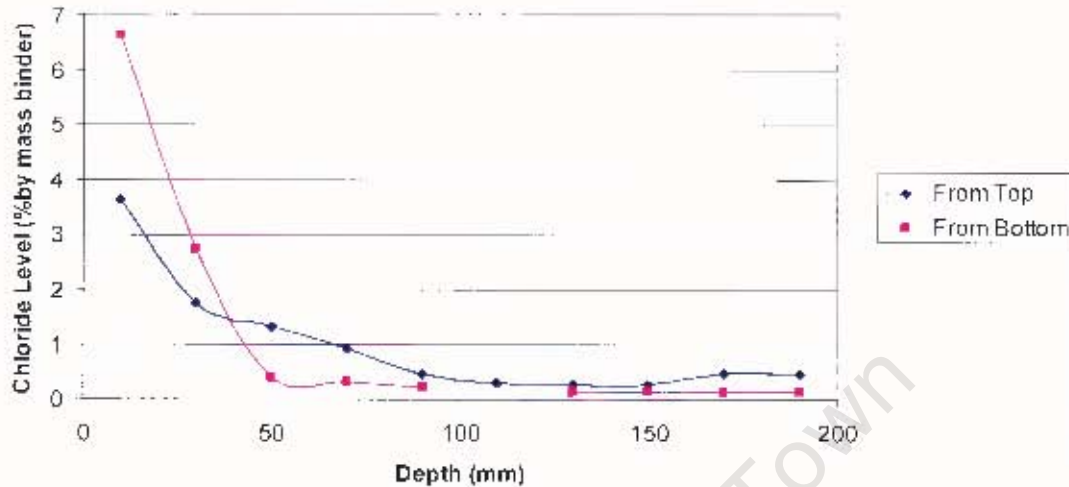
Figure 6-6: Average chloride profiles for Trawler Quay Vertical cores

As this deck is in such close proximity to the sea, the results for the chloride levels were expected to be high (See Figure 6-6). These are compared to the results obtained for the deck cores extracted from St Helena bay in the following chapter.

The results show a typical chloride profile, with a high surface concentration value (in the order of 5-8% by mass of binder each side). Beyond a depth of 100 mm into the concrete, the chloride levels drop below the 0.4% threshold.

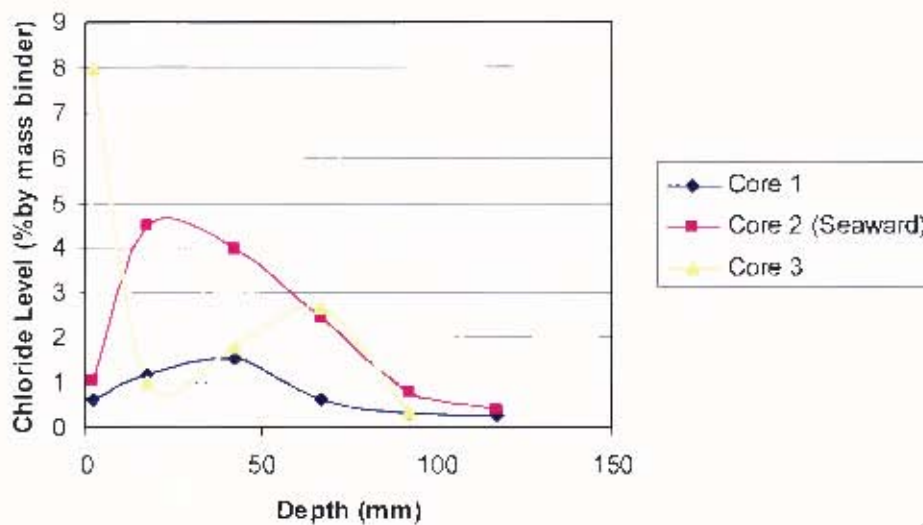
Figure 6-7: Chloride Profile for Trawler Quay Horizontal Cores

Three 100 mm diameter cores were extracted from the Trawler Quay edge beam and tested for chlorides. These cores were drilled horizontally, core 2 from the seaward side whilst cores 1 and 3 were extracted from the sheltered side.

Whilst the results show considerable scatter, there are some points that can be made from the profiles. There is definite ‘leaching’ present, accounting for the low surface values of cores 1 and 2. Also notable is the high level of chlorides (>2%) at considerable depth, reaching up to 80 mm and beyond. The beams/wall from which these cores were extracted showed high levels of corrosion damage (cracking and spalling) and were subsequently demolished and replaced.

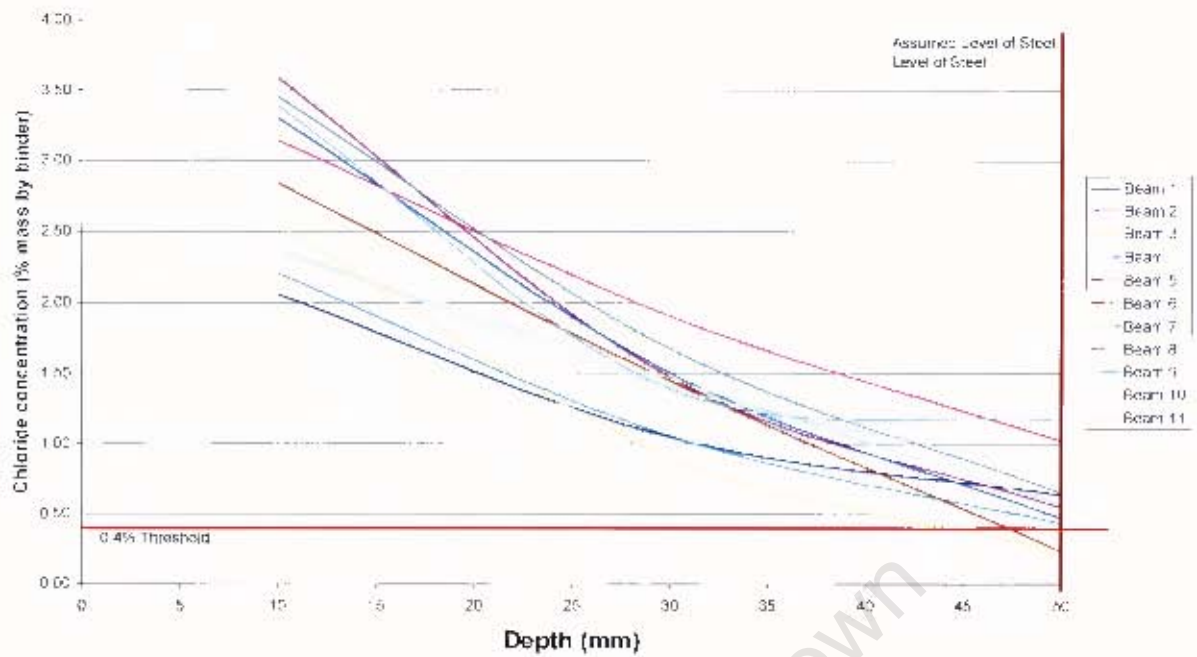
Figure 6-9: 11 Chloride profiles for St Helena Jetty 1

Drilled powder samples were taken from eleven transverse beams underneath the deck. At each beam, four locations were drilled to ensure a large enough sample. The drilled powder was collected in 20 mm increments to a depth of 60 mm. Testing was not done at beams where corrosion staining was present, assuming that these beams were already beyond repair. Contact was made with reinforcement at one location at a depth of approximately 50 mm. The longitudinal beams that crossed the eleven transverse beams showed signs of major corrosion with large scale cracking and spalling present, and had been condemned.

The results of the chloride profile testing showed that there is a high chloride presence in these beams. Using chloride profiling techniques it can be seen that the depth of the 0.4% threshold is well into the estimated level of cover in many beams, in fact all but one. This indicates that corrosion is likely to be active and the beams are being steadily deteriorated. As the structure is 32 years of age, it would be expected to be corroding under such a harsh marine environment.

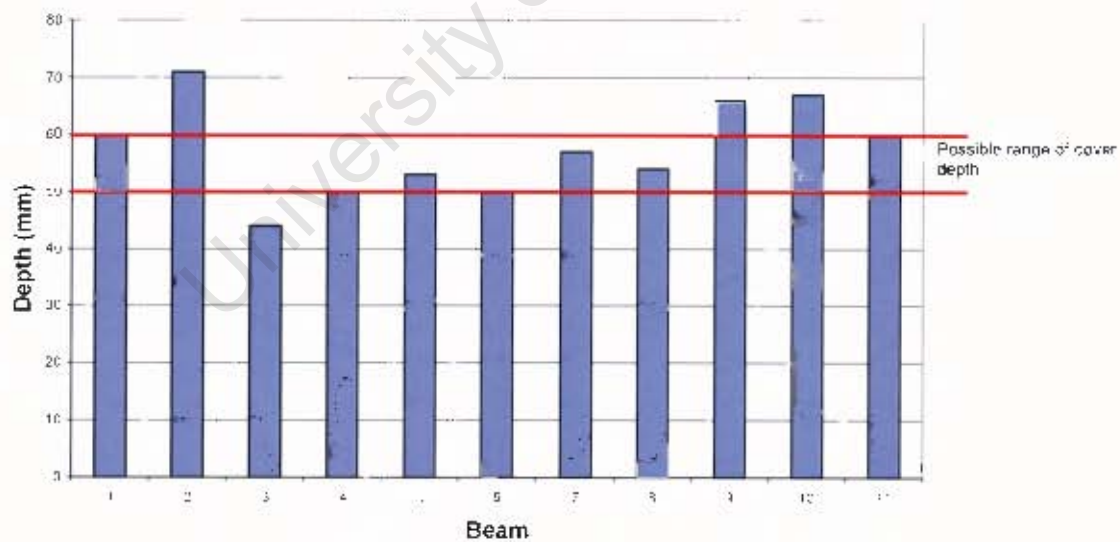
Figure 6-10: Depths of the 0.4% threshold at which corrosion risk becomes imminent

This figure shows that at present, the threshold value at which corrosion risk becomes imminent (0.4% chlorides by mass of cement) is in many instances (2, 9, 10, 11) at a

depth that is greater than the suspected range of cover (50-60 mm). The possibility of corrosion being active in many of these beams is therefore high.

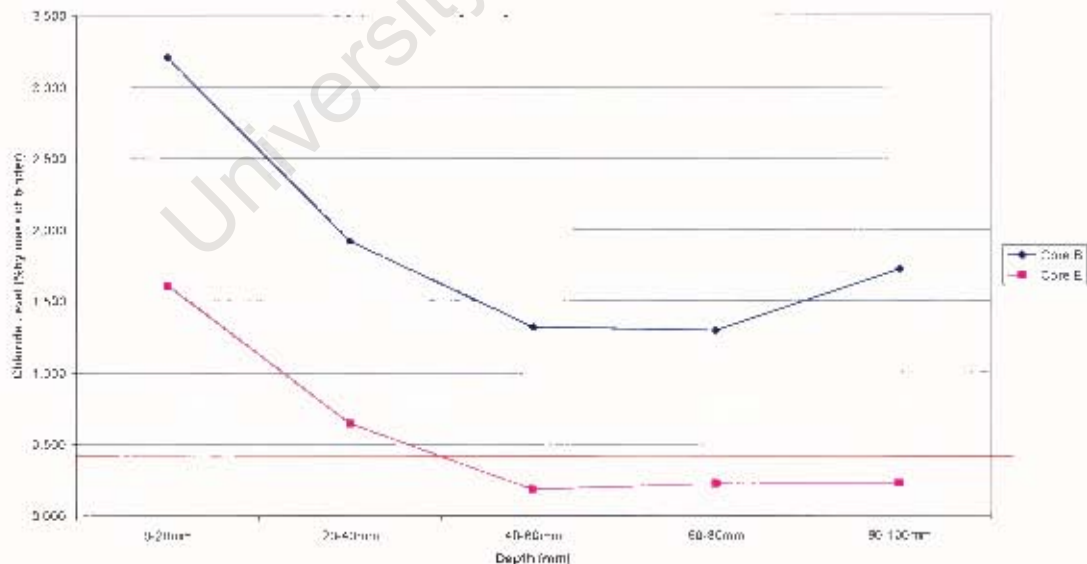
Figure 6-11: Chloride profiles for Jetty 1 from Soffit

The results for Core E are in both cases (top and bottom profiles) lower than for Core B. This could be as a result of a difference in location (Core E was extracted from a more sheltered location than Core B). The key result to notice, however, is that the chloride values are very high at great depth into the deck. It is clear that even in the case of high cover to reinforcement (>100mm), it is very likely that active corrosion is present throughout the deck. The red line in the graph shows the chloride threshold value of 0.4% chloride by mass of binder, and it is only in Core E at a depth of greater than 40mm from the soffit, that the level is lower than this.

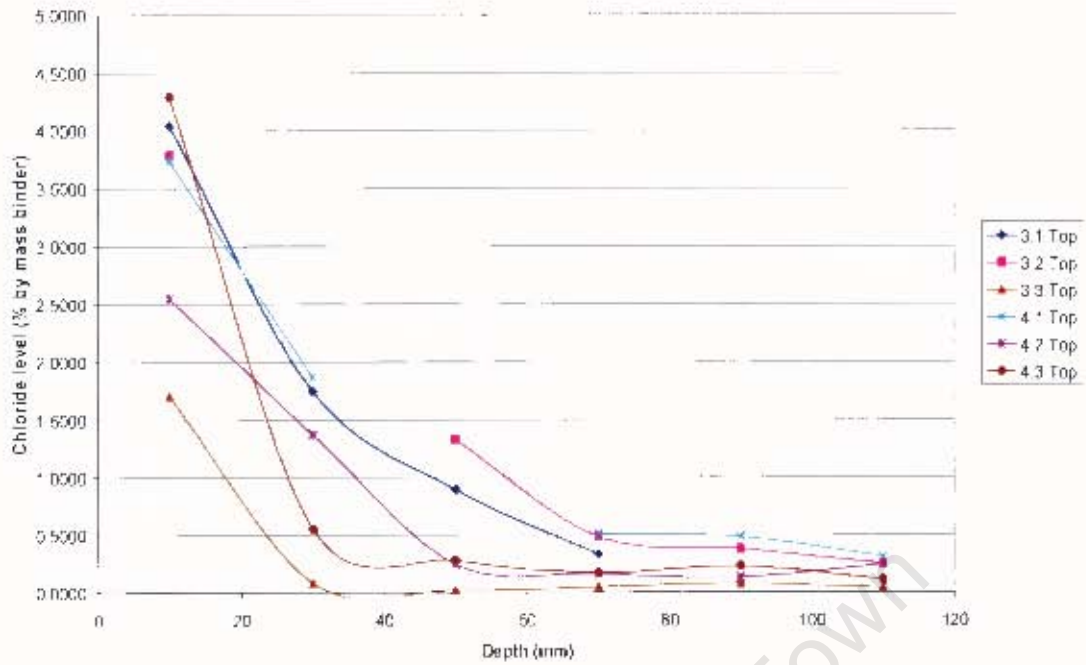
Figure 6-13: Chloride profiles from top of deck

Figure 6-13 and Figure 6-14 showed that there were instances where the measured chloride value at a depth greater than 60 mm is relatively high i.e. 0.4%-1.0% chloride concentration by mass binder, for example in Cores 3.1 and 3.2. This would indicate that certain remedial measures could be appropriate for the state of the structure at present. The scatter of the results could be attributed to the variable porosity as evidenced by the presence of some large pores. The variability of the measured cover values present in the cores should also be noted.

On site, it was these results that led the engineers to investigate the opportunities for use of a penetrating corrosion inhibitor to prevent further corrosion damage in the existing structure, based on the success of the testing performed at the Saldanha Bay site (UCT, 2004).

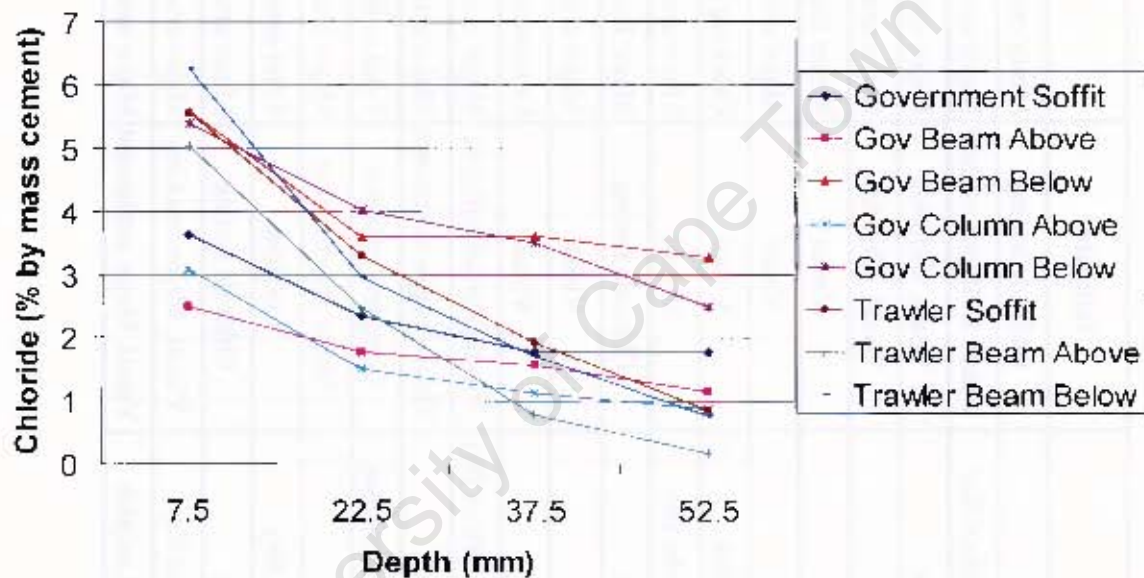
Figure 7-1: Summary of Chloride Results for Saldanha Bay

Figure 7-1 shows a summary of the results obtained from the Government Jetty and Trawler Quay chloride investigations. The results of the tests are presented fully in Chapter 6.2.1, but a key point that led to the recommendation of repair methods was the high chloride levels that were found at large depths (> 55 mm). The values were high enough to recommend that suitable long-term measures be investigated/budgeted for, as the recommended measures (Corrosion Inhibitors and Surface Treatments) would only be suitable to 'buy time'.

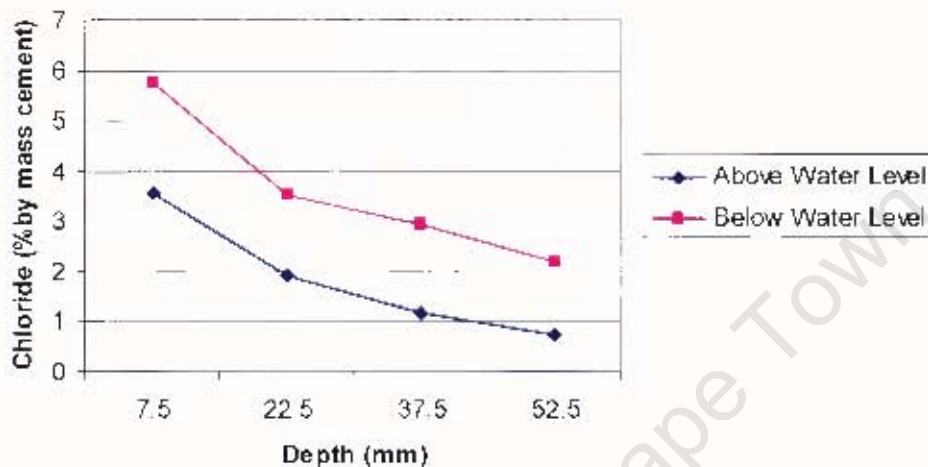
Figure 7-2: Saldanha Bay Chloride results showing influence of mean sea level

The results also revealed an interesting point, shown in Figure 7-2, that chloride levels below the mean sea level (MSL) were significantly higher in general than the than

those for the samples extracted above MSL. This is perhaps to be expected with the areas below MSL being in constant contact with sea water, but the visible damage on site did not correlate with the level of chlorides. This was attributed to the fact that the corrosion process operates at a slower rate in saturated conditions, i.e. it is starved of oxygen. Thus it was not deemed necessary to specify repair techniques to elements that were permanently submerged.

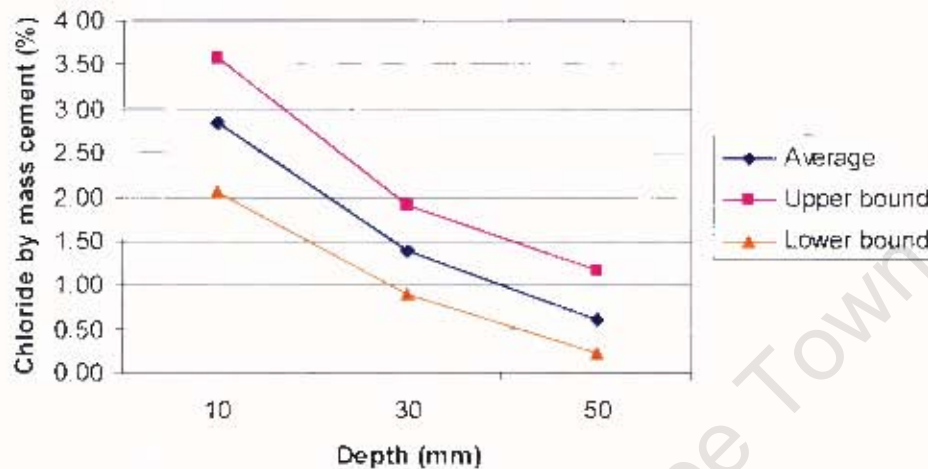
Figure 7-3: Summary of Jetty 1 Beam Chloride Profiles – St Helena Bay

The results are summarised in Figure 7-3, with good consistency obtained across the eleven samples. An average value for chloride concentration at 50 mm depth (the depth at which steel was found in a sample) was approximately 0.6% by mass of

cement, which is above the 'threshold' value of 0.4% where corrosion is suspected to commence. This was reported to the consulting engineers for the project and the decision was taken to replace all the beams in the structure, as well as the deck which was also found to be severely contaminated (See next section). The piled columns, which were not investigated, were retained and the new beam and slab system was cast upon them.

The implications of this decision are noteworthy. The recorded chloride levels were within the range that would potentially be suitable for the application of corrosion inhibition, but instead of opting for this method (as was implemented at Saldanha Bay), the decision was made to demolish and reconstruct the beam and deck elements. The reason for this decision was that the central spanning beam had already deteriorated beyond the point of repair, and thus it was impractical to retain the rest of the structure whilst replacing that element. Where this not the case, it is likely that remedial measures such as surface treatments and corrosion inhibitors would have been more suited for the repair.

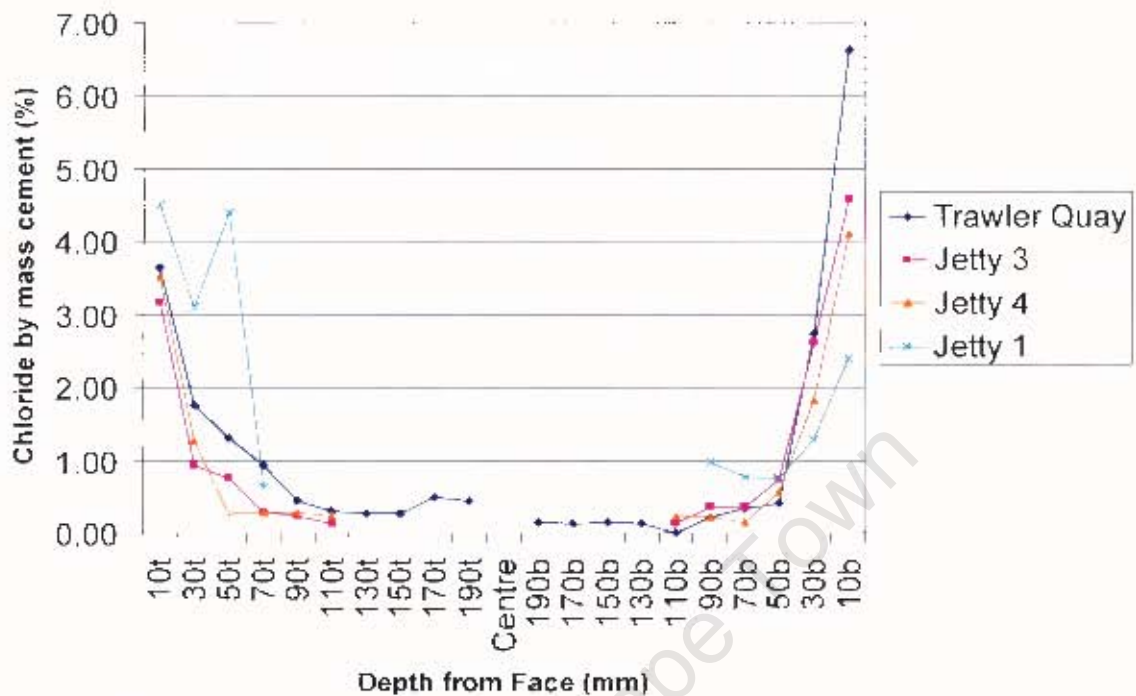
Figure 7-4: Chloride profiles for deck cores

The chloride profiling of four reinforced concrete jetty decks (Jetty 1, 3 and 4 at St Helena bay and Trawler Quay at Saldanha bay) showed the difference in chloride profiles between the top and bottom faces of reinforced concrete decks. Jetty 1 at St Helena Bay was tested prior to demolition, whilst the other decks are still in use. The

combined profiles are shown in Figure 7-4, expressing chloride level versus depth from top face (t) or bottom/soffit (b).

It was found in the chloride profiling results that the chlorides had been able to penetrate to a significant level (>50 mm) from both the top surface as well as the soffit of the deck slabs. It could be expected that the close proximity of seawater to the soffit would result in increased levels of chlorides, relative to the top surface. This is shown to be true for the soffit, which shows higher surface chloride values than the top of the deck. A factor that may influence the migration of chlorides from the deck surface could be the ponding of seawater on top of the deck for appreciable periods of time. This would create a constant driving pressure head as well as a constant source of chlorides, and would result in more chlorides penetrating to greater depth. The likelihood of such an occurrence is debatable, and was not observed on site.

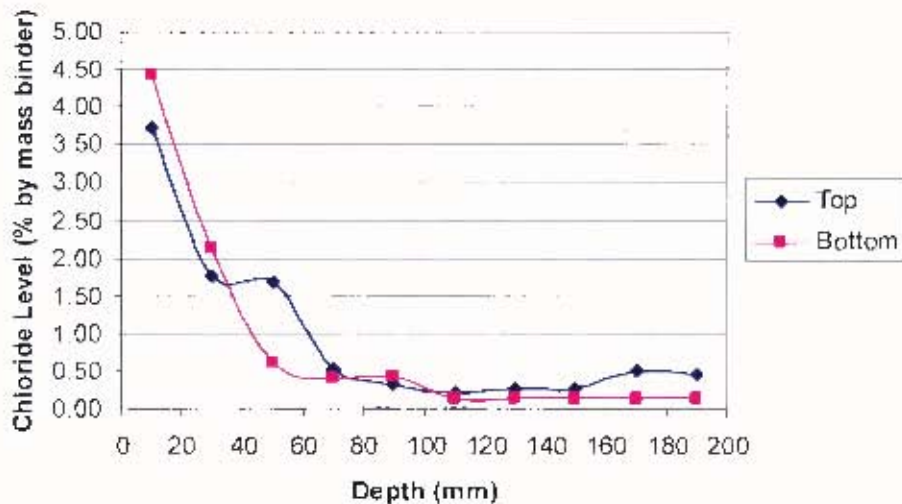
Figure 7-5: Average chloride profiles for deck cores from top and bottom

Figure 7-5 above shows the averaged profiles from Figure 7-4. Beyond a depth of 100 mm, the differences between the profiles are minimal, but there is a moderate difference shown in the near surface results. For the top surface, the chloride transport mechanisms of sorption and diffusion account for a higher result at depth (50mm), while flushing during rain could potentially account for the lower surface concentration. For the bottom surface, the more frequent contact with seawater explains the higher surface concentration while the mechanism of diffusion only would link to a lower concentration at depth.
