Department of Civil Engineering

**A comparative study on the structural behaviour of concrete arch
dams subjected to swelling due to aggregate silica reactions**

Civil Infrastructure Management and Maintenance

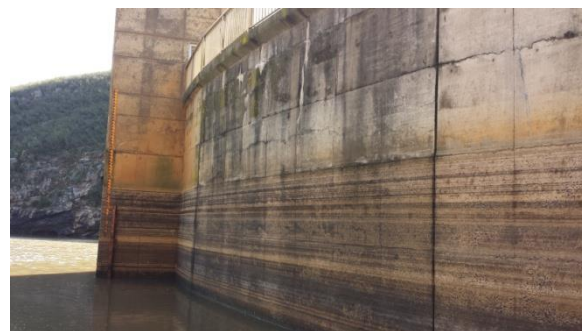
The upstream face of the right flank mostly displayed horizontally orientated cracks (see Figure 4-2 and Figure 4-3).

Figure 4-3: Hartebeeskuil Dam: The upstream concrete face viewed towards the inlet tower

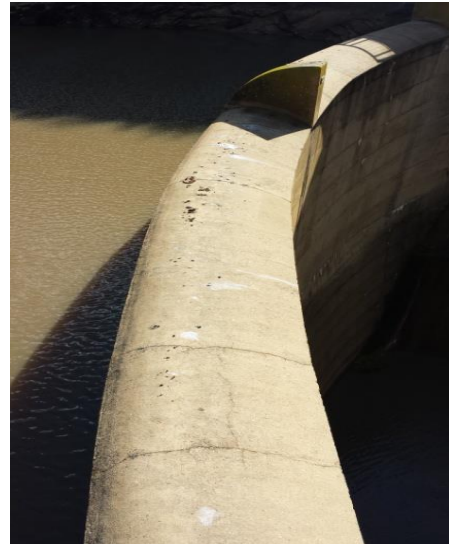
Figure 4-13: Hartebeeskuil Dam: General view of the spillway crest

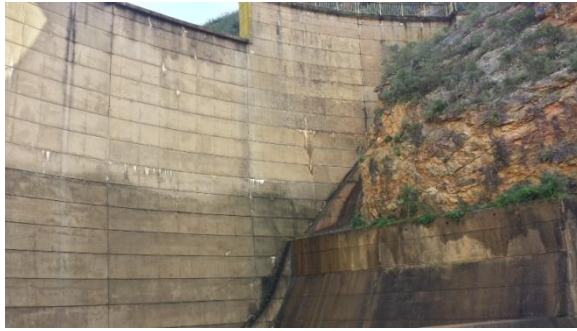
The left flank upstream face and non-overspill crest (NOC) could not be accessed. The left flank downstream face displayed more of the same cracks as were evident on the right flank downstream face though slightly less prominent (see Figure 4-15 to Figure 4-17).

Figure 4-15: Hartebeeskuil Dam: Spillway and left flank downstream face

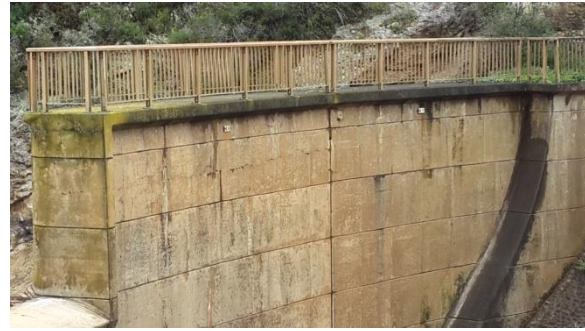
Figure 4-16: Hartebeeskuil Dam: Close-up view of left flank downstream face

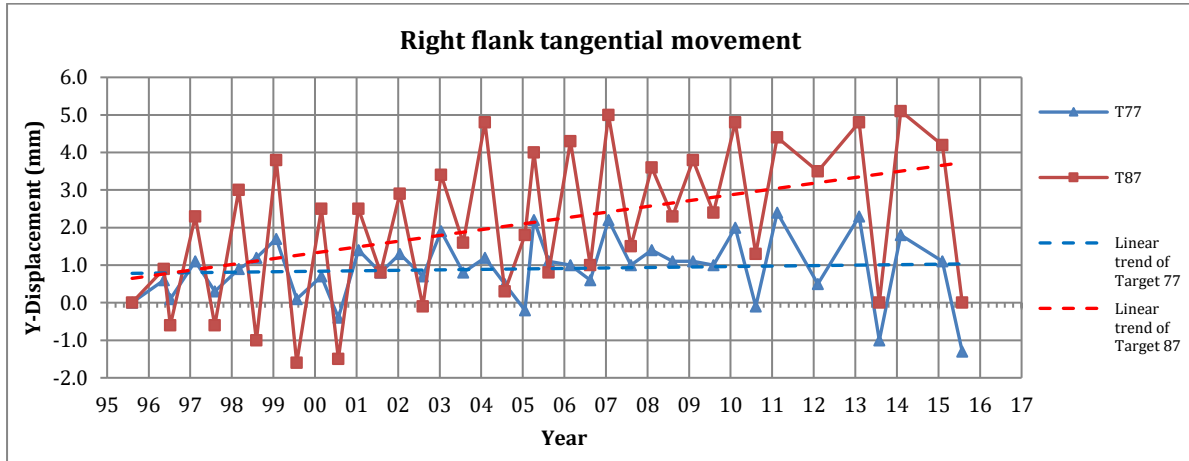
Figure 4-19: Tangential movements of T77 and T87 at Hartbeeskuil Dam

The far-right flank (T77) shows small permanent trends of approximately 1 mm towards the right abutment (see Figure 4-19). The middle-right flank (T84, T85 and T87) shows more significant permanent trends of approximately 3 mm towards the right abutment (see Figure 4-19 and Figure 4-20). The spillway crest (T82 and T83) show permanent trends of approximately 1-2.5 mm towards the left abutment. The far-left flank (T78) shows permanent trends of approximately 2.5 mm towards the left abutment. The middle-left flank (T79, T80 and T81) shows more significant permanent trends of approximately 3-4 mm towards the left

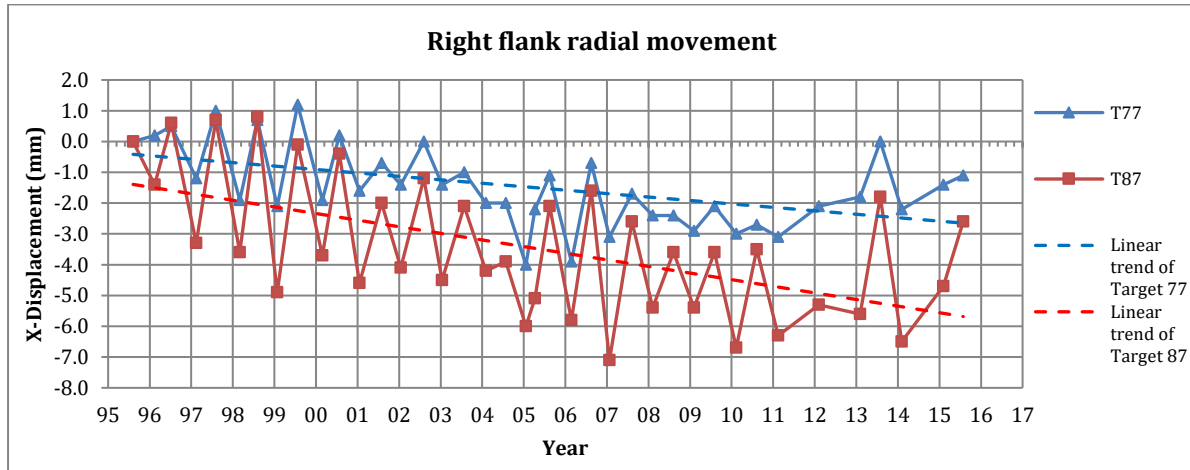
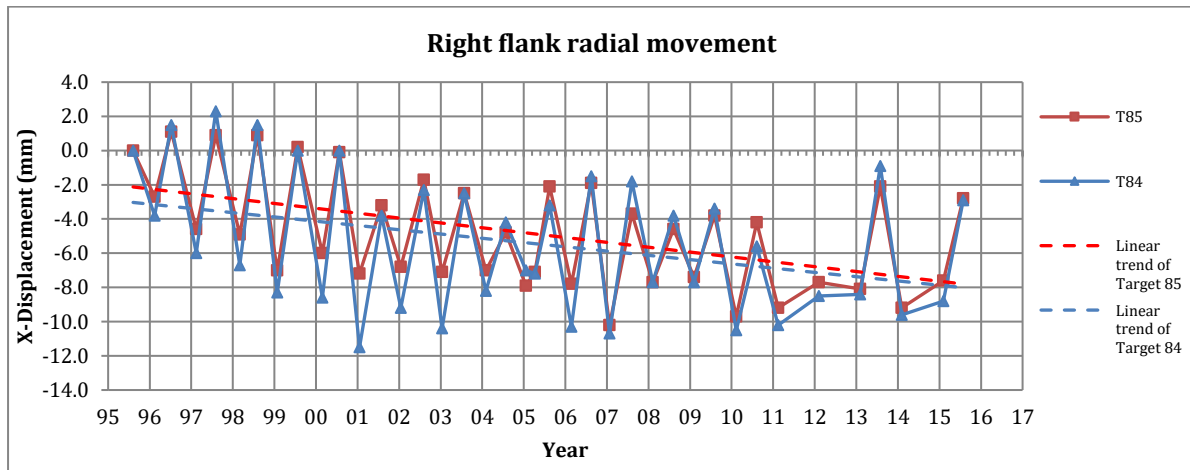
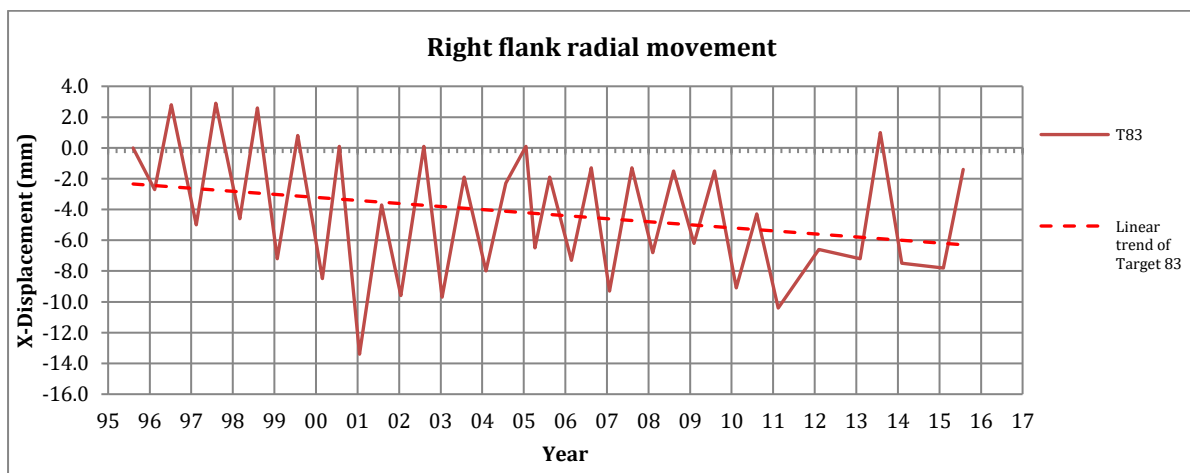
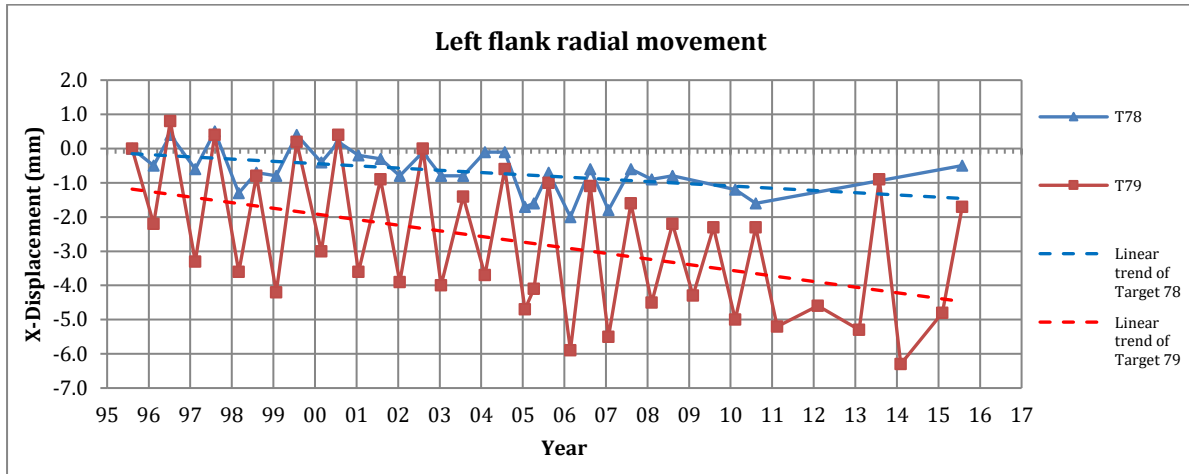
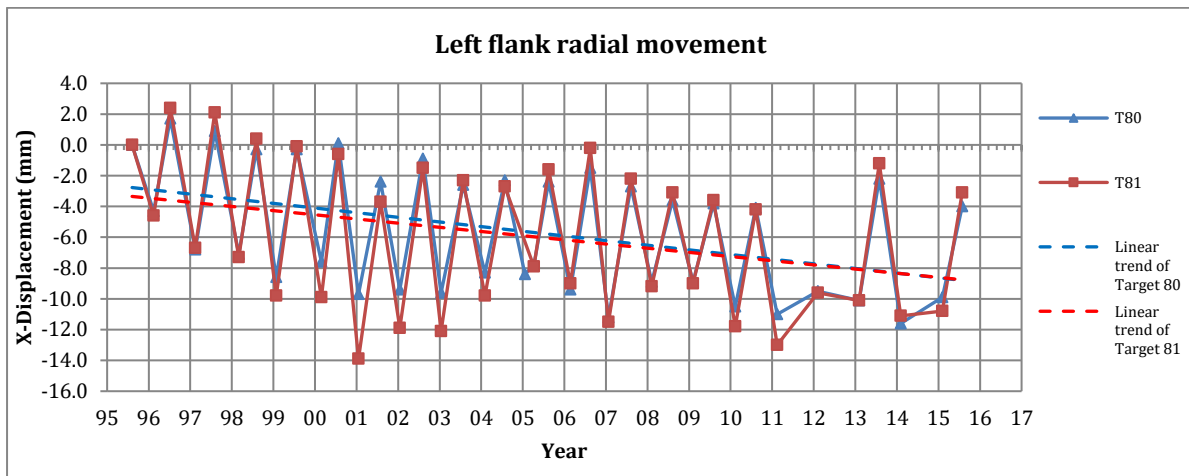
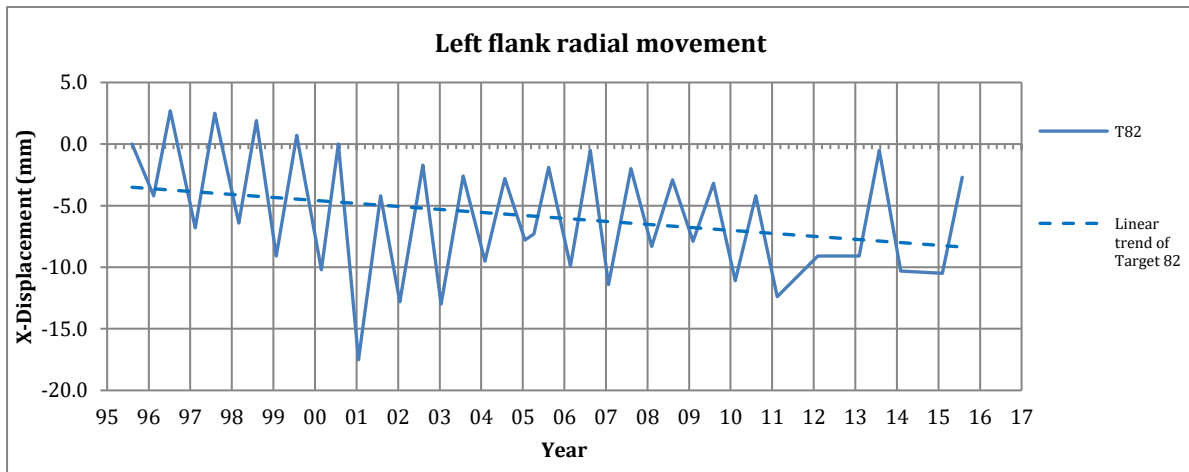
The right flank, left flank and spillway show permanent trends toward the upstream side of approximately 1-6 mm. The smallest upstream trends occur on the far-right and far-left flanks. The biggest trends occur more toward the centre of the arch structure. In summary, these results prove that there is a permanent swelling action in an upstream direction.

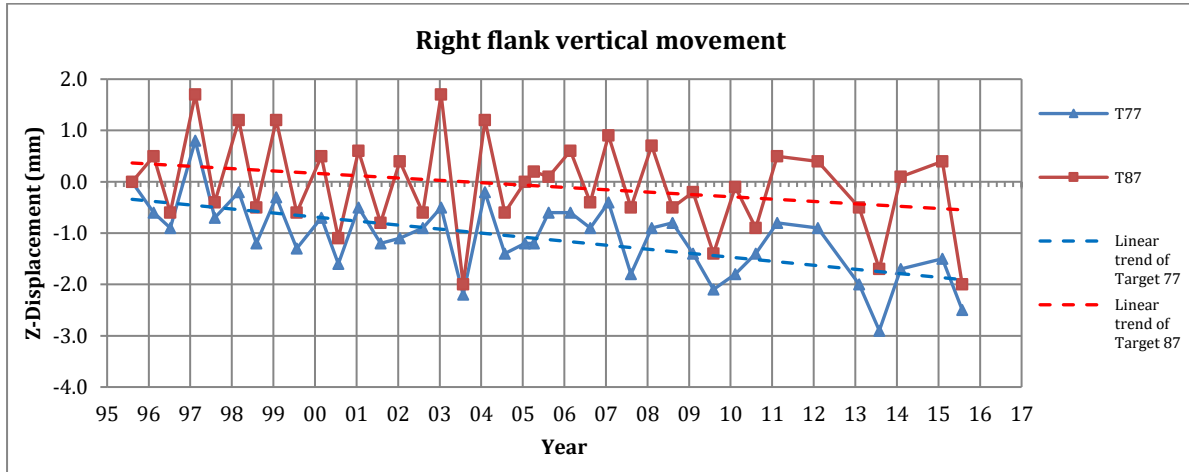
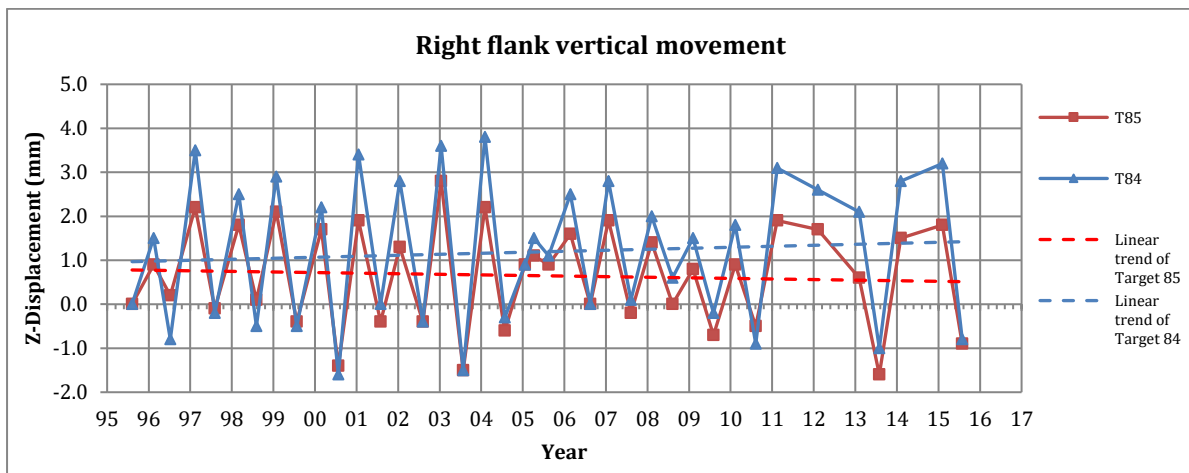
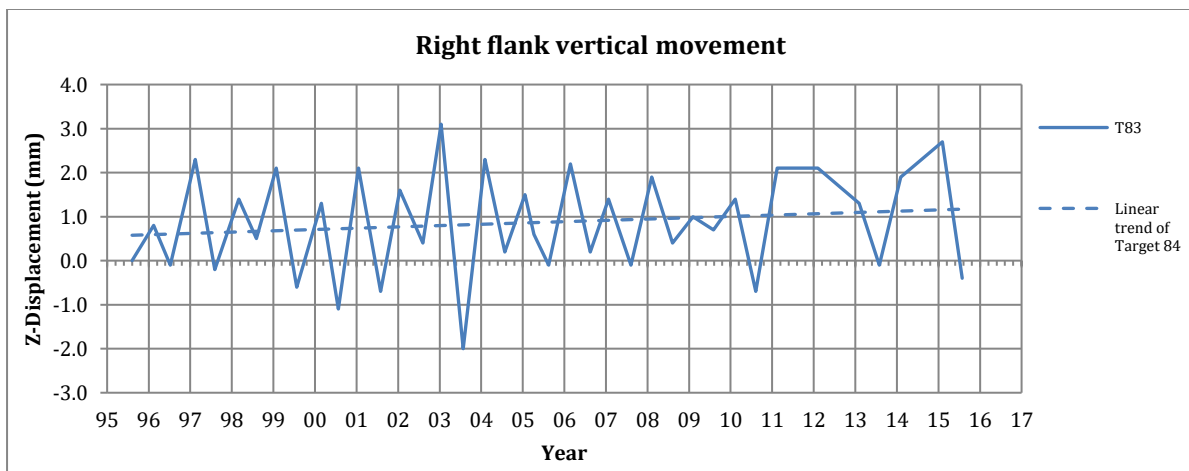
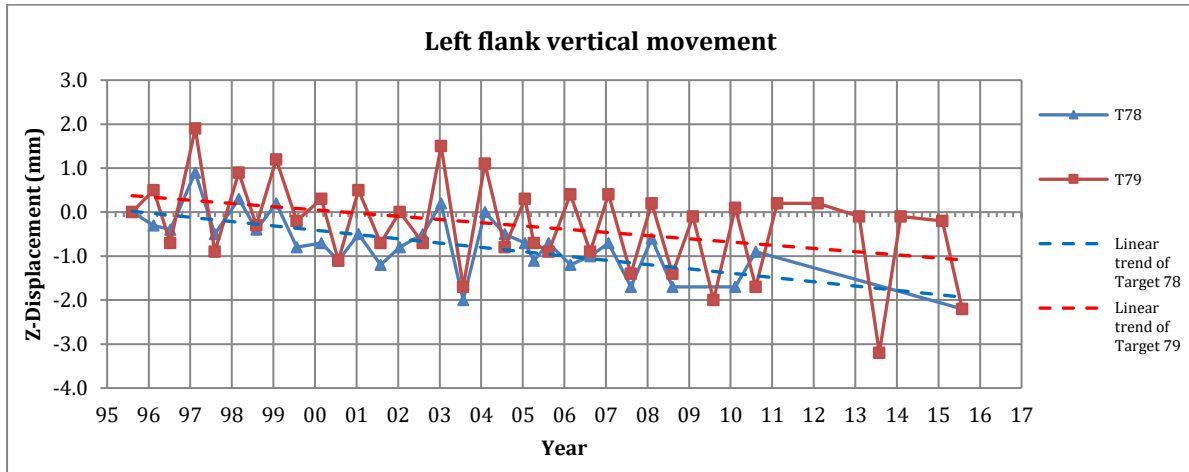
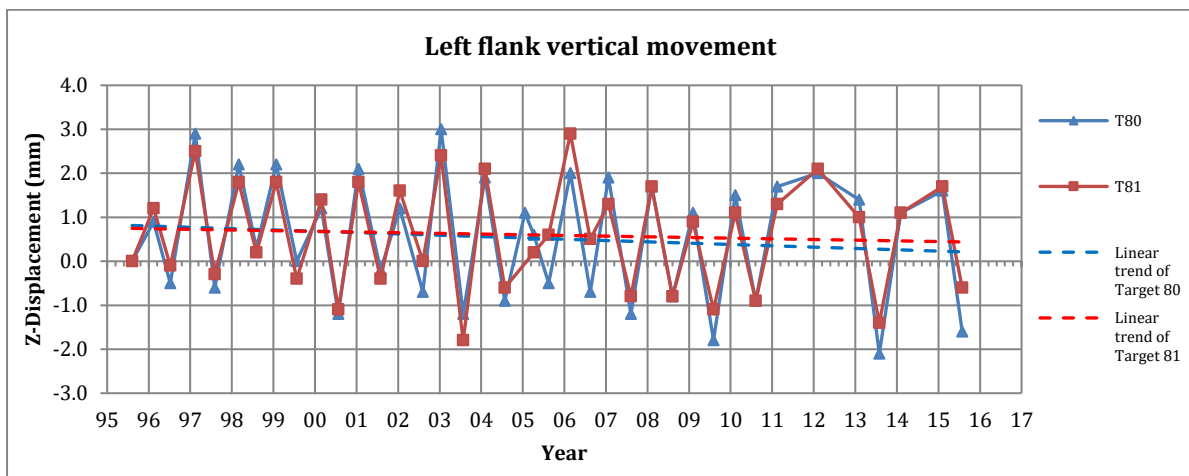
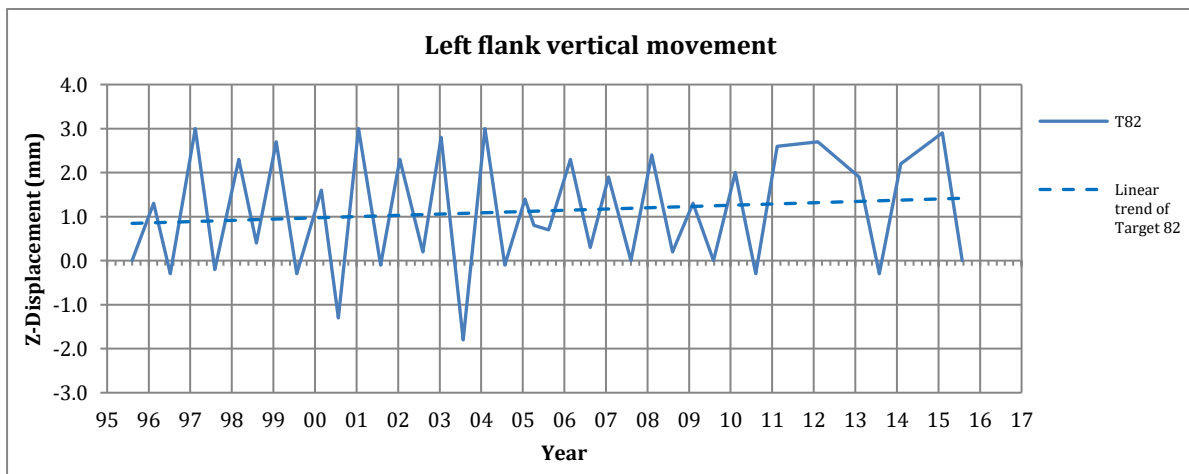
The far-right flank and far-left flank show permanent settlement trends of approximately 1-2 mm. The targets toward the middle of the dam wall show very stable trends, with some signs of rising crest elevation at the spillway (T82 and T83); the permanent trends are very small and do not exceed 2 mm. In summary, these results prove that both the flanks are settling, and the middle of the dam is rising slightly.

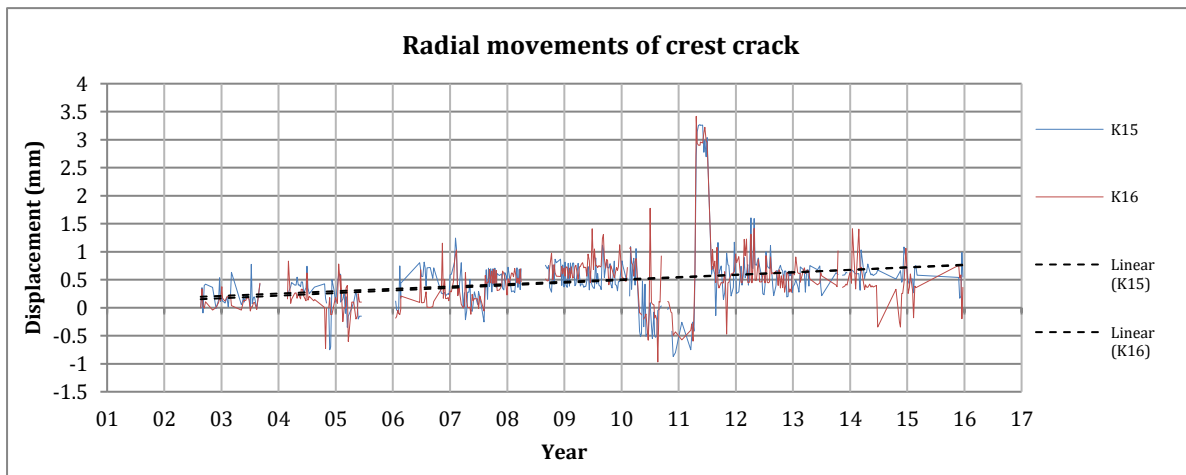
Figure 4-37: Radial movements of the tangential crest crack at Hartebeeskuil Dam

The radial measurements show that the crack has opened slightly - less than 1 mm (see Figure 4-37). The tangential measurements show that the upstream section of the crack has moved in the direction of the right flank relative to the downstream section - less than 1 mm (see Figure 4-38). Gauge K16 shows that the upstream section moved slightly upward relative to the downstream section of the crack - less than 1 mm. Gauge K15 shows a stable trend, but the movements hint at a swelling trend of the upstream section of the arch dam (see Figure 4-39).

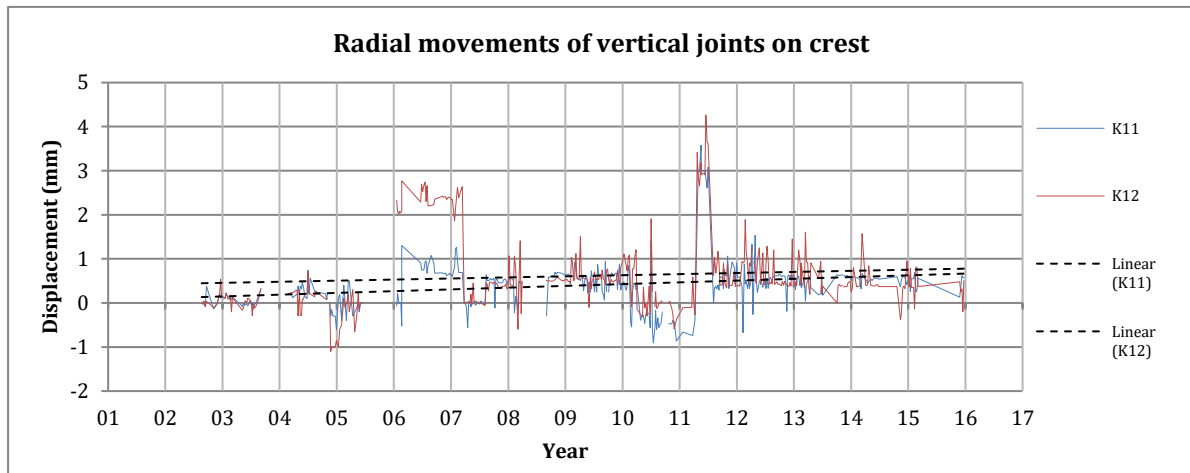
Figure 4-41: Radial movements of crest vertical joints at Hartebeeskuil Dam

The radial movements show that Block 9 moved slightly downstream relative to Block 8 and that block 8 moved downstream relative to Block 7 with permanent trends of less than 1 mm (see Figure 4-41). The tangential movements show that the joints are closing slightly with permanent trends of less than 1 mm (see Figure 4-42). The vertical movements show that Block 9 moved upwards relative to Block 8. Block 8 moved downwards relative to Block 7 with permanent trends of less than 1 mm (see Figure 4-43). No clear swelling trends are evident from these results.

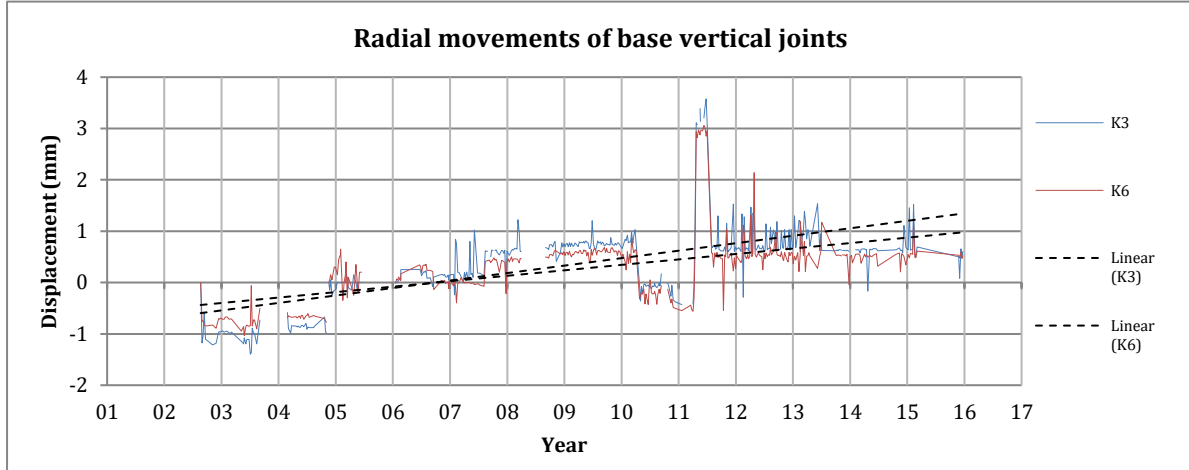
Figure 4-44: Radial movements of base vertical joints at Hartebeeskul Dam

Block 9 has moved downstream relative to block 8 and Block 7 has moved downstream relative to block 6 with permanent trends of less than 2 mm (see Figure 4-44). Both K3 and K6 show closing of the joints with permanent trends of less than 2 mm (see Figure 4-45). Blocks 8 and 9 have remained more or less even with regards to permanent vertical trends. Block 6 has moved up relative to block 7 with permanent trends of less than 3 mm (see Figure 4-46). Due to the erratic nature of some of the readings, it is hard to draw any certain conclusions on the crack width results.

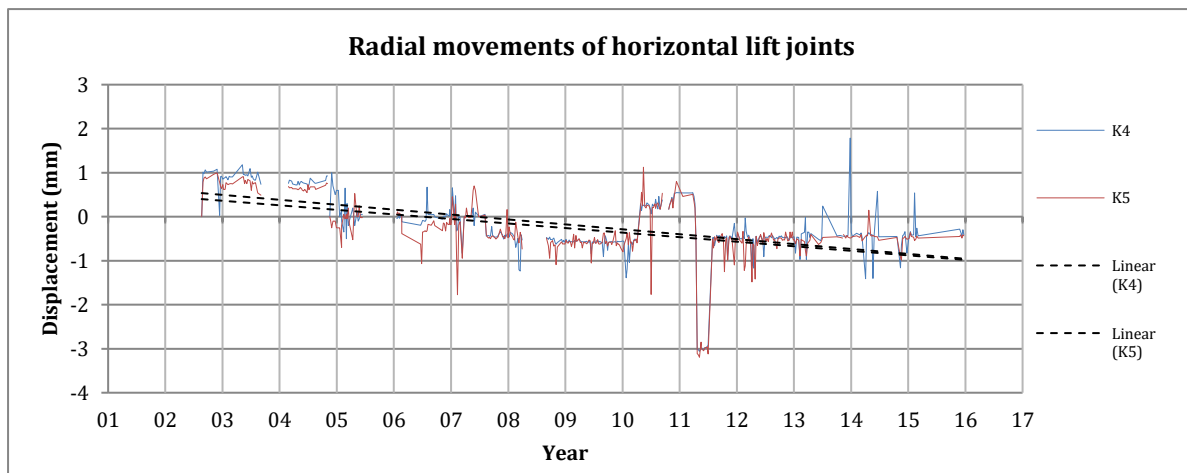
Figure 4-47: Radial movements of horizontal lift joints at Hartebeeskul Dam

The radial movements show that the top lifts on the joints generally move upstream relative to the bottom lifts with permanent trends of less than 2 mm (see Figure 4-47). The tangential movements show that the top lifts on the joints generally move to the right relative to the bottom lifts with permanent trends of less than 2 mm (see Figure 4-48). The vertical movements show that the joints have generally closed with permanent trends of less than 2 mm (see Figure 4-49). Due to the erratic nature of some of the readings, it is hard to draw any certain conclusions on the crack width results.

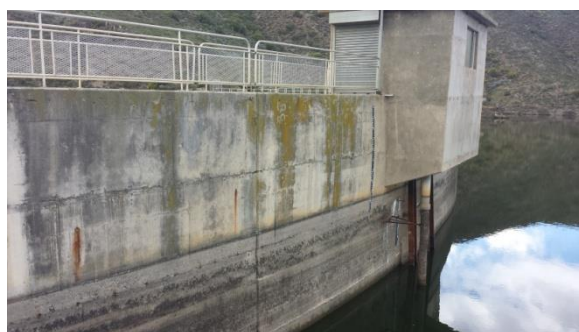
The upstream face of the left flank was in a fairly good condition with no major cracks visible (see Figure 5-2 and Figure 5-3).

Figure 5-2: Poortjieskloof Dam: General view of left flank upstream face

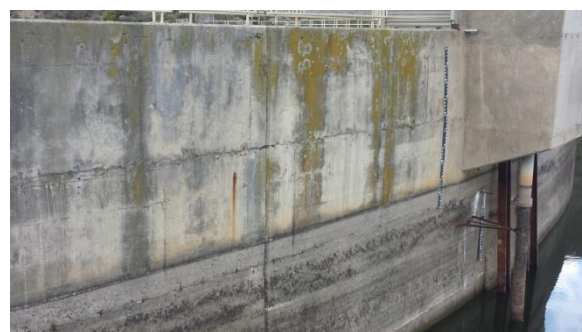
Figure 5-3: Poortjieskloof Dam: Close-up view of left flank upstream face

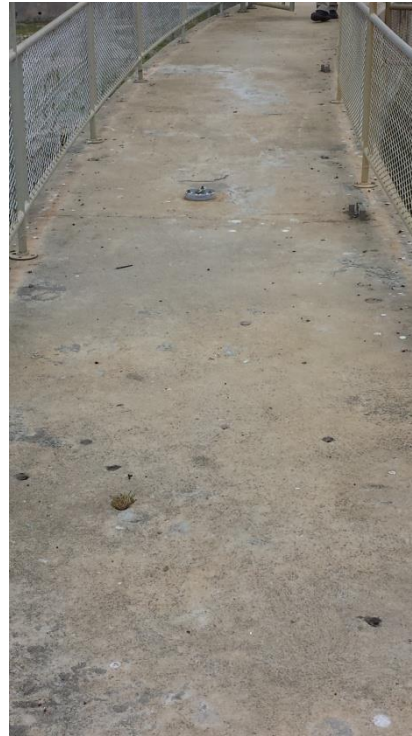
The left flank NOC was in a good condition (see Figure 5-5). The concrete structure to the left of the NOC (which include the steps from the parking area) displayed AAR cracking patterns as shown in Figure 5-4 and Figure 5-6.

Figure 5-5: Poortjieskloof Dam: The left flank NOC

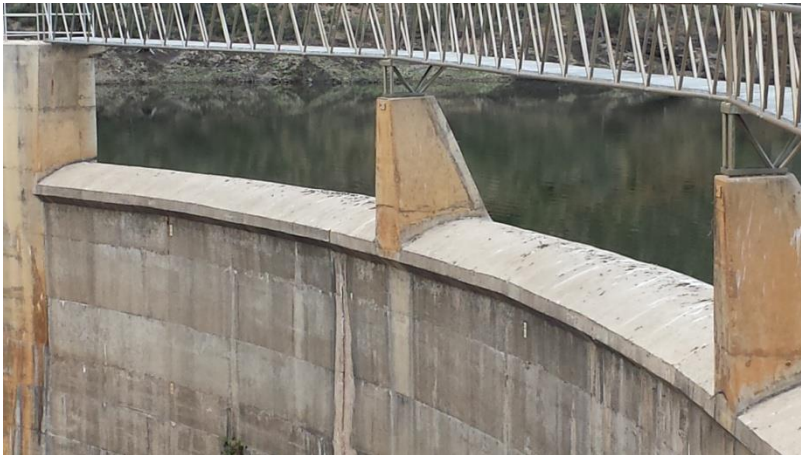
The upstream face of the spillway could not be inspected due to restricted access. The crest of the spillway generally displayed no real signs of distress or cracking as shown in Figure 5-11.

Figure 5-11: Poortjieskloof Dam: View of spillway crest

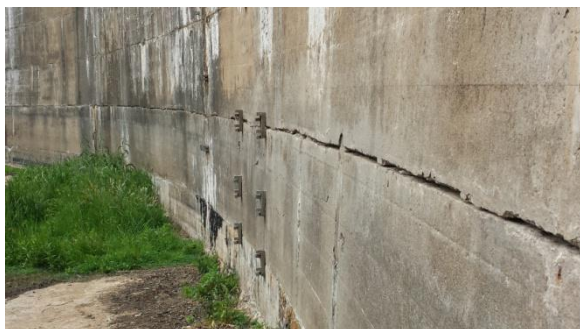
The downstream face of the spillway displayed excessive seepage through the horizontal construction lift joints, which is characterised by calcite staining and moist areas (see Figure 5-12). The first major lift joint above the apron showed clear separation on the downstream side (see Figure 5-14). The separation and excessive leakage of the horizontal construction lift joints are typical AAR expansion phenomena.

Figure 5-14: Poortjieskloof Dam: Clear separation of first horizontal construction lift joint above apron

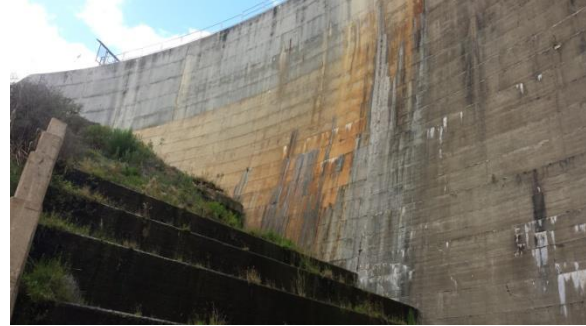
The right flank upstream face and NOC could not be accessed. The downstream face displayed some significant cracking patterns similar to those on the left flank downstream face (see Figure 5-15 to Figure 5-18).

Figure 5-16: Poortjieskloof Dam: General view of the right flank downstream face

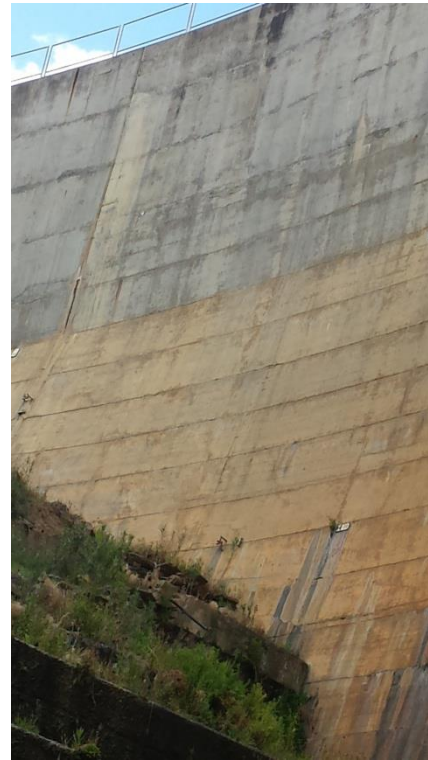
Figure 5-18: Poortjieskloof Dam: Close-up view of the far-right flank downstream face

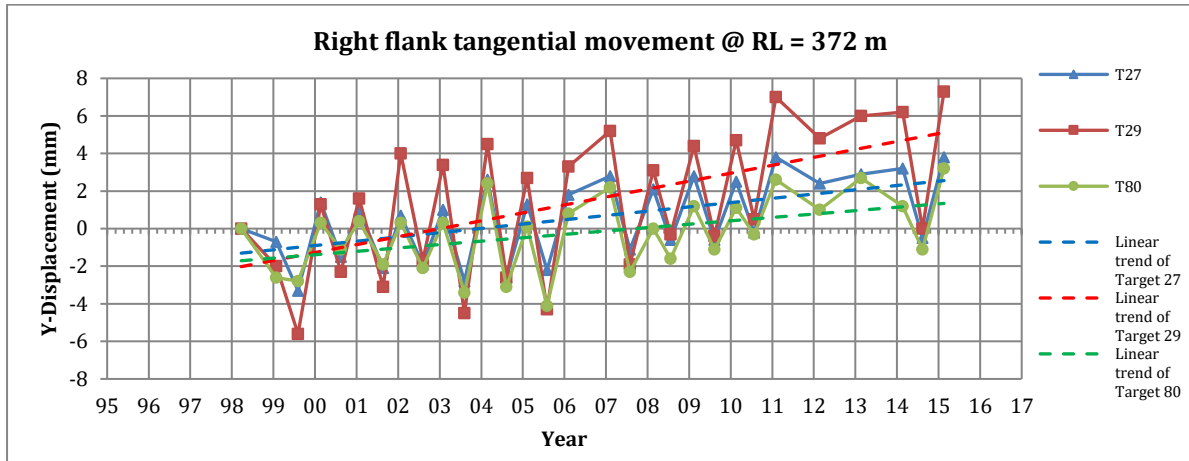
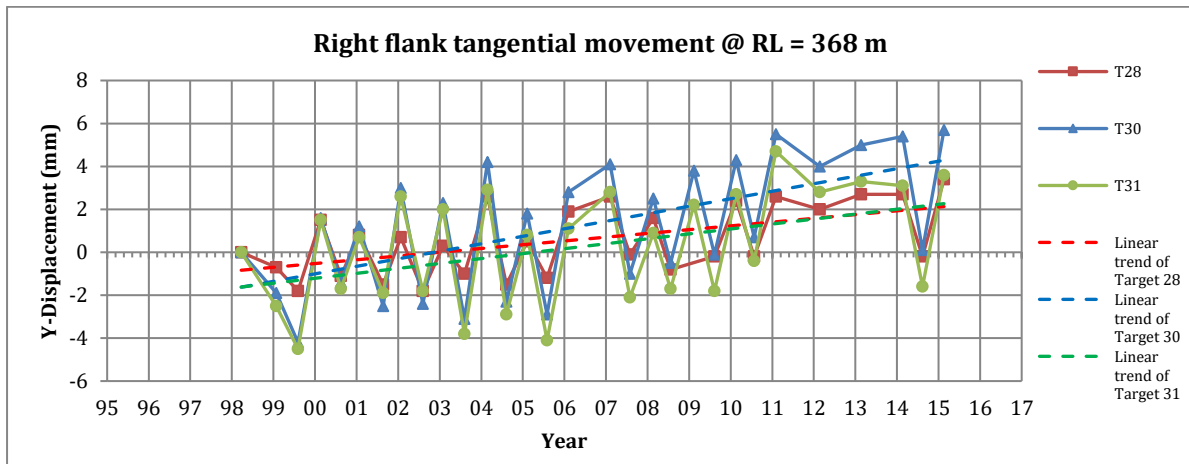
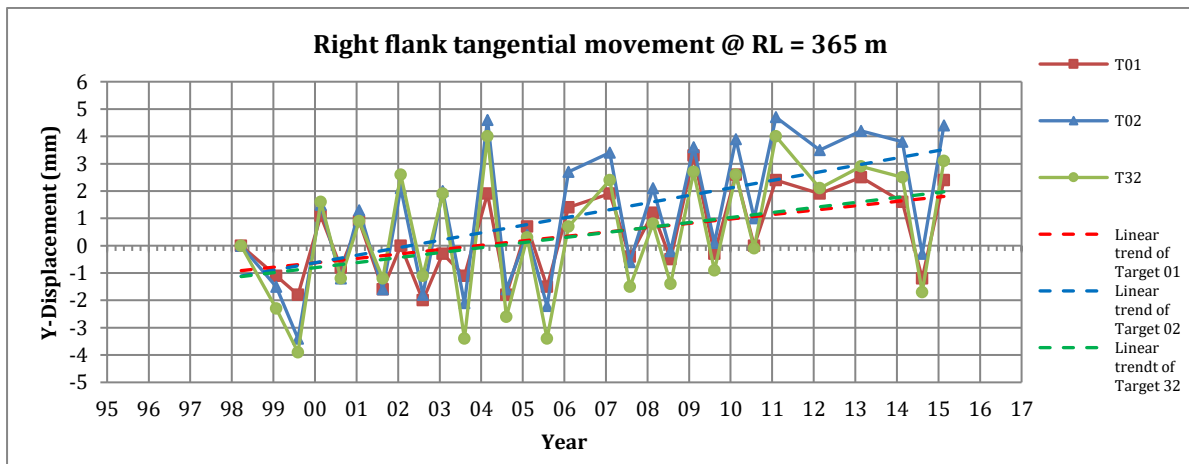
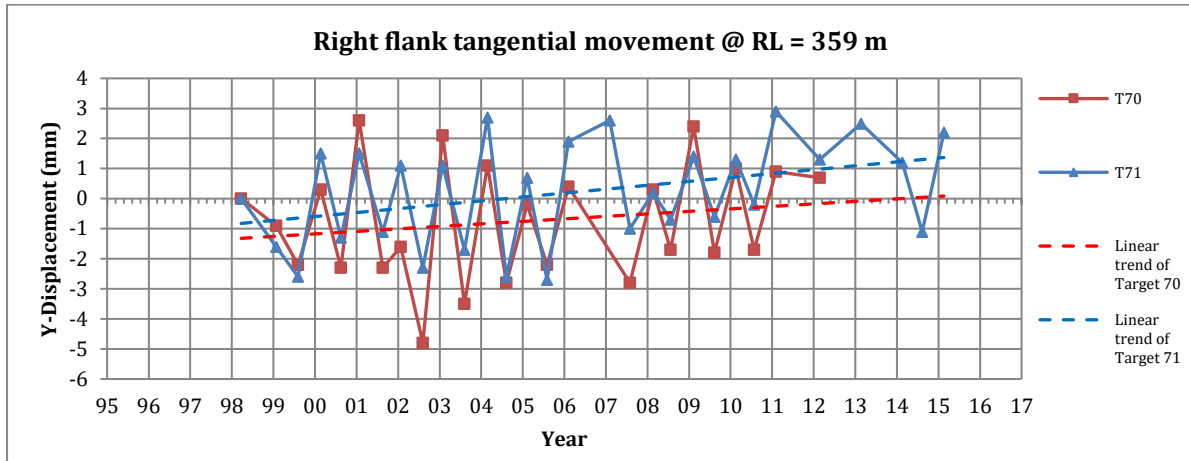
Figure 5-21: Tangential movements of T27, T29 and T80 at Poortjieskloof Dam

Figure 5-22: Tangential movements of T28, T30 and T31 at Poortjieskloof Dam

Figure 5-23: Tangential movements of T01, T02 and T32 at Poortjieskloof Dam

Figure 5-24: Tangential movements of T70 and T71 at Poortjieskloof Dam

The right flank targets display a definite trend of permanent displacement towards the right flank. T29 (RL = 372 m), T30 (RL = 368 m) and T02 (RL = 365 m) which are all located on Block 7 (the approximate quarter point of the arch from the right flank), display the biggest permanent trends - permanent trends do not exceed 7 mm. (Refer Figure 5-21 to Figure 5-24).

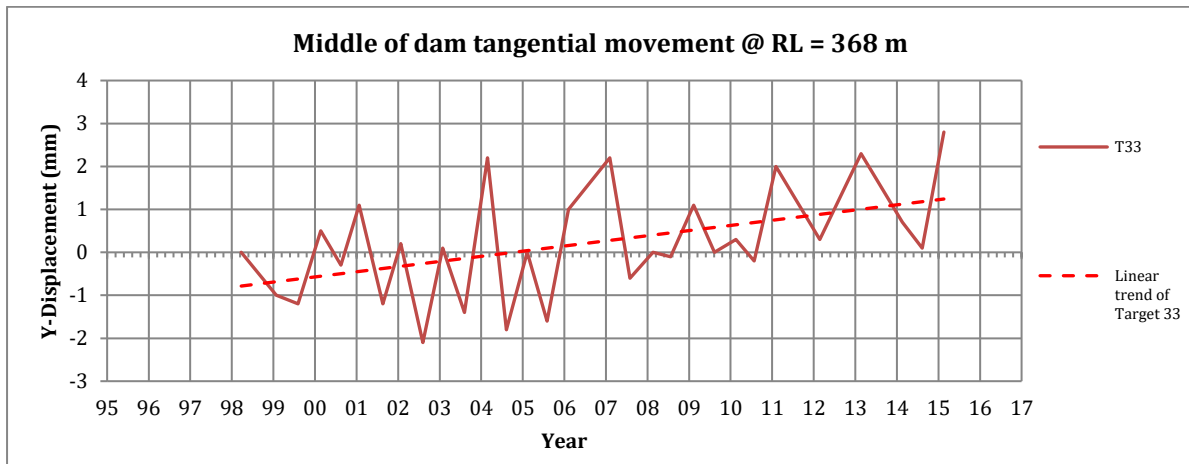
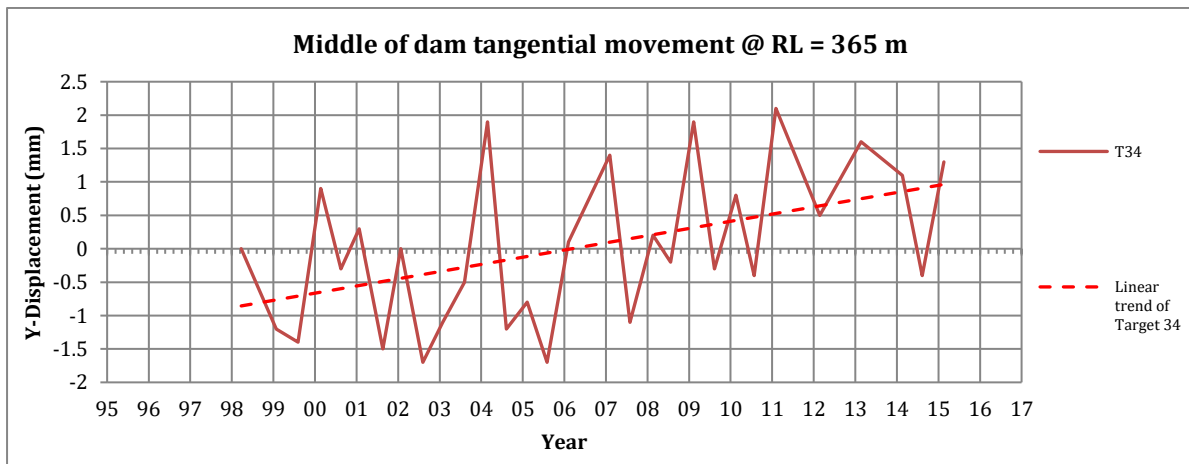
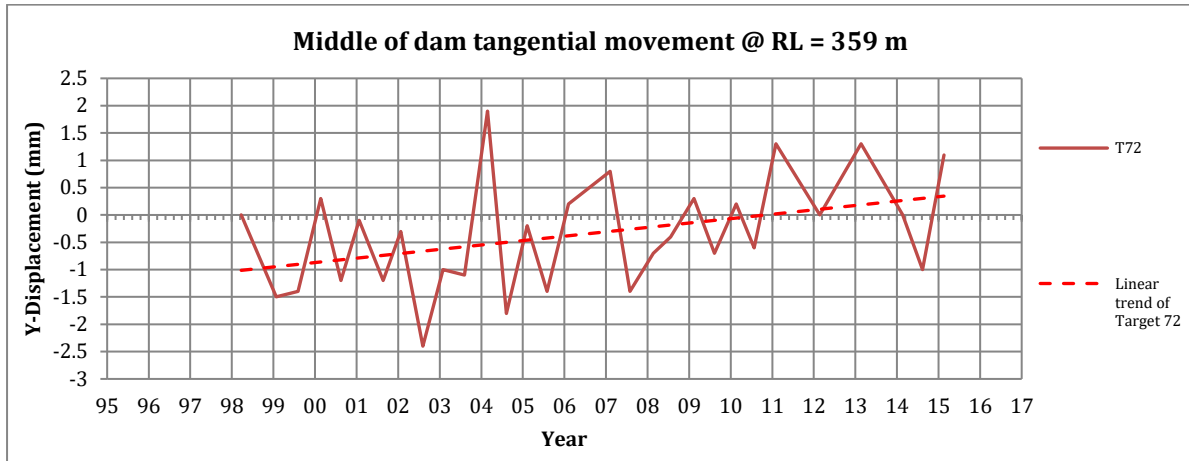
Figure 5-25: Tangential movements of T33 at Poortjieskloof Dam

Figure 5-26: Tangential movements of T34 at Poortjieskloof Dam

Figure 5-27: Tangential movements of T72 at Poortjieskloof Dam

The targets located in the middle of the arch dam display a slight trend of permanent movement in the direction of the right flank. Permanent trends are very small and do not exceed 2 mm. (Refer Figure 5-25 to Figure 5-27).

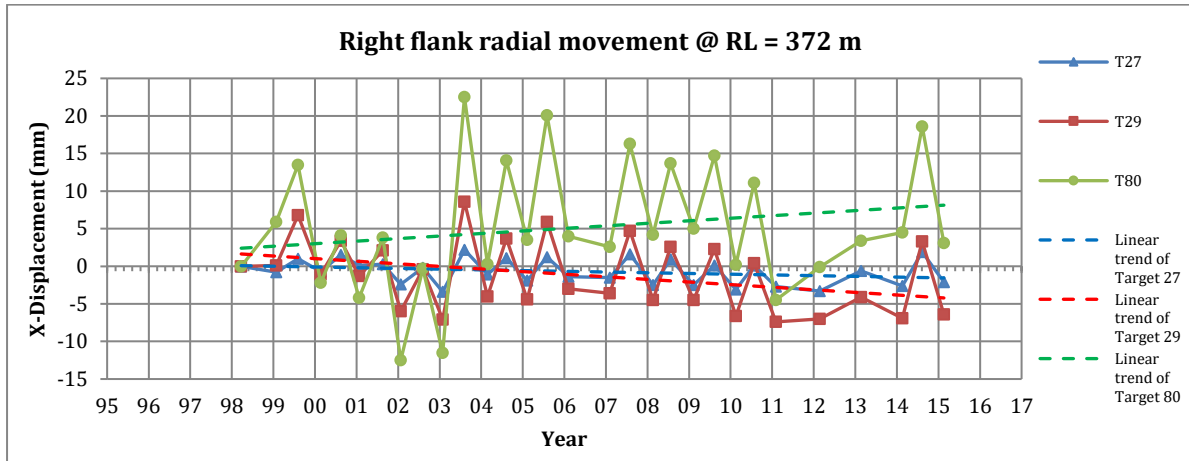
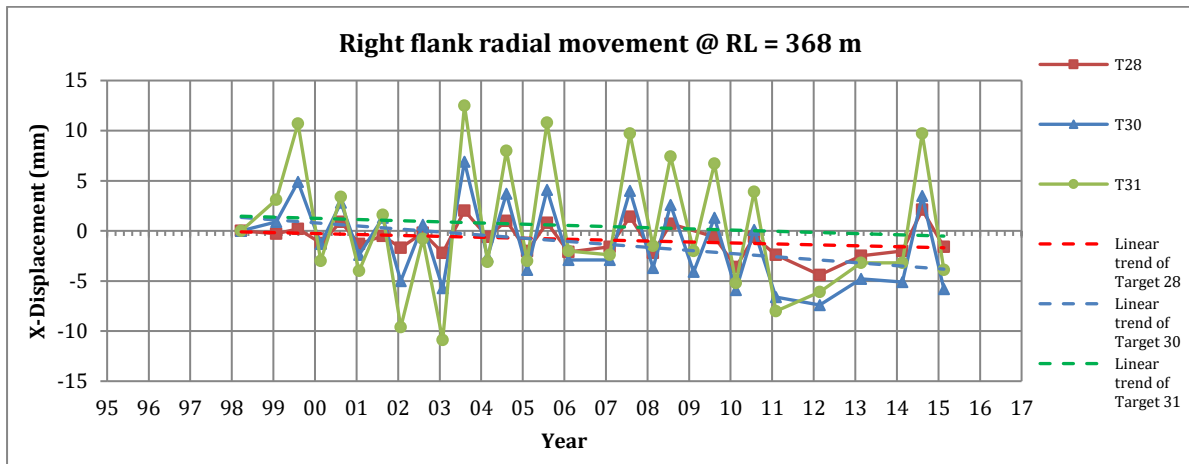
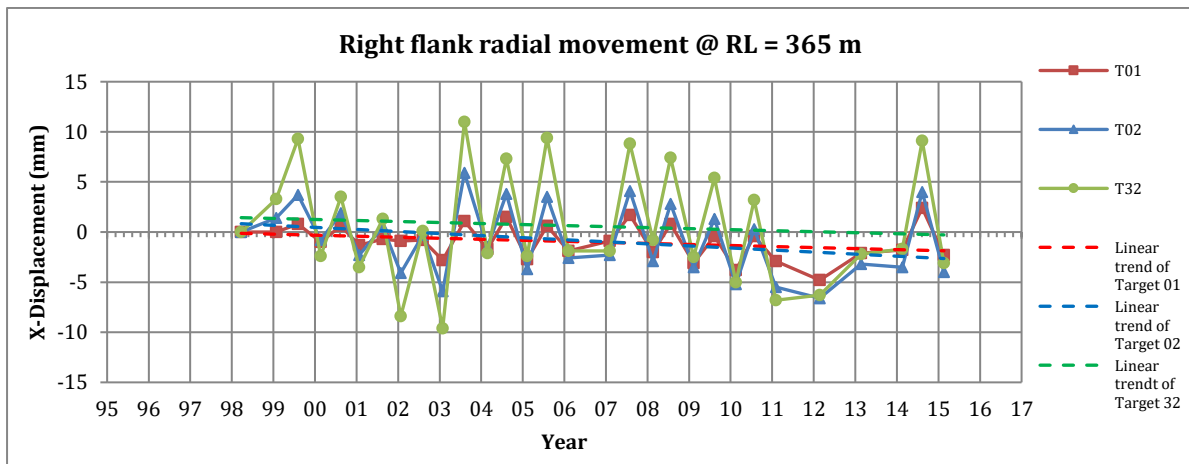
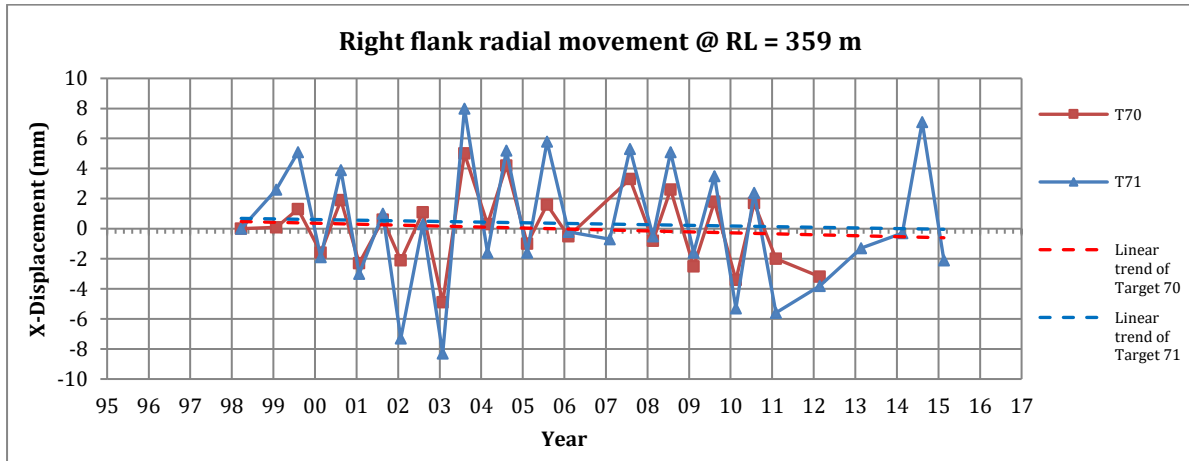
Figure 5-32: Radial movements of T27, T29 and T80 at Poortjieskloof Dam

Figure 5-33: Radial movements of T28, T30 and T31 at Poortjieskloof Dam

Figure 5-34: Radial movements of T01, T02 and T32 at Poortjieskloof Dam

Figure 5-35: Radial movements of T70 and T71 at Poortjieskloof Dam

The right flank targets generally show a permanent upstream displacement trend, except for T80, which is located on the spillway splitter. T80 displays a downstream trend which does not exceed 5 mm. The targets on the upper sections (T27, T28, T29, and T30) located on Blocks 7 and 8 display the biggest permanent upstream trends. Trends do not exceed 5 mm. The targets on the lower sections display very small upstream trends that do not exceed 2 mm. The targets that are located closer to the middle (T31, T32, and T71) of the arch dam on Block 6 display much smaller upstream trends. (Refer Figure 5-32 to Figure 5-35).

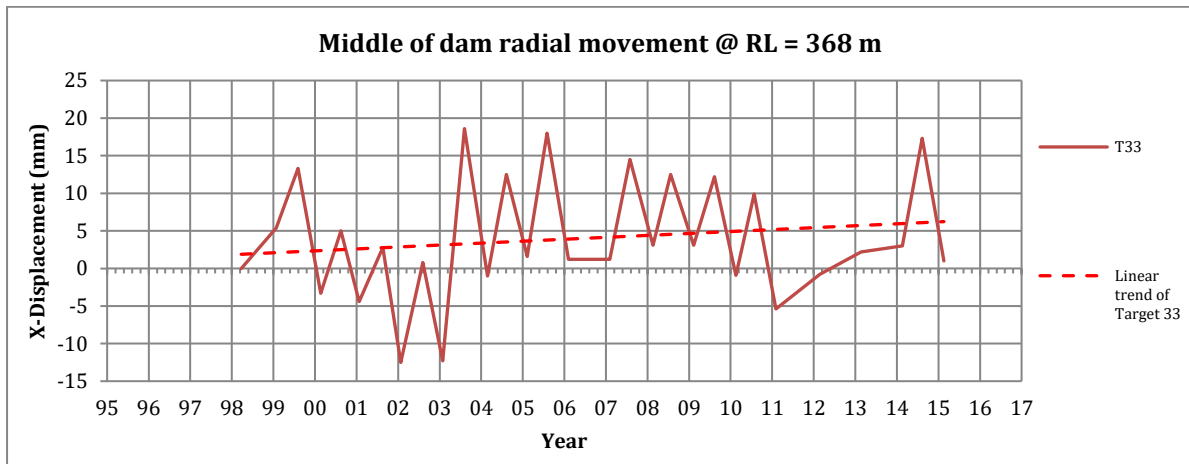
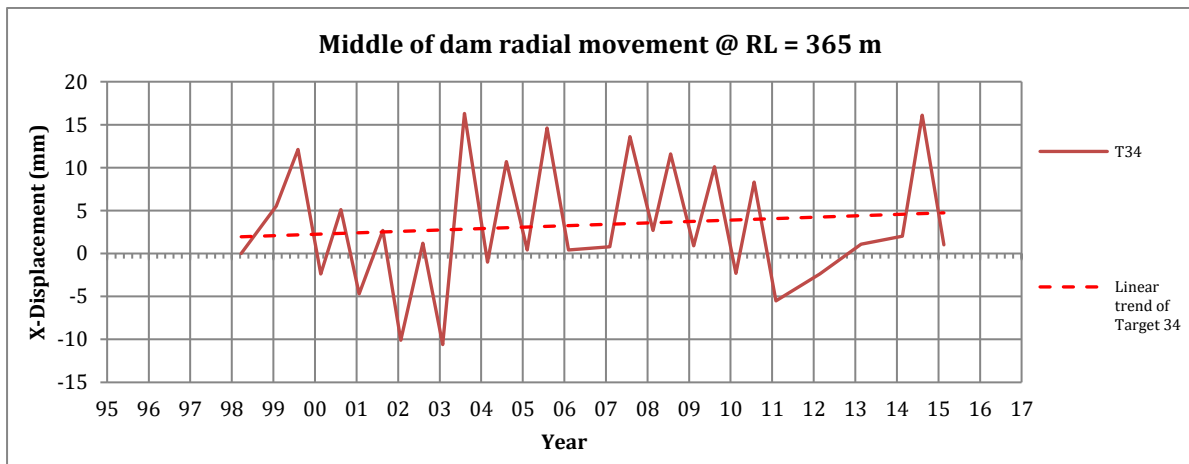
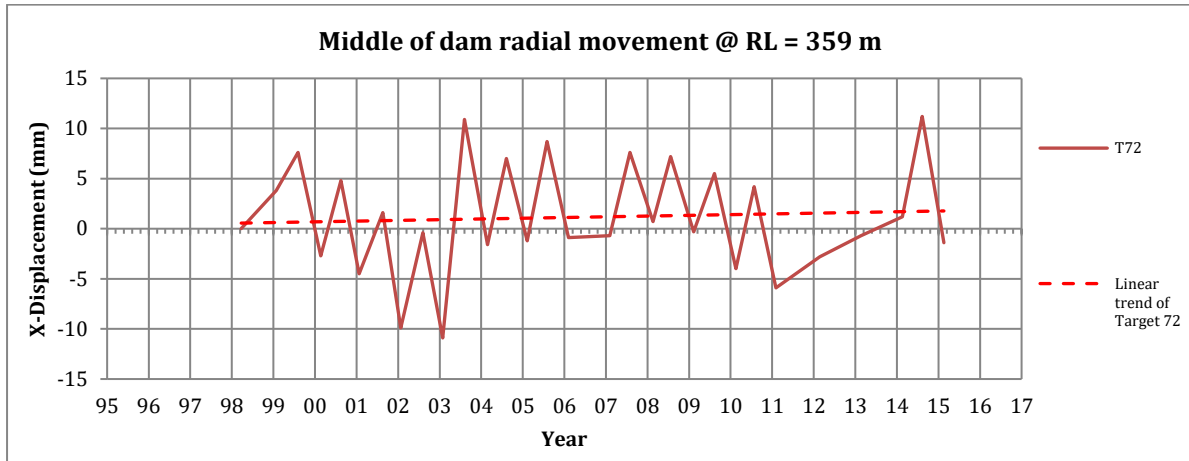
Figure 5-36: Radial movements of T33 at Poortjieskloof Dam

Figure 5-37: Radial movements of T34 at Poortjieskloof Dam

Figure 5-38: Radial movements of T72 at Poortjieskloof Dam

The targets located in the middle of the arch dam (T33, T34, and T72) display a downstream trend. The largest downstream trends are higher up on the dam wall and the trend decreases with decreasing elevations. The largest trend (T33) does not exceed 5 mm and the smallest trend (T72) does not exceed 2 mm. (Refer Figure 5-36 to Figure 5-38).
