Department of Civil Engineering

**A comparative study on the structural behaviour of concrete arch
dams subjected to swelling due to aggregate silica reactions**

Civil Infrastructure Management and Maintenance

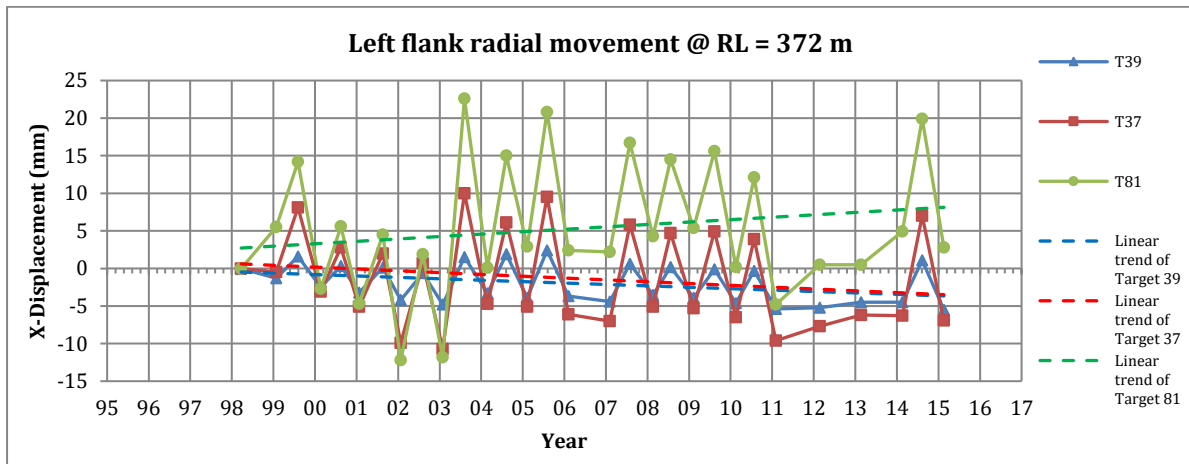
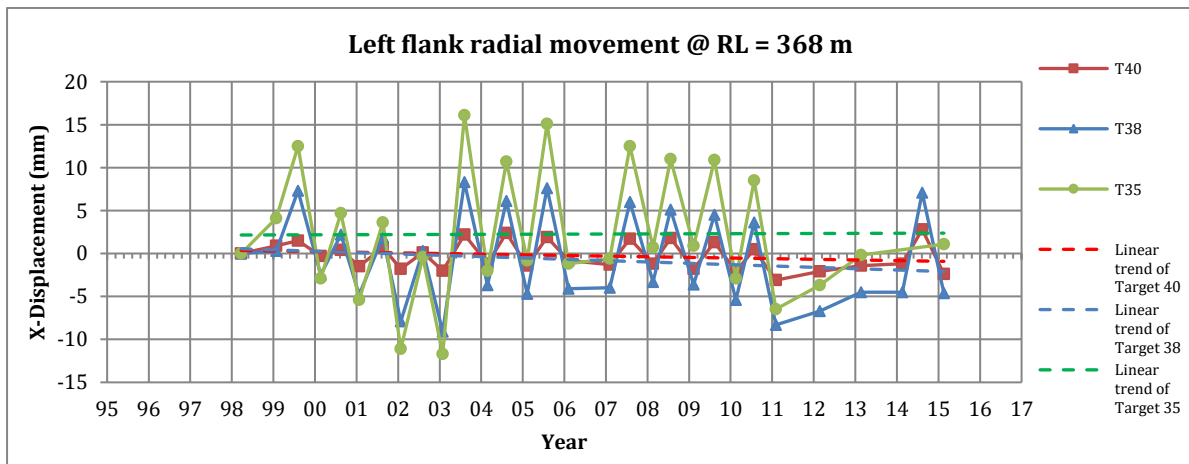
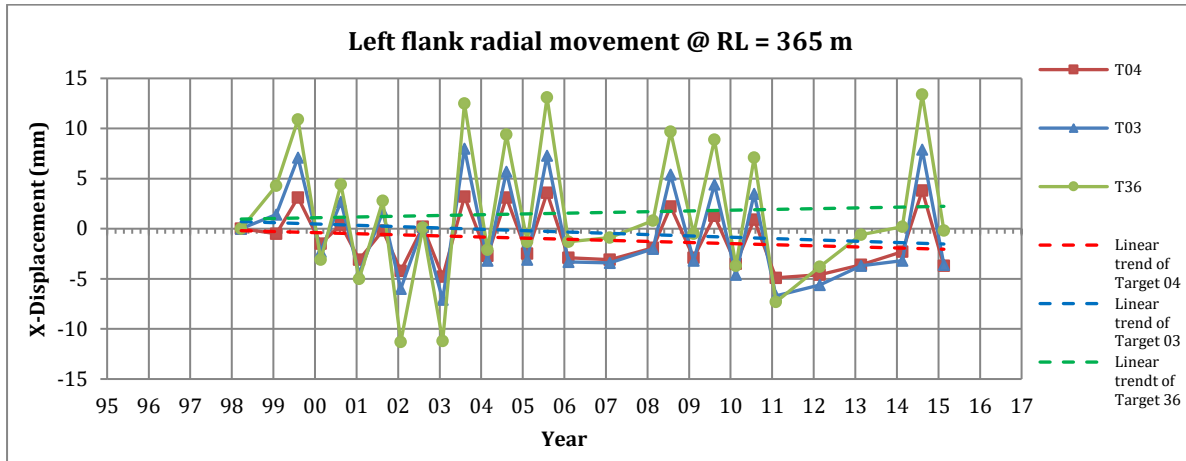
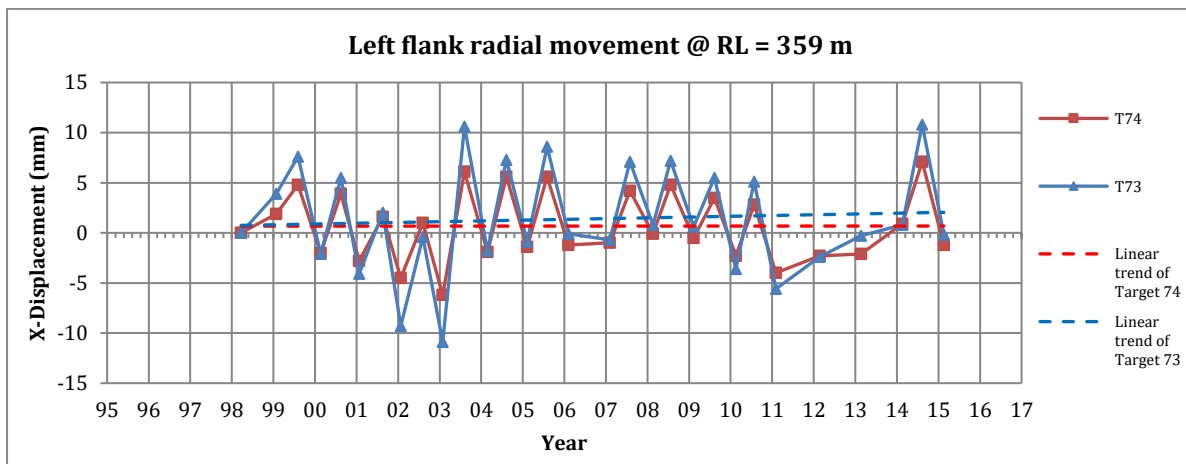
Figure 5-39: Radial movements of T39, T37 and T81 at Poortjieskloof Dam

Figure 5-40: Radial movements of T40, T38 and T35 at Poortjieskloof Dam

Figure 5-41: Radial movements of T04, T03 and T36 at Poortjieskloof Dam

Figure 5-42: Radial movements of T74 and T73 at Poortjieskloof Dam

The left flank targets generally show a permanent upstream displacement trend, except for T81, which is located on the spillway splitter. T81 displays a downstream trend which does not exceed 5 mm. The targets on the upper sections (T37, T38, T39, and T40) located on Blocks 2 and 3 display the biggest permanent upstream trends. Trends do not exceed 5 mm. The targets on the lower sections display very small trends that do not exceed 2 mm. The targets that are located closer to the middle (T35, T36, and T73) of the arch dam on Block 4 display very small downstream trends. Trends smaller than 2 mm. (Refer Figure 5-39 to Figure 5-42).

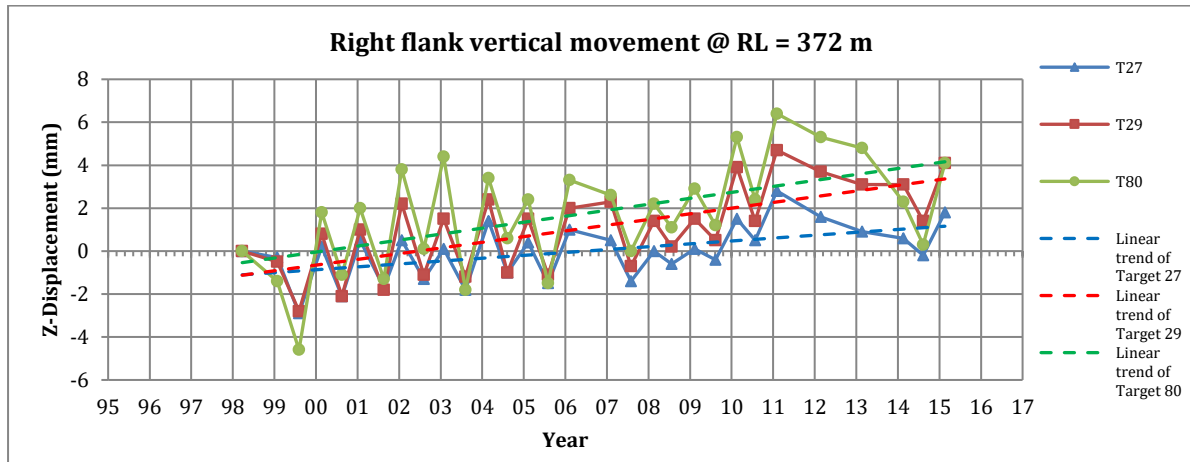
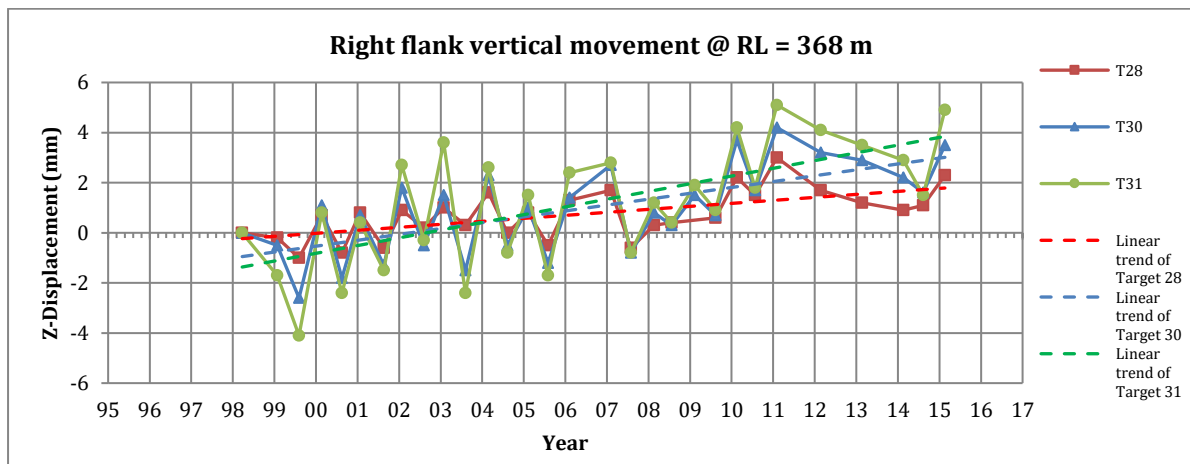
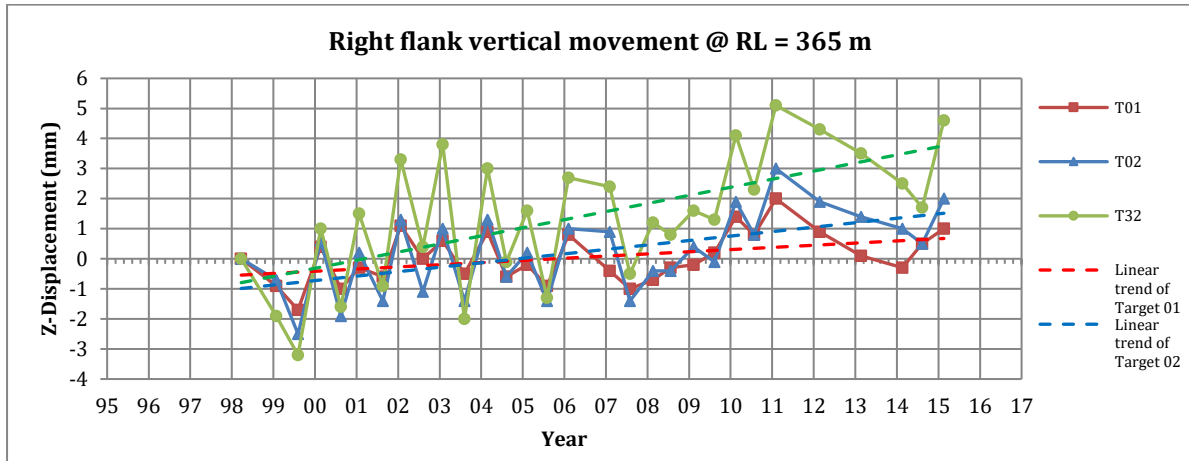
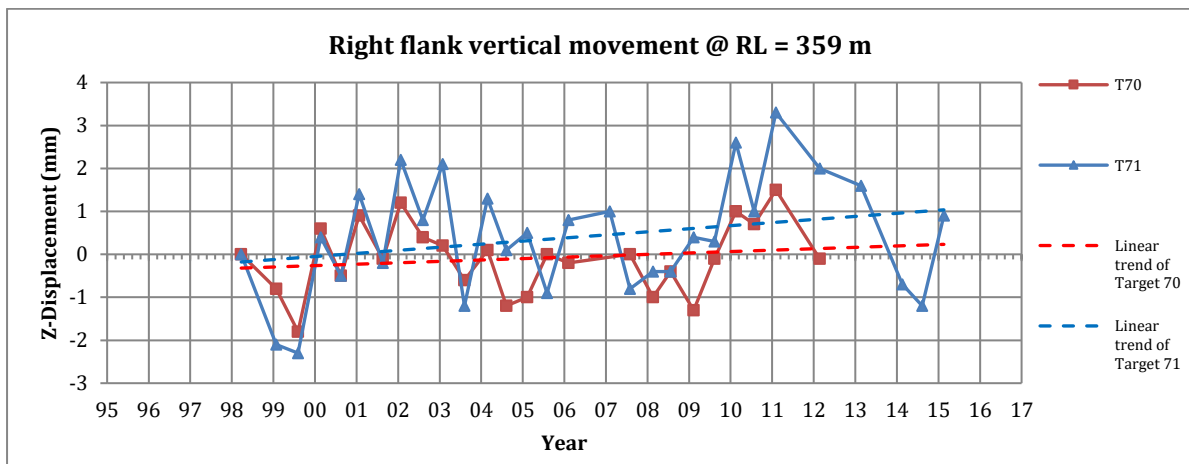
Figure 5-43: Vertical movements of T27, T29 and T80 at Poortjieskloof Dam

Figure 5-44: Vertical movements of T28, T30 and T31 at Poortjieskloof Dam

Figure 5-45: Vertical movements of T01, T02 and T32 at Poortjieskloof Dam

Figure 5-46: Vertical movements of T70 and T71 at Poortjieskloof Dam

The right flank targets generally show trends of permanent rising elevation levels. The targets located on the spillway splitter (T80) and Block 6 (T31, T32) display the largest permanent trends. Trends do not exceed 6 mm. The targets located closer to the right abutment on Block 7 (T02, T29, and T30) display smaller permanent trends. Trends do not exceed 4 mm. The targets on RL 359 m (T70, T71) display the smallest trends - all less than 2 mm. (Refer Figure 5-43 to Figure 5-46).

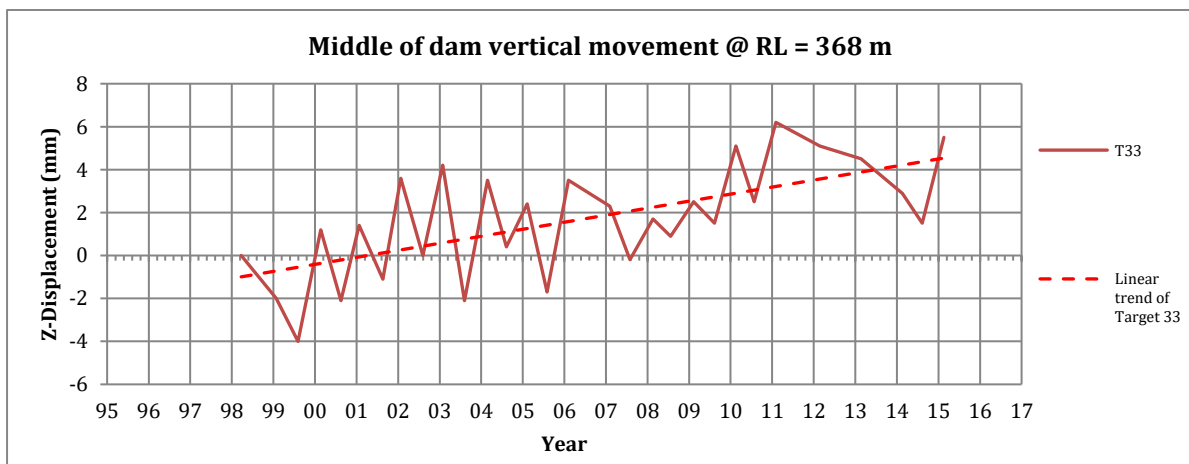
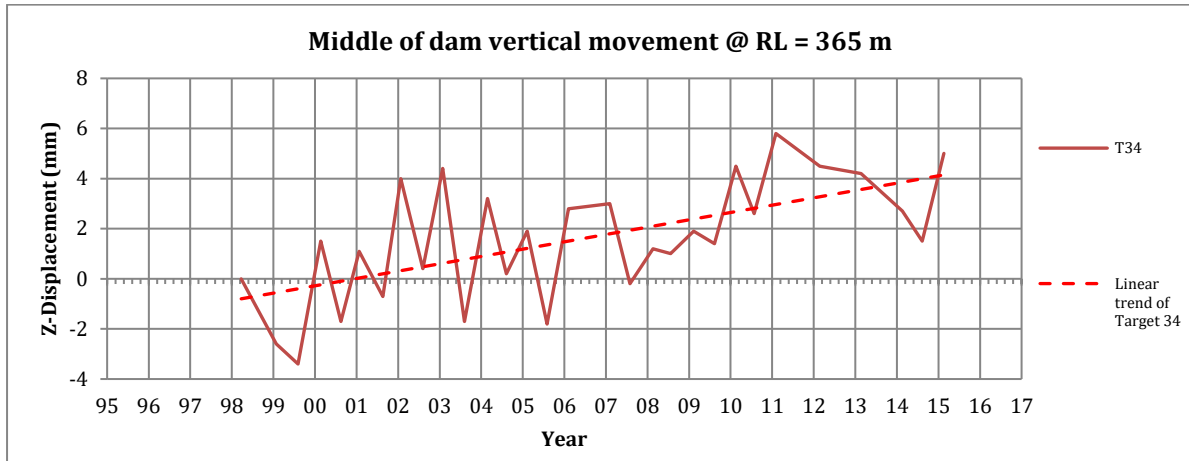
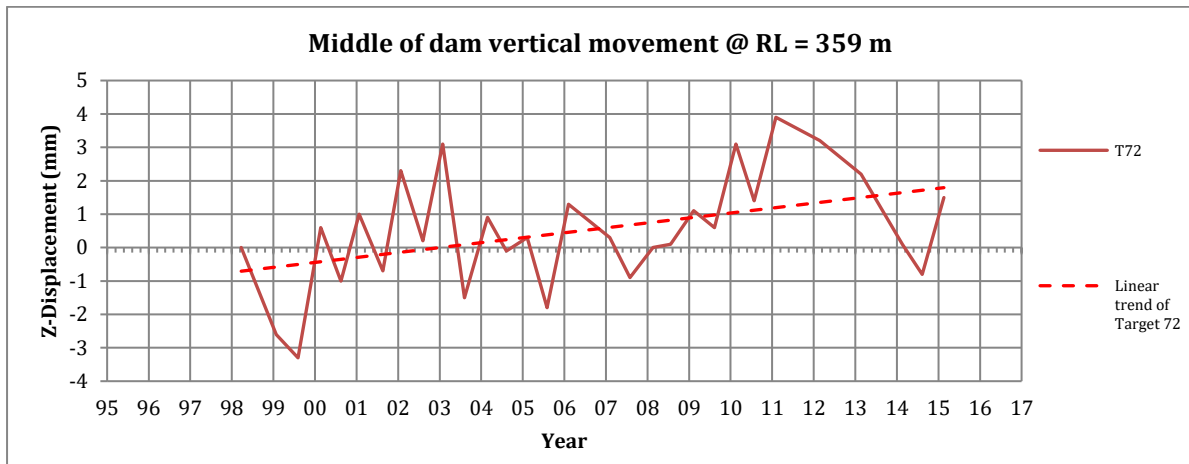
Figure 5-47: Vertical movements of T33 at Poortjieskloof Dam

Figure 5-48: Vertical movements of T34 at Poortjieskloof Dam

Figure 5-49: Vertical movements of T72 at Poortjieskloof Dam

mm and T34 a permanent rise of about 5 mm. T72 on RL 359 m displays the smallest trend (less than 3 mm). (Refer Figure 5-47 to Figure 5-49).

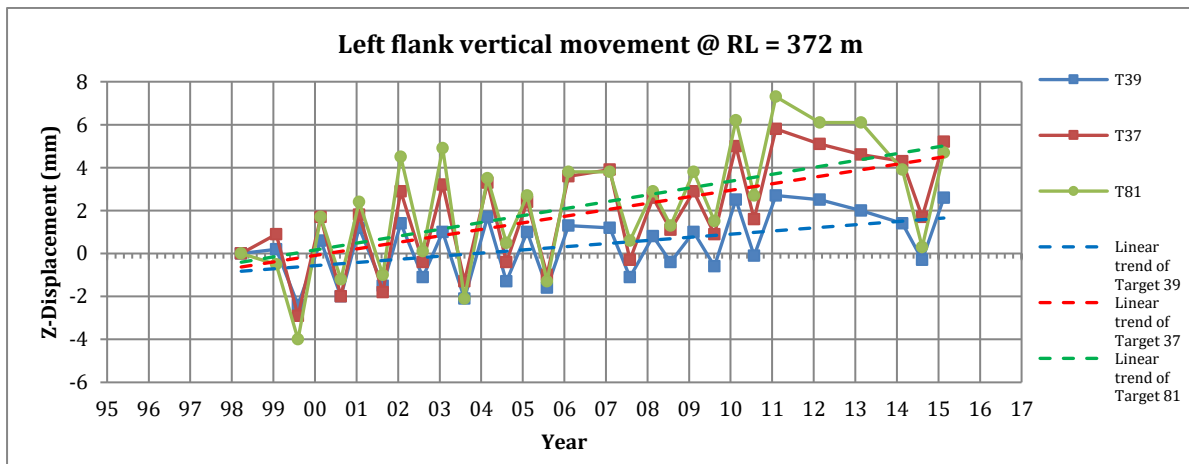
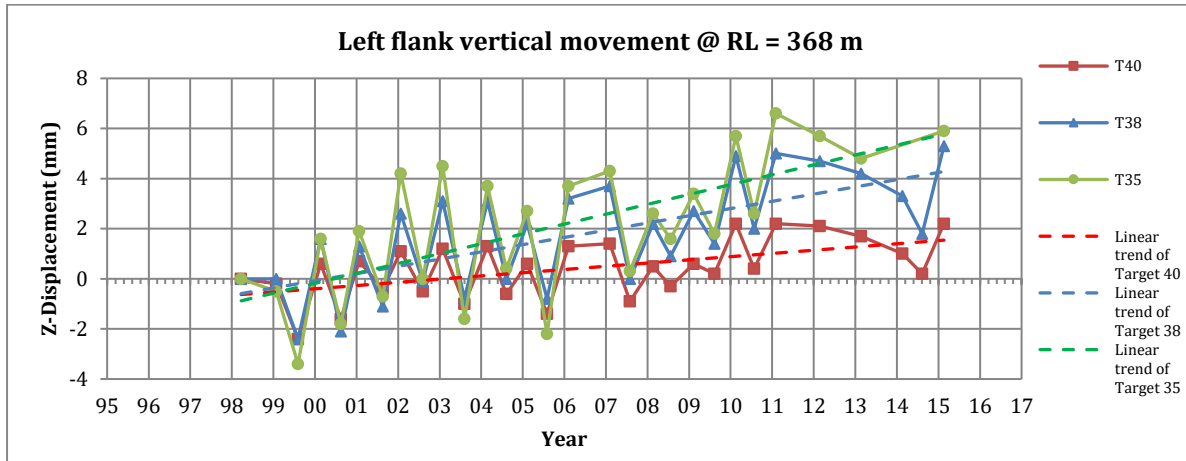
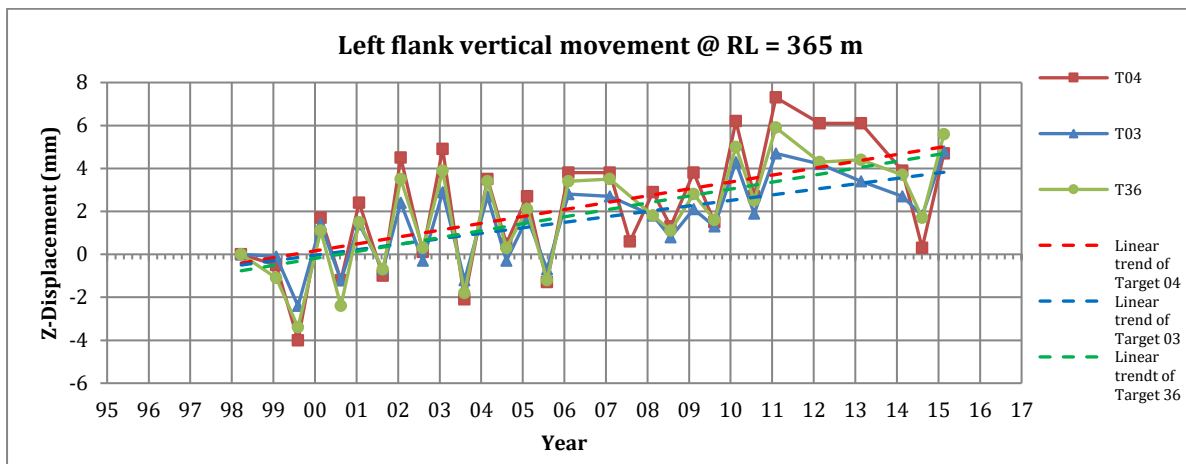
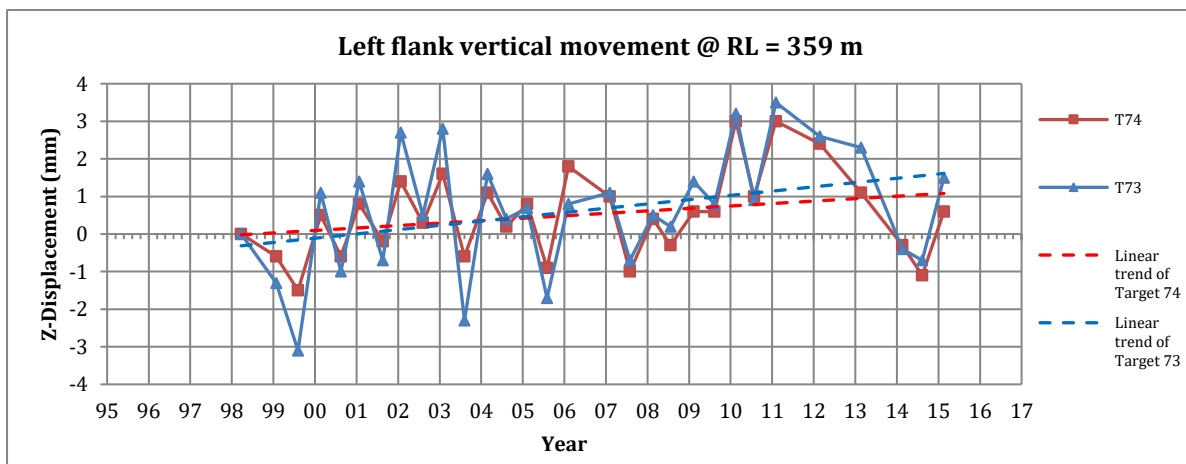
Figure 5-50: Vertical movements of T39, T37 and T81 at Poortjieskloof Dam

Figure 5-51: Vertical movements of T40, T38 and T35 at Poortjieskloof Dam

Figure 5-52: Vertical movements of T04, T03 and T36 at Poortjieskloof Dam

Figure 5-53: Vertical movements of T74 and T73 at Poortjieskloof Dam

The right flank targets generally show trends of permanent rising elevation levels. The targets located on the spillway splitter (T81) and Block 4 (T35, T36) display the largest permanent trends. These trends do not exceed 7 mm. The targets located closer to the left abutment on Blocks 2 & 3 (T03, T04, T37, and T38) display similar permanent trends. These trends do not exceed 6 mm. The targets on RL 359 m (T70, T71) display the smallest trends - all less than 2 mm. (Refer Figure 5-50 to Figure 5-53).

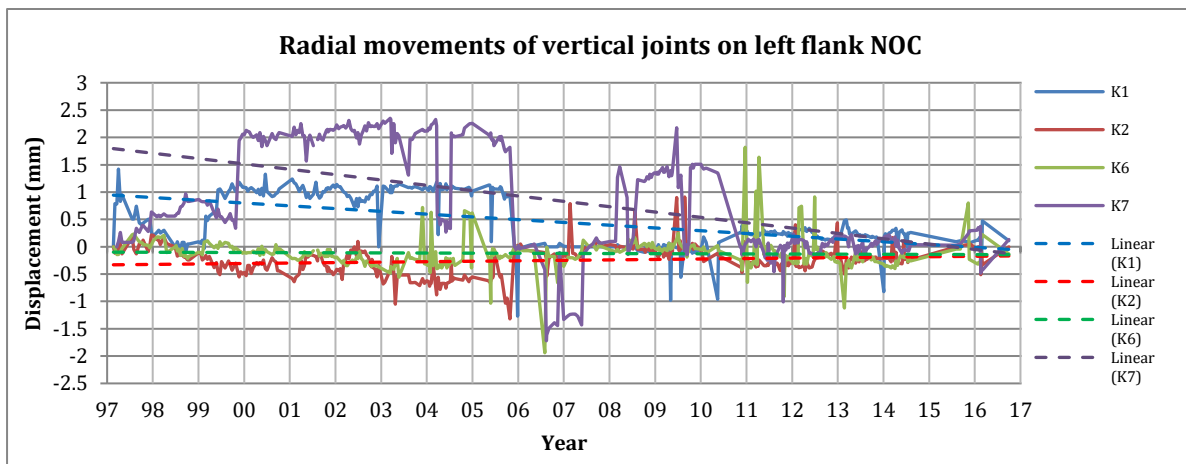
Figure 5-54: Radial movements of the vertical joints on the left flank NOC

The radial measurements of K2 and K6 show little to no trends while the radial measurements of K1 and K7 show an upstream movement trend of the blocks (see Figure 5-54). The tangential measurements show that the joints seem to be closing generally with K1 and K7 displaying largest trends (see Figure 5-55). The vertical measurements show that Block 2 settled slightly relative to Block 1 and Block 3 shows a rising trend relative to Block 2 (see Figure 5-56). K1 and K7 display the largest trends.

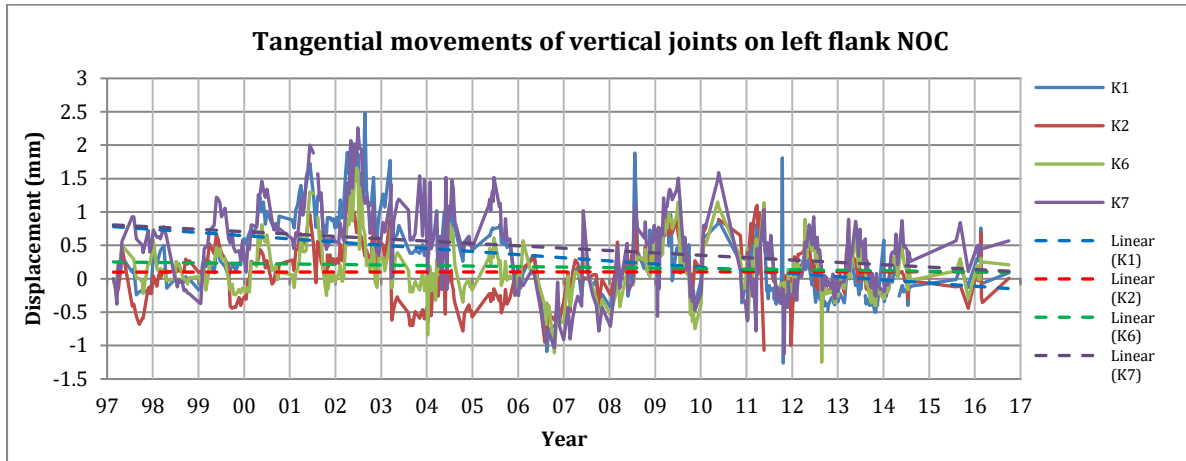
Figure 5-55: Tangential movements of the vertical joints on the left flank NOC

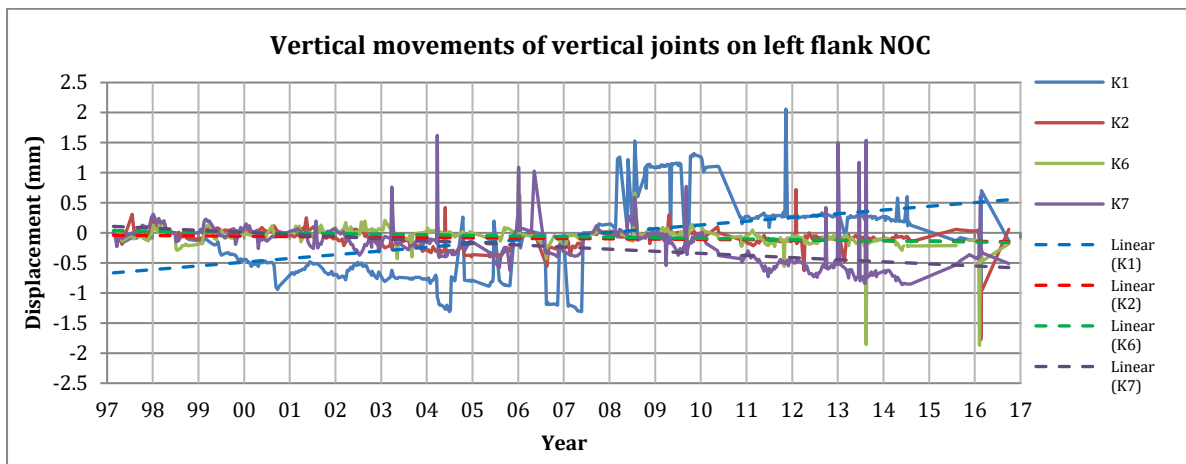
Figure 5-56: Vertical movements of the vertical joints on the left flank NOC

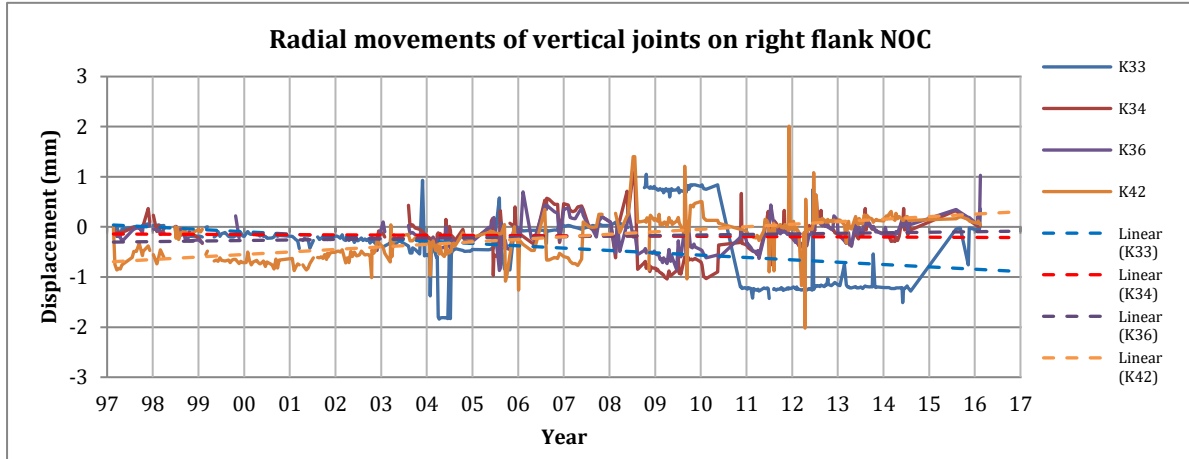
Figure 5-57: Radial movements of the vertical joints on the right flank NOC

The radial measurements show little to no trends. If anything, the trend shows a slight upstream movement of the blocks (see Figure 5-57). The tangential measurements show that the joints seem to be closing generally toward the right flank with the exception of K42 (between Blocks 6 and 7) which shows an opening trend (see Figure 5-58). The vertical measurements show a trend of rising elevation (see Figure 5-59).

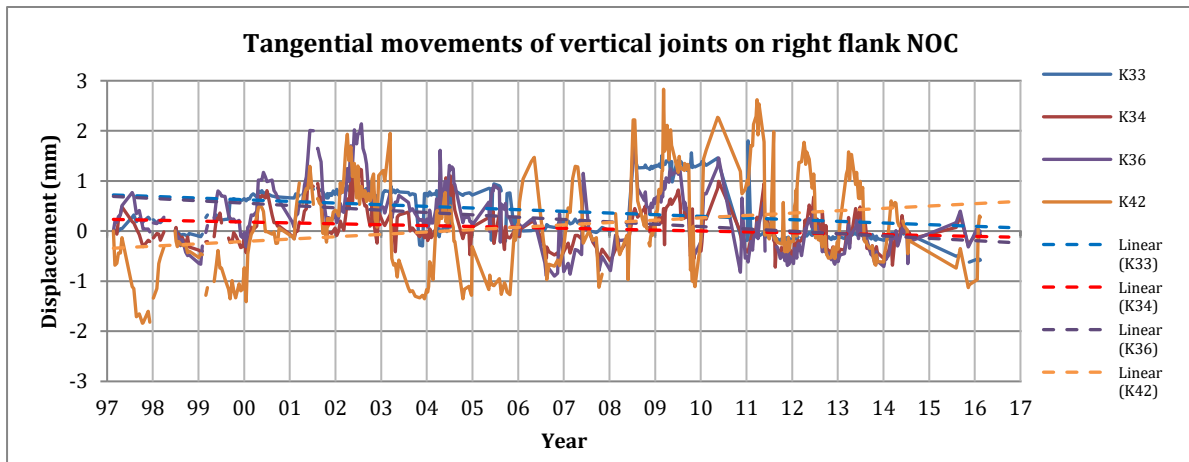
Figure 5-58: Tangential movements of the vertical joints on the right flank NOC

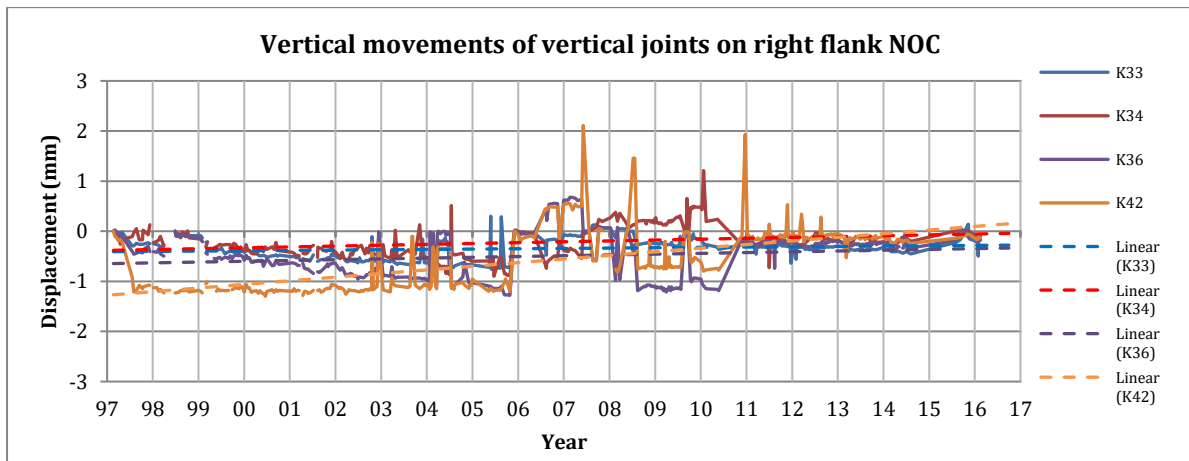
Figure 5-59: Vertical movements of the vertical joints on the right flank NOC

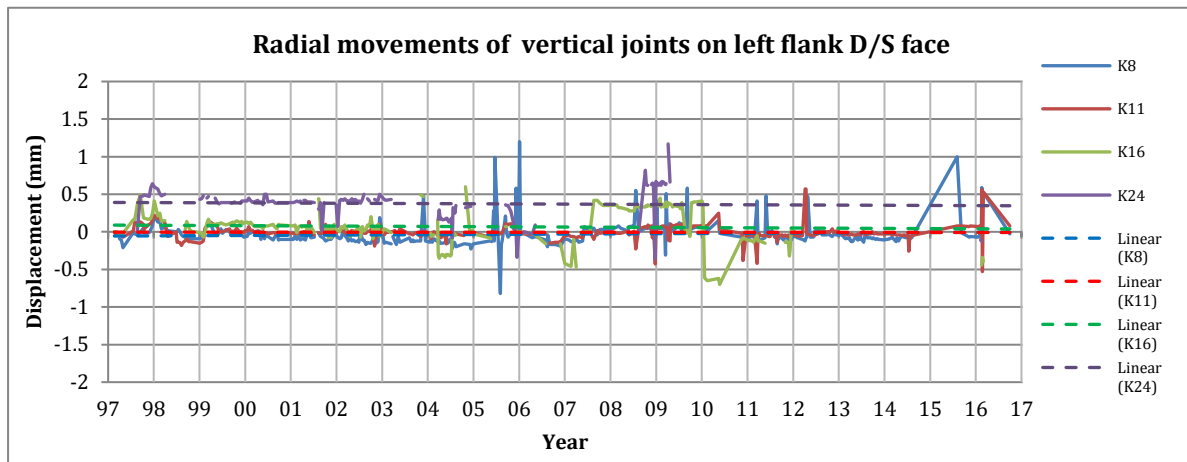
Figure 5-60: Radial movements of the vertical joints on the left flank downstream face

The radial measurements show little to no trends (see Figure 5-60). The tangential measurements show little to no trends except for K11 which shows a slight closing of the joint (see Figure 5-61). The vertical measurements show little to no trends except for K24 which shows a slight rise in elevation of Block 5 relative to Block 4 (see Figure 5-62).

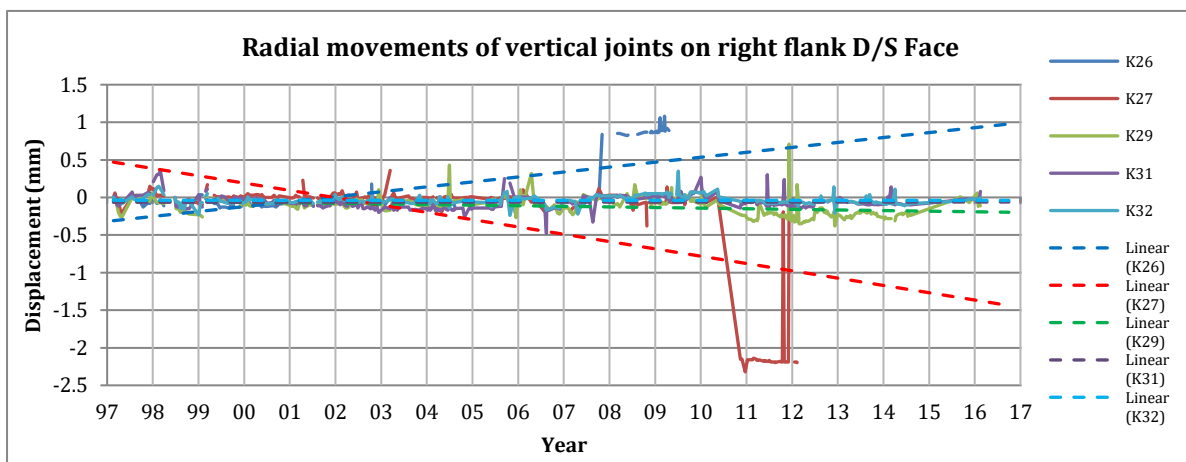
Figure 5-63: Radial movements of the vertical joints on the right flank downstream face

The radial measurements show some erratic readings which make for unreliable trends in the readings of K26 and K27 (see Figure 5-63). Generally, there are no clear trends visible. The tangential measurements show that the joints have closed (see Figure 5-64). The vertical measurements show a slight drop in relative elevations with the exception of K29 (see Figure 5-65).

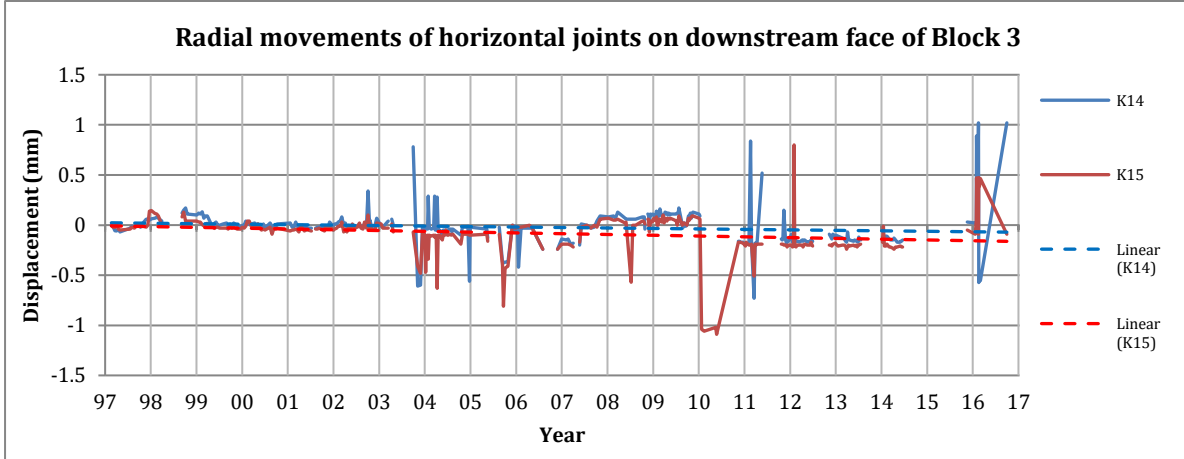
Figure 5-66: Radial movements of the horizontal joints on the downstream face of Block 3

The radial measurements show little to no trends. If anything, the trend hints at an upstream movement (see Figure 5-66 and Figure 5-69). The tangential measurements show little to no trends except the horizontal cracks which show a slight trend where the top lifts move toward the left flank (see Figure 5-67 and Figure 5-70). The vertical measurements show that the joints and cracks both display a slight closing trend (see Figure 5-68 and Figure 5-71).

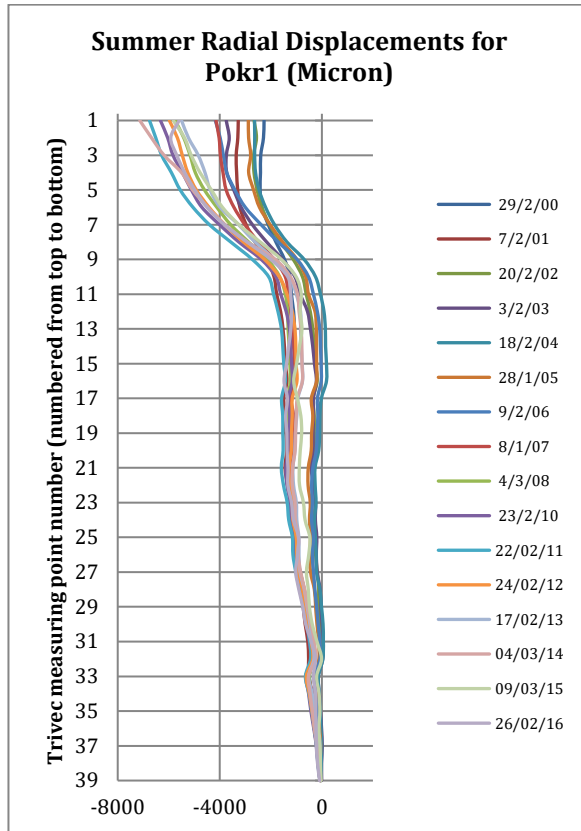
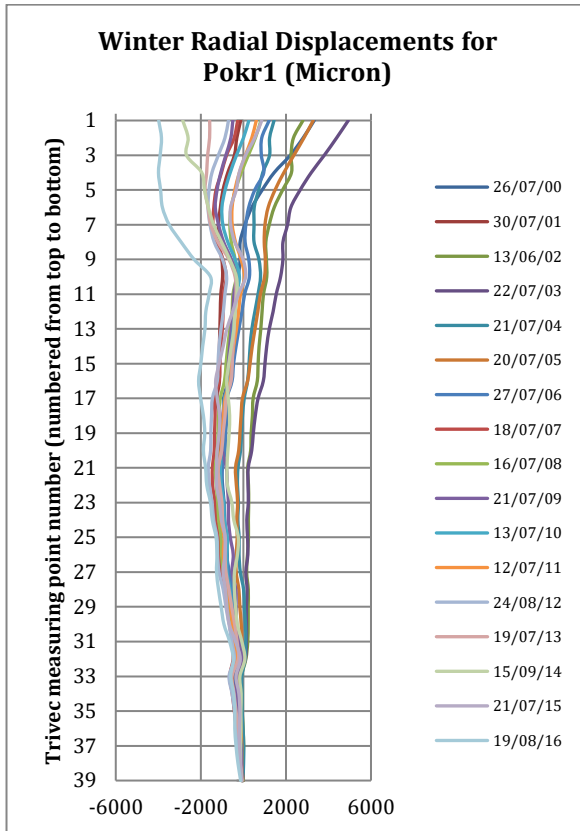
The radial movements show a clear upstream displacement trend relative to the base date, especially in the upper parts of the dam wall. A permanent upstream displacement of approximately 5 mm can be observed at the crest since the base date (see Figure 5-73 and Figure 5-74).

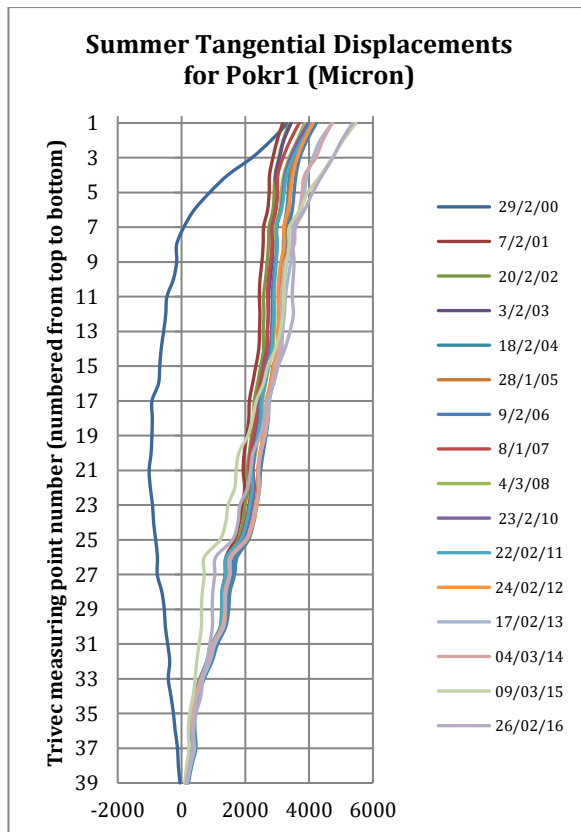
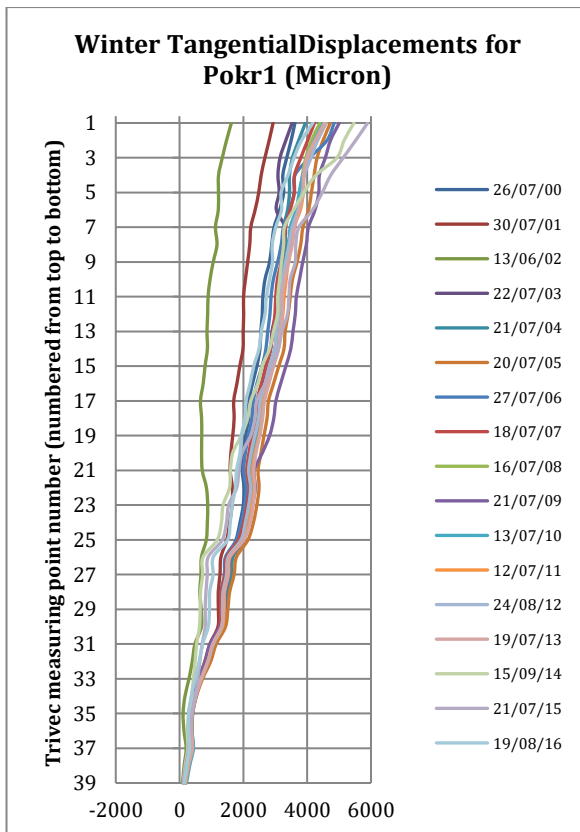
The tangential movements show a definite trend of displacement toward the left flank since the base date, which become more exaggerated in the upper parts of the dam wall. A permanent displacement towards the left flank of approximately 2.5 mm can be observed at the crest since the base date (see Figure 5-75 and Figure 5-76).

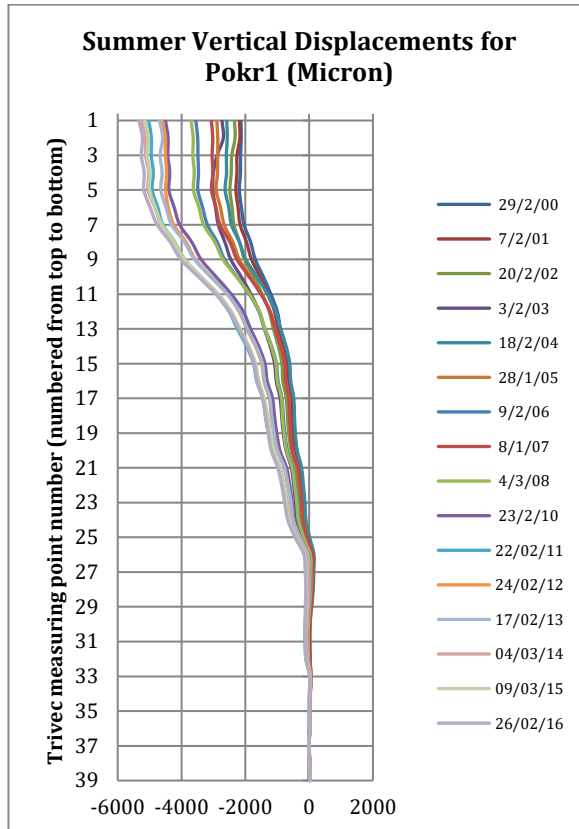
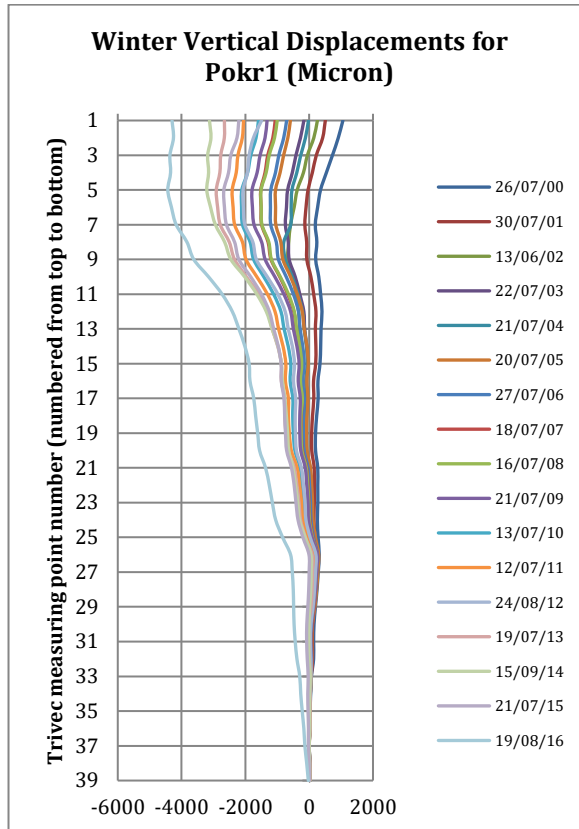
The vertical movements show a definite trend of rising elevations throughout the height of the dam wall relative to the base date, with the upper parts displaying the biggest displacements. A permanent rise in elevation of approximately 5 mm can be observed at the crest since the base date (see Figure 5-77 and Figure 5-78).

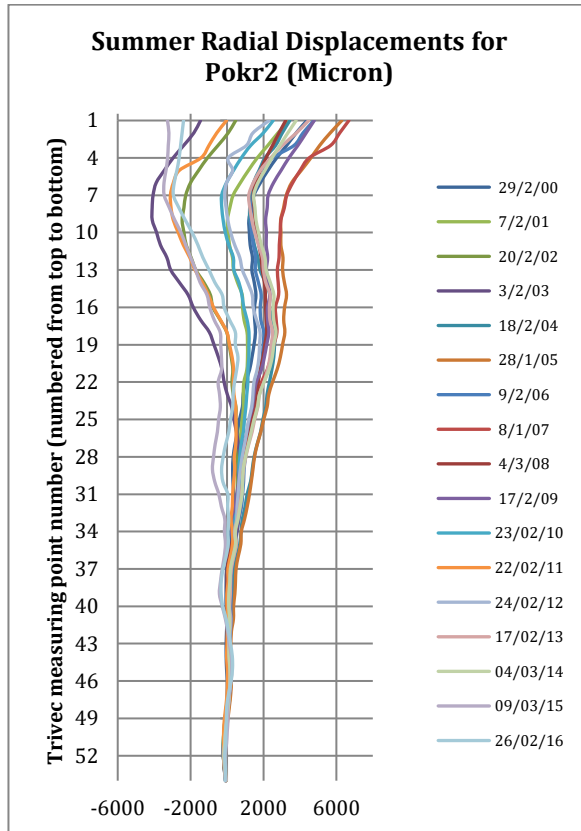
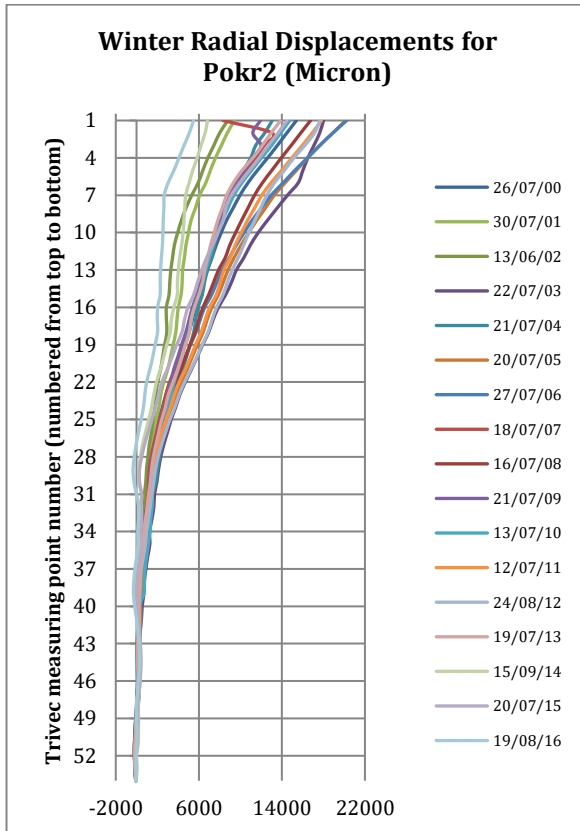
The radial movements show a clear upstream displacement trend relative to the base date, especially in the upper parts of the dam wall, but the trend is much smaller than Pokr 1. A permanent upstream displacement of approximately 2.5 mm can be observed at the crest since the base date (see Figure 5-79 and Figure 5-80).

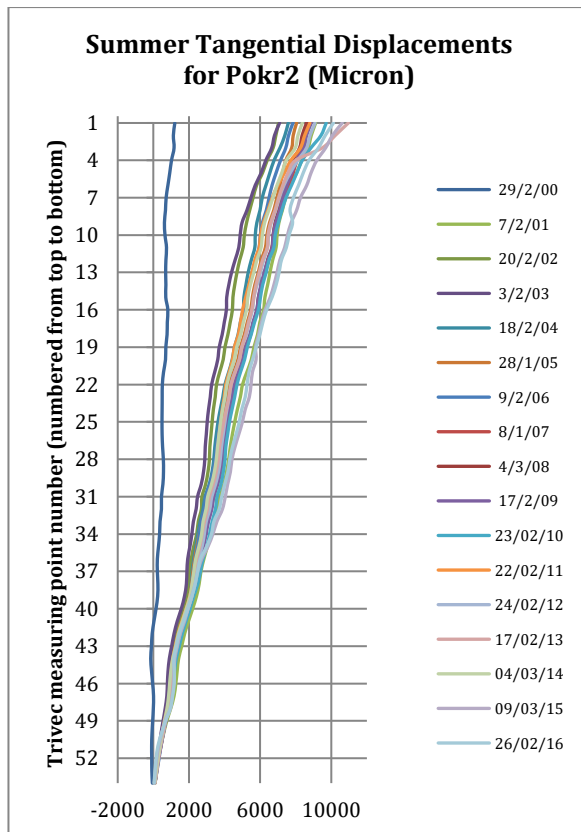
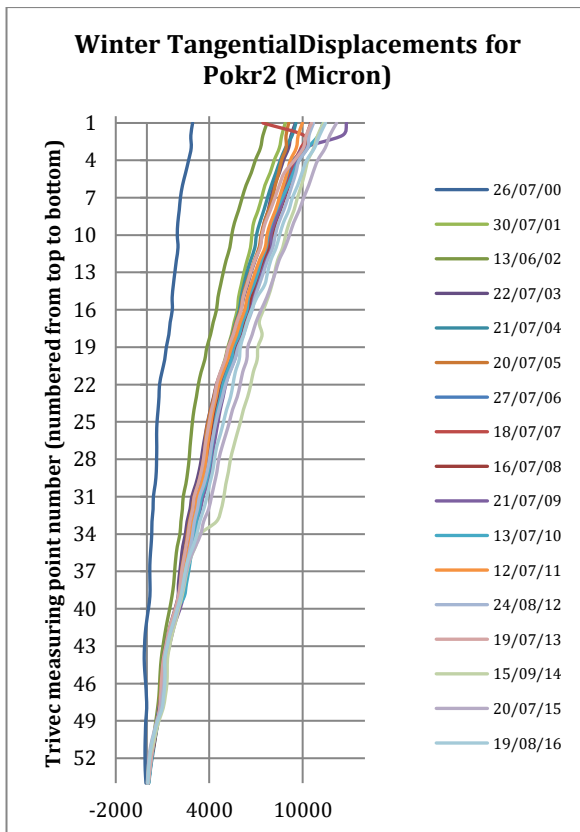
The tangential movements show a definite trend of displacement toward the left flank relative to the base date which become more exaggerated in the upper parts of the dam wall. A permanent displacement towards the left flank of approximately 5.5 mm can be observed at the crest since the base date (see Figure 5-81 and Figure 5-82).

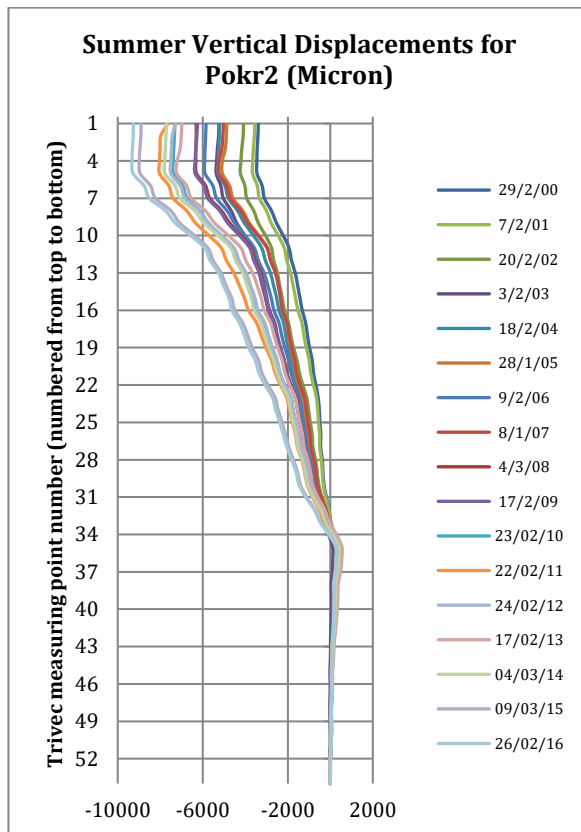
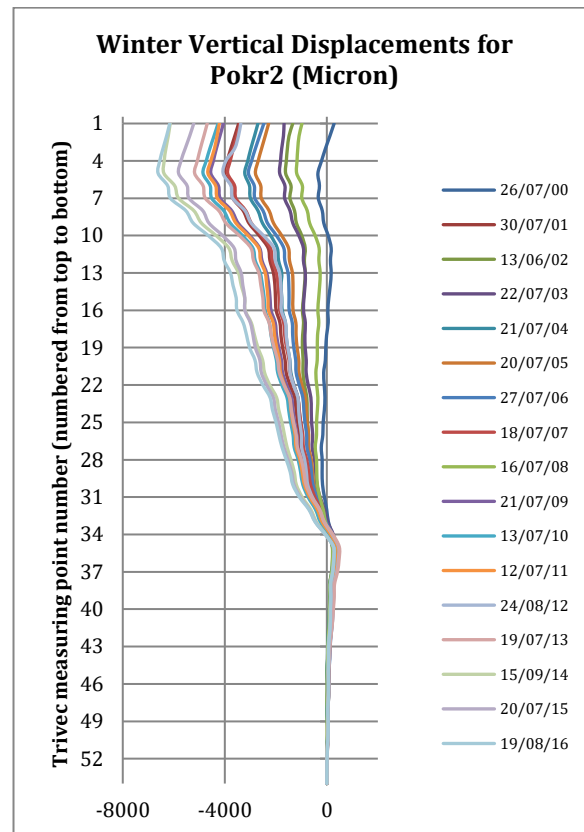
The vertical movements show a definite trend of rising elevations throughout the height of the dam wall relative to the base date, with the upper parts displaying the biggest displacements. A permanent rise in elevation of approximately 5 mm can be observed at the crest since the base date (see Figure 5-83 and Figure 5-84).

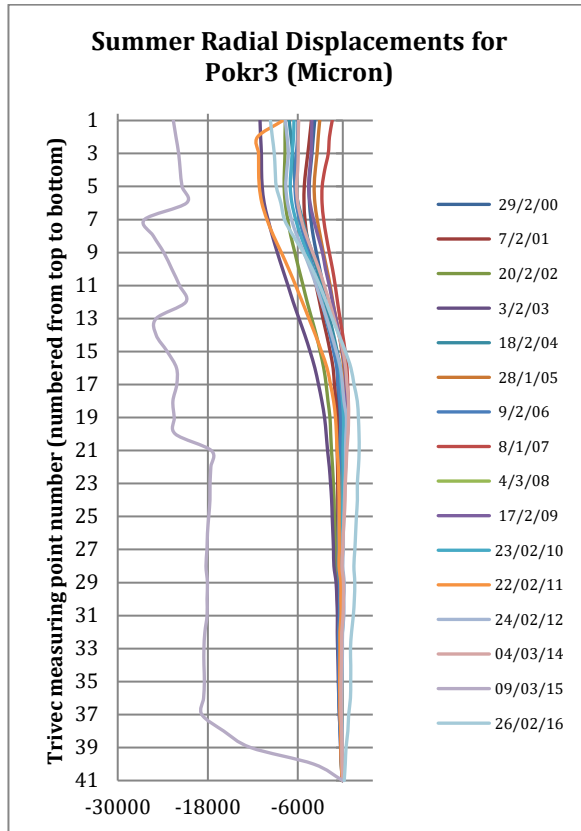
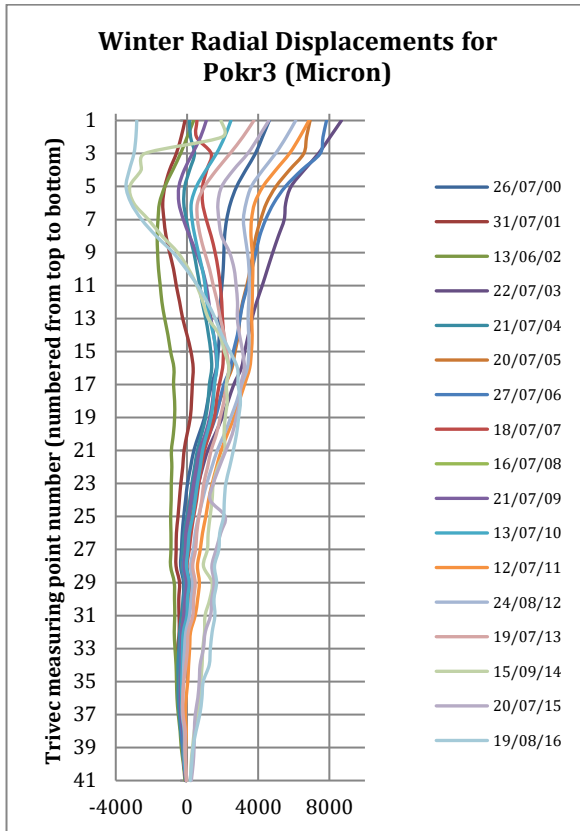
The radial movements show a clear upstream displacement trend relative to the base date, especially in the upper parts of the dam wall. A permanent upstream displacement of approximately 3 mm can be observed at the crest since the base date (see Figure 5-85 and Figure 5-86).
