Department of Civil Engineering

**A comparative study on the structural behaviour of concrete arch
dams subjected to swelling due to aggregate silica reactions**

Civil Infrastructure Management and Maintenance

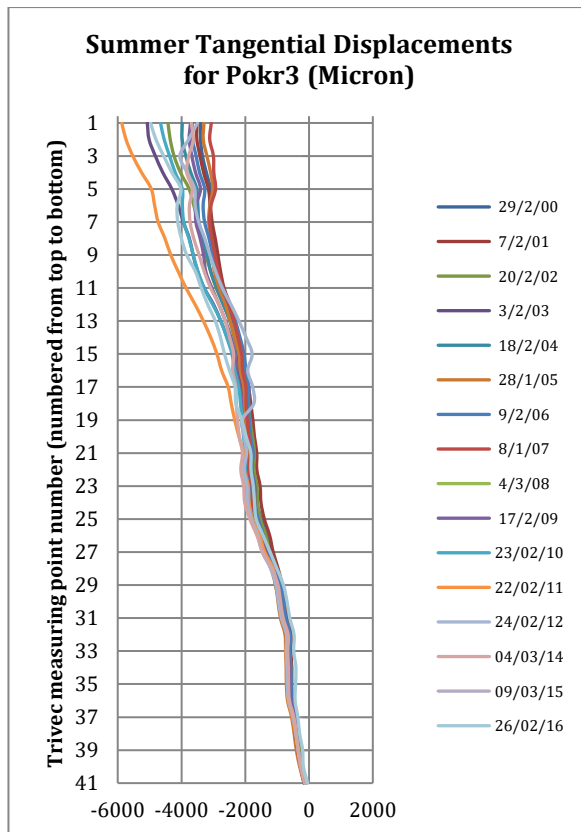
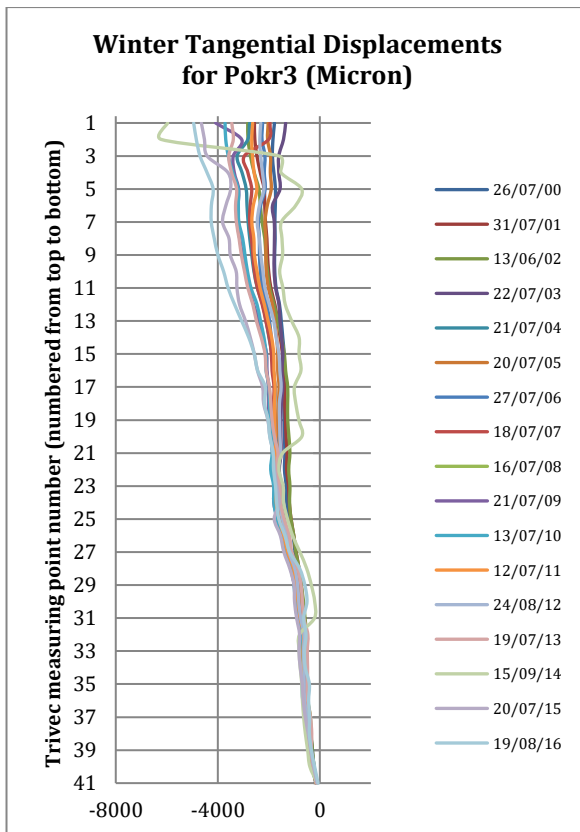
The tangential movements show a definite trend of displacement toward the right flank relative to the base date which become more exaggerated in the upper parts of the dam wall. A permanent displacement towards the right flank of approximately 2 mm can be observed at the crest since the base date (see Figure 5-87 and Figure 5-88).

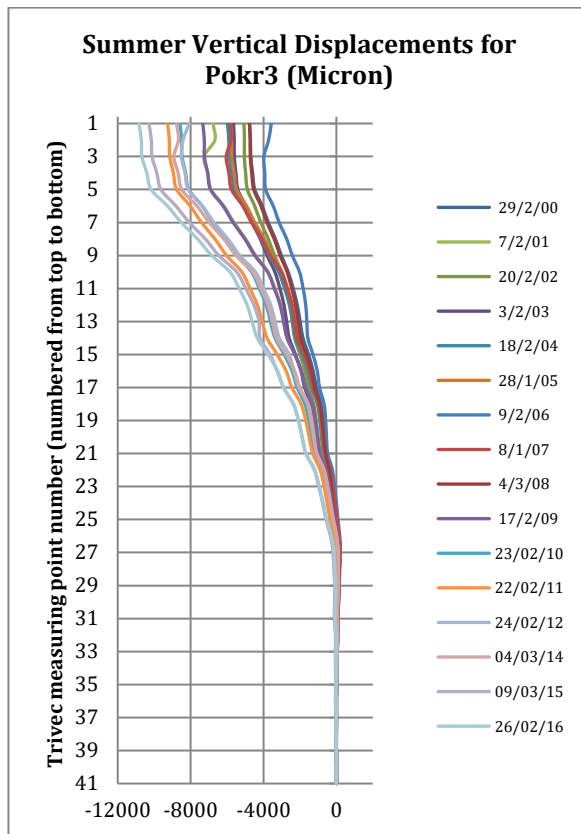
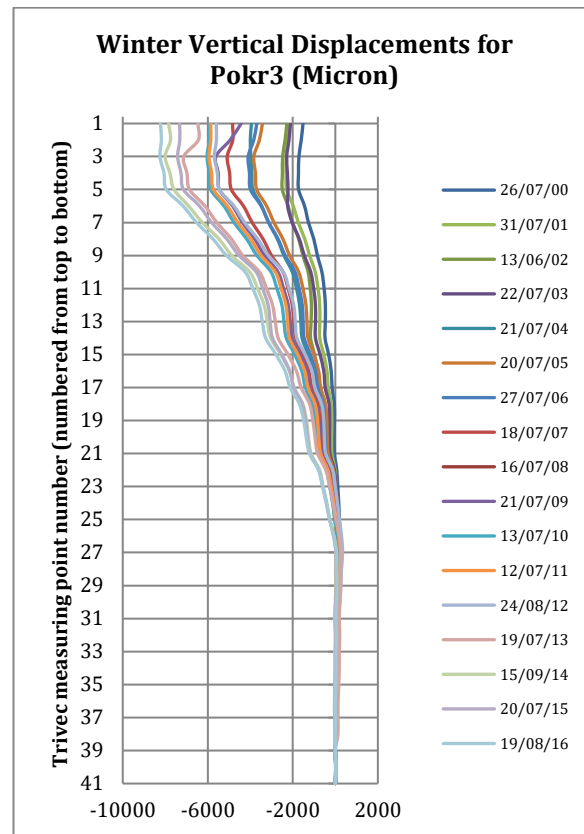
The vertical movements show a definite trend of rising elevations throughout the height of the dam wall relative to the base date, with the upper parts displaying the biggest displacements. A permanent rise in elevation of approximately 6 mm can be observed at the crest since the base date (see Figure 5-89 and Figure 5-90).

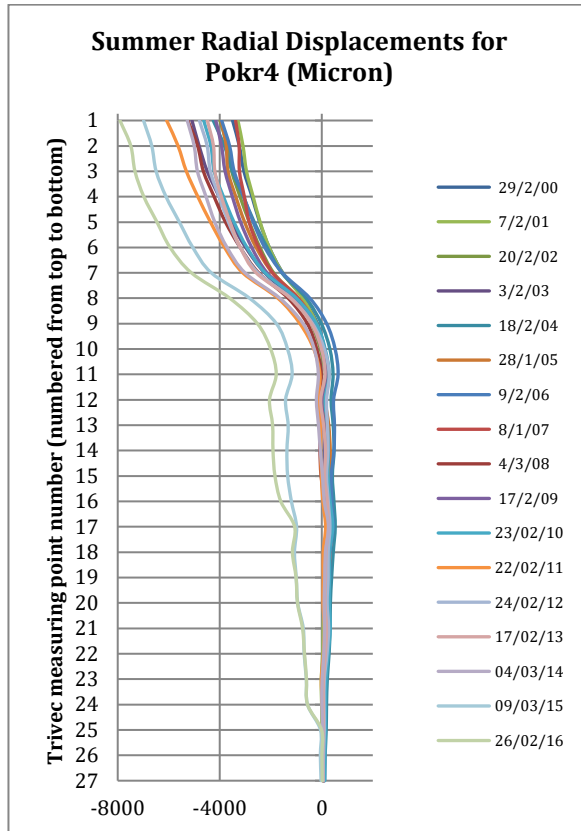
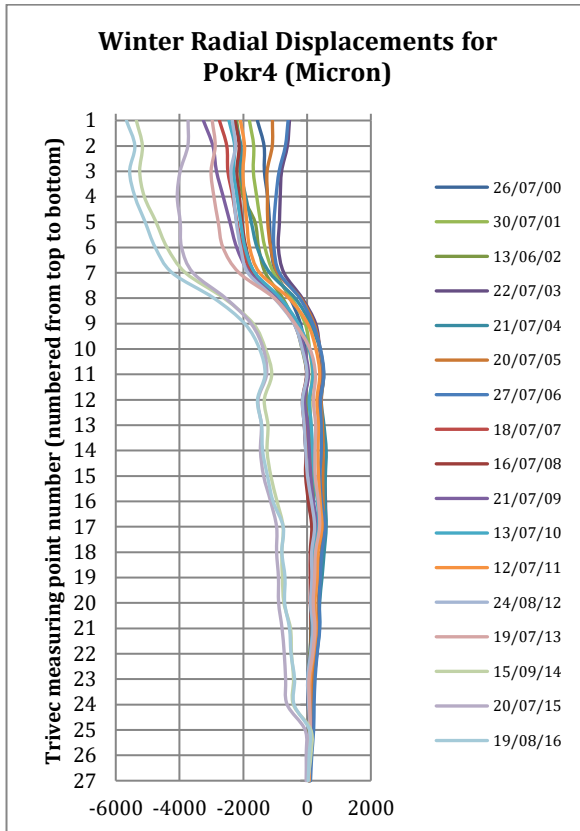
The radial movements show a clear upstream displacement trend relative to the base date, especially in the upper parts of the dam wall. A permanent upstream displacement of approximately 3.5 mm can be observed at the crest since the base date (see Figure 5-91 and Figure 5-92).

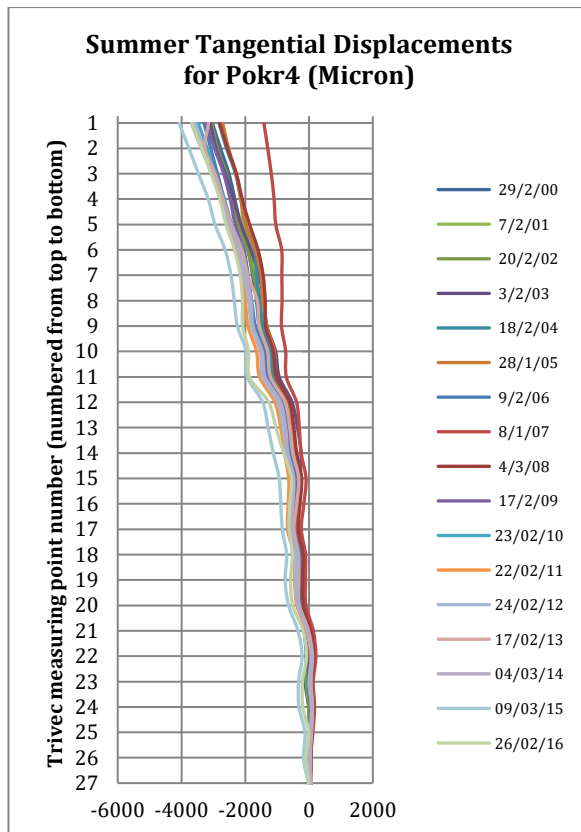
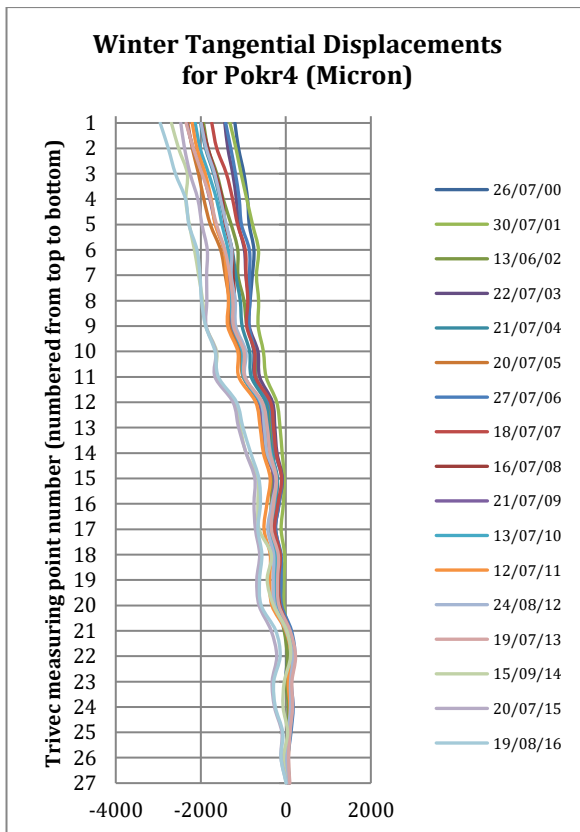
The tangential movements show a definite trend of displacement toward the right flank relative to the base date which become more exaggerated in the upper parts of the dam wall. A permanent displacement towards the right flank of approximately 1.5 mm can be observed at the crest since the base date (Figure 5-93 and Figure 5-94).

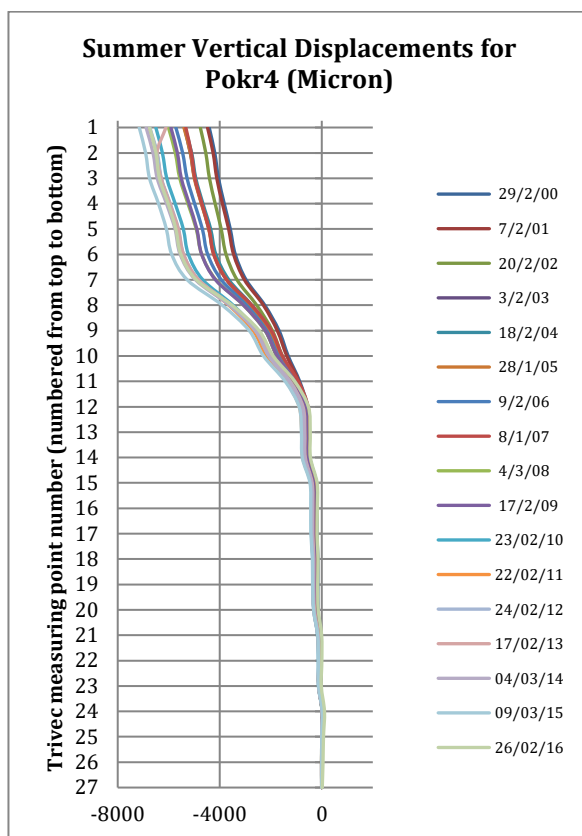
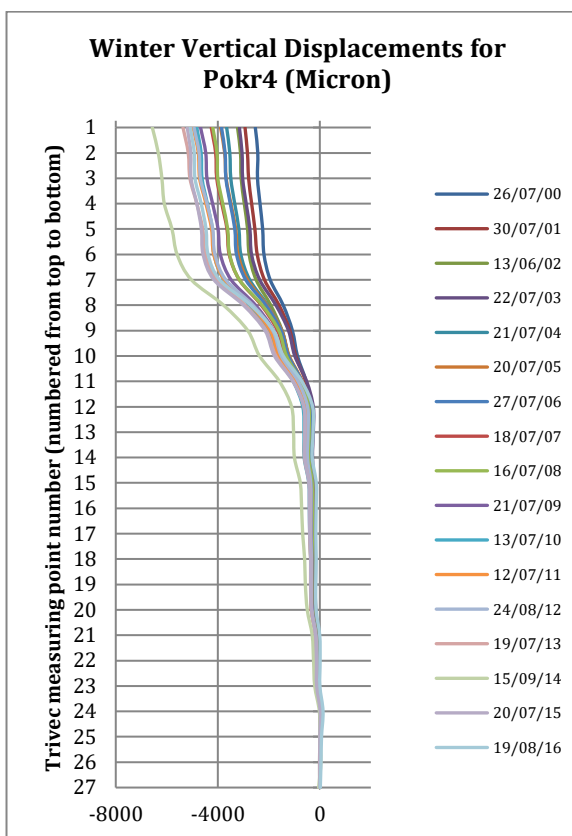
The vertical movements show a definite trend of rising elevations throughout the height of the dam wall relative to the base date, with the upper parts displaying the biggest displacements. A permanent rise in elevation of approximately 3 mm can be observed at the crest since the base date (see Figure 5-95 and Figure 5-96).

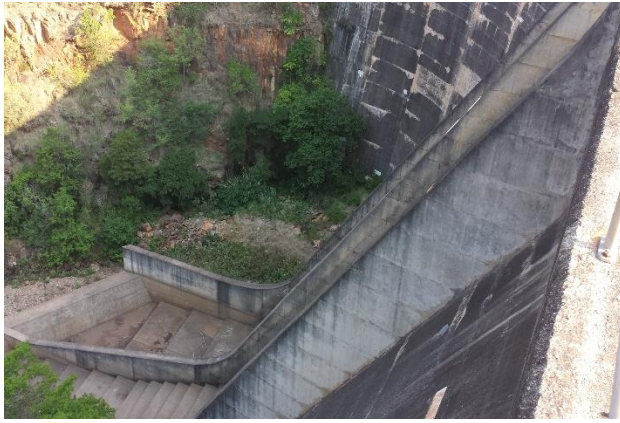
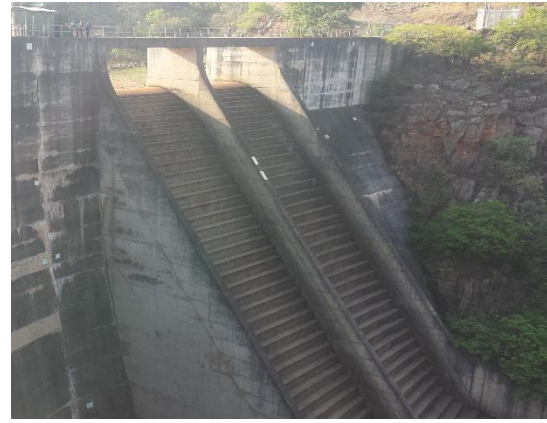
Apart from occasional cracking and some seepage characterised by calcite staining on the horizontal lift joints, there were no signs of distress in the concrete on the downstream face (see Figure 6-2 and Figure 6-3). Seepage could indicate separation of the horizontal lift joints due to swelling in the concrete.

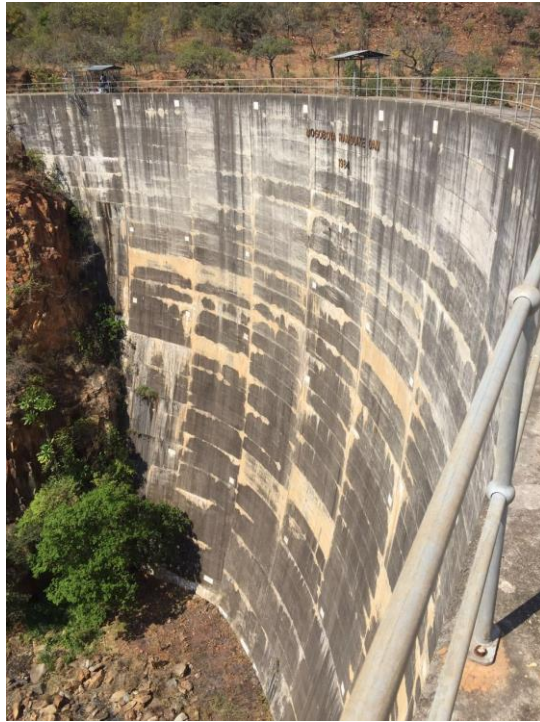
Figure 6-6: General view of the downstream face of the arch

The downstream face displayed frequent areas of calcite staining along the horizontal lift joints (see Figure 6-6). The frequency seemed to increase towards the right flank abutment area. Near the base of the right flank there was a fairly major crack which orientation hints at a slightly unfavourable stress distribution (see Figure 6-4). The crack is orientated about 20° upwards from the horizontal plane. There were no major peripheral cracks that run parallel to the abutment contact. There was one lift joint which displayed active seepage (see Figure 6-5).

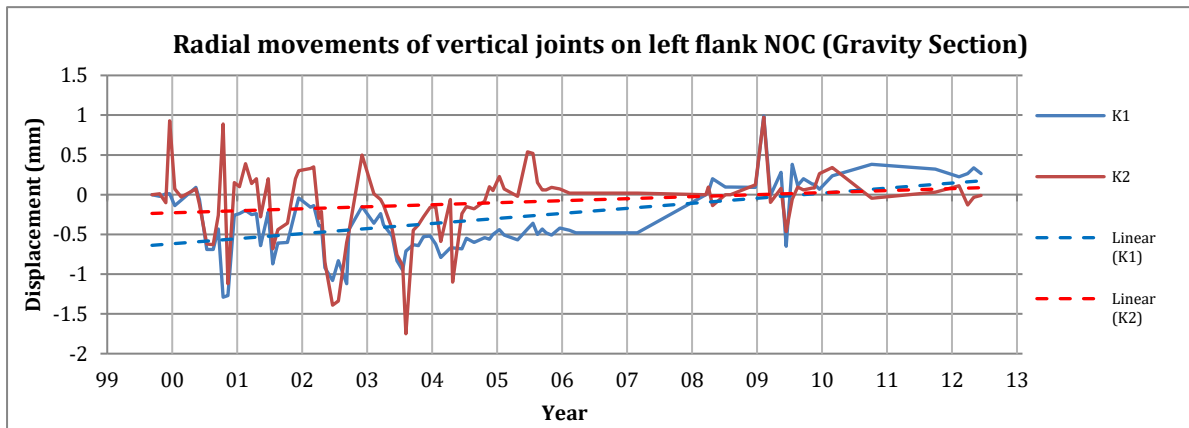
Figure 6-8: Radial movements of the vertical joints on the left flank NOC

The radial measurements from both K1 and K2 show that the blocks to the right have moved downstream slightly relative to the blocks on the left (see Figure 6-8). Permanent trends are approximately 0.5 - 1 mm. The tangential measurements from both K1 and K2 show trends of the joints opening (see Figure 6-9). Permanent trends are approximately 1.5 - 2 mm. The vertical measurements from both K1 and K2 show that the blocks to the right have decreased in elevation relative to the blocks on the left (see Figure 6-10). Permanent trends are approximately 1.5 - 2 mm.

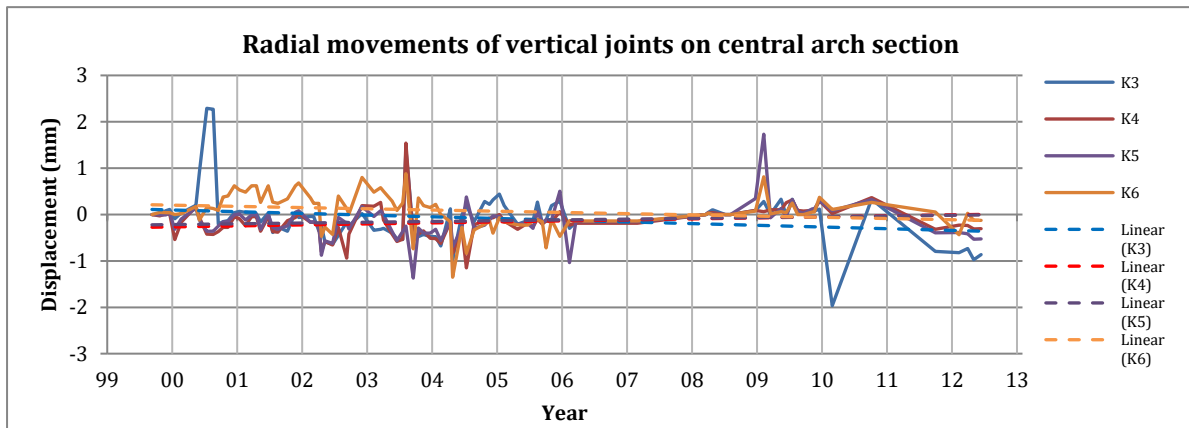
Figure 6-11: Radial movements of the vertical joints on the NOC of the central arch section

The radial measurements of K3 to K6 show little to no trends (see Figure 6-11). The tangential measurements of K3 to K6 all show trends of joints opening (see Figure 6-12). Permanent trends are approximately 1 - 2.5 mm. The vertical measurements of K3 to K6 show that the blocks to the right have decreased in elevation relative to the blocks on the left (see Figure 6-13). Permanent trends are approximately 1 - 2.5 mm.

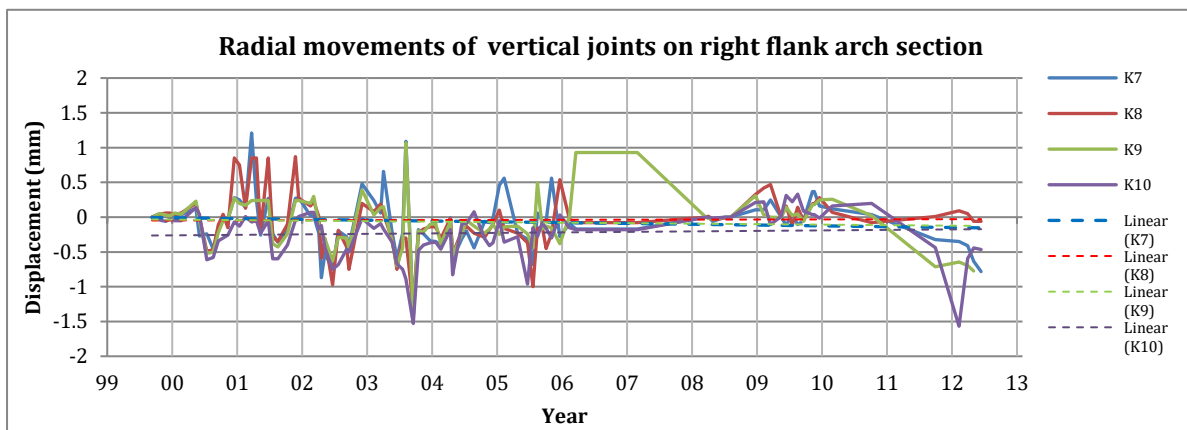
Figure 6-14: Radial movements of the vertical joints on the NOC of the right flank arch section

The radial measurements of K7 to K10 show little to no trends (see Figure 6-14). The tangential measurements of K7 to K10 all show trends of the joints opening (see Figure 6-15). Permanent trends are approximately 2.2 - 2.75 mm. The vertical measurements of K7 to K10 show that the blocks to the right have decreased in elevation relative to the blocks on the left (see Figure 6-16). Permanent trends are approximately 2.4 - 2.6 mm.

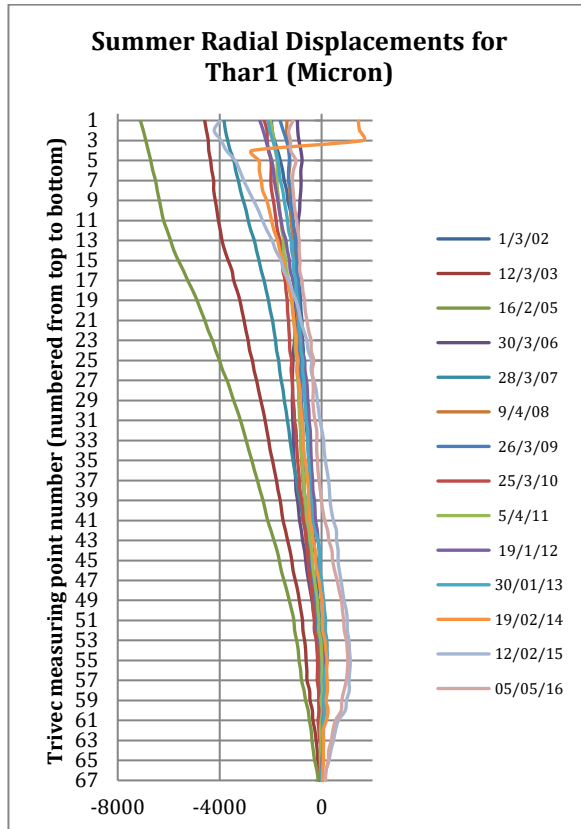
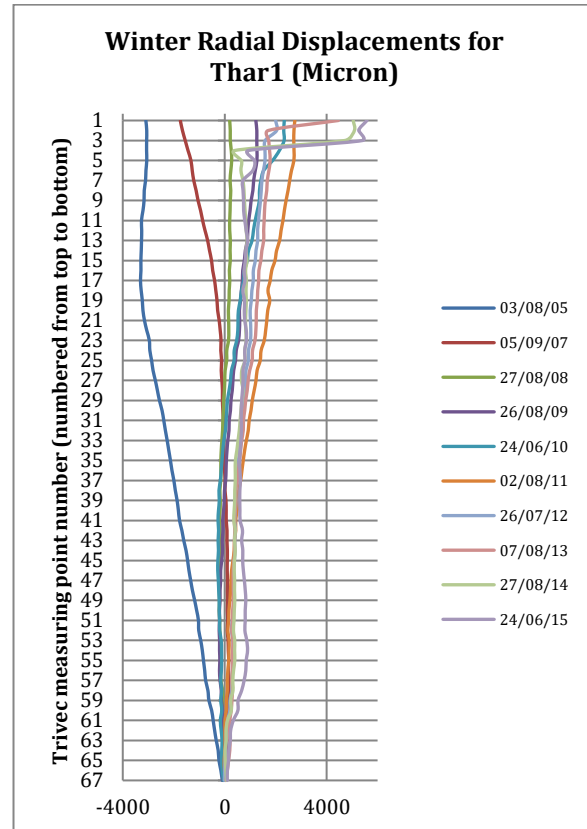
Figure 6-18: Summer radial displacements of Trivec borehole Thar1

Figure 6-19: Winter radial displacements of Trivec borehole Thar1

The radial movements show a downstream displacement trend since 2002 especially in the upper parts of the dam wall. A permanent downstream displacement of approximately 6 mm can be observed at the crest since 2002 (see Figure 6-18 and Figure 6-19).

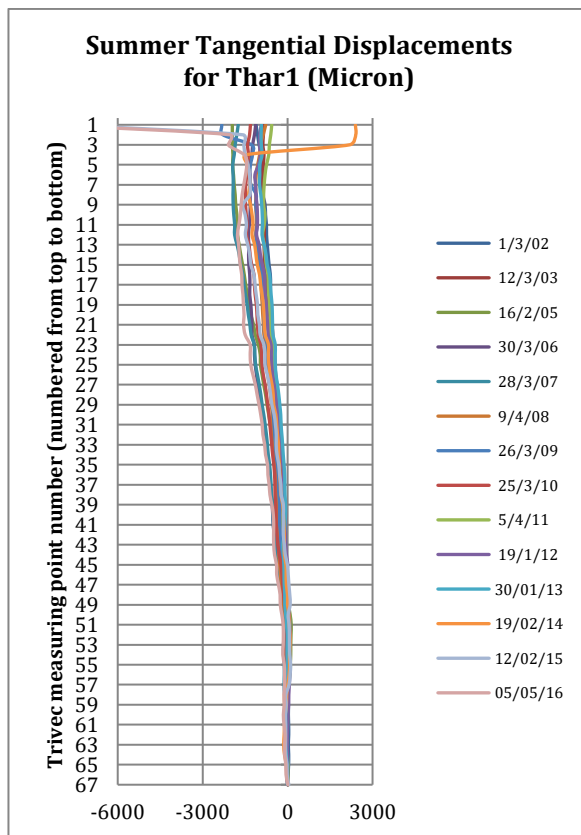
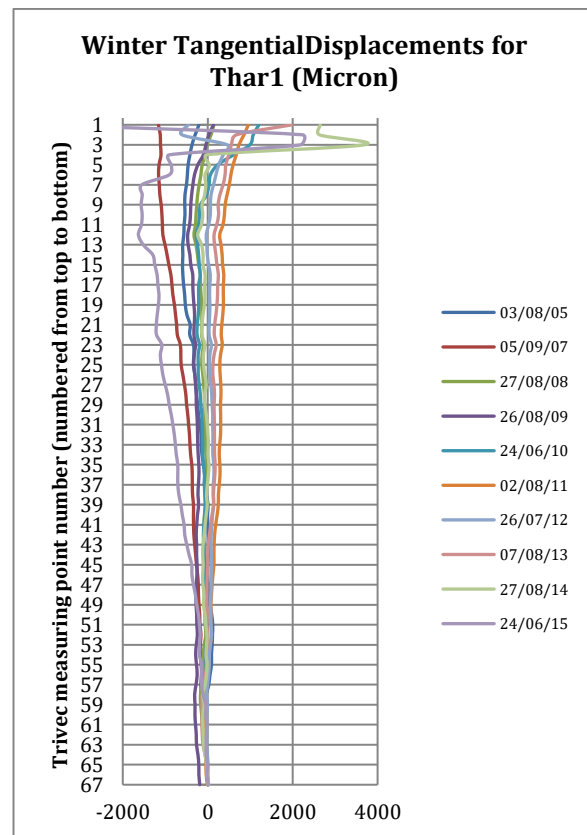
Figure 6-20: Summer tangential displacements of Trivec borehole Thar1

Figure 6-21: Winter tangential displacements of Trivec borehole Thar1

The tangential movements show a slight but definite trend of displacement toward the right flank relative to the base date, which become more exaggerated in the upper parts of the dam wall. A permanent displacement towards the right flank of approximately 2 mm can be observed at the crest since the base date (see Figure 6-20 and Figure 6-21).

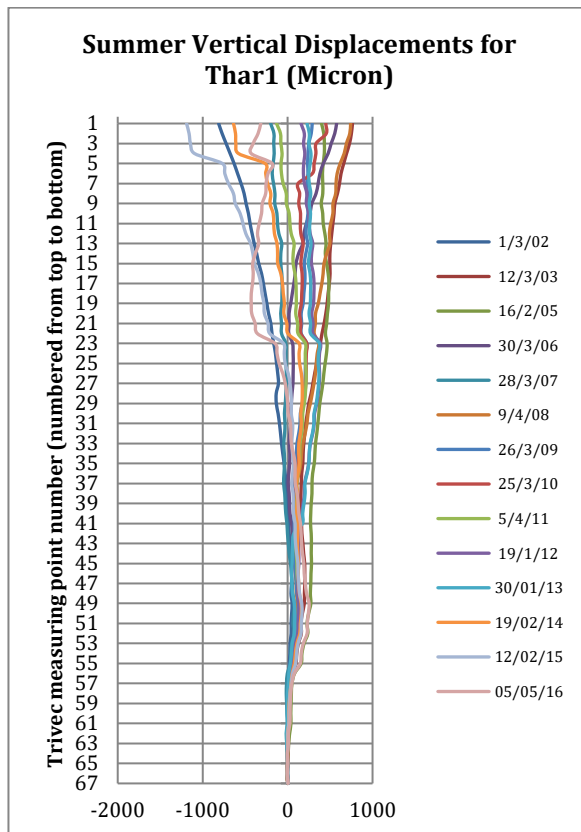
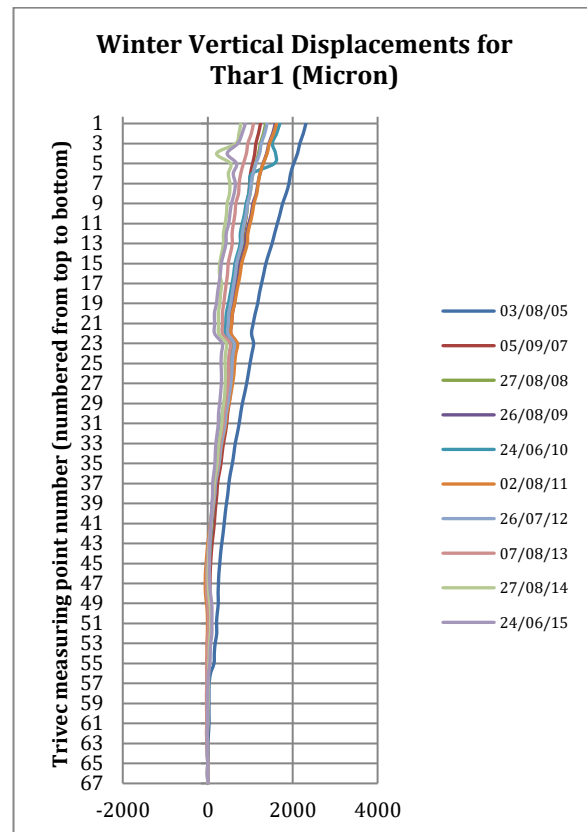
Figure 6-22: Summer vertical displacements of Trivec borehole Thar1

Figure 6-23: Winter vertical displacements of Trivec borehole Thar1

The vertical movements show a slight trend of rising elevations relative to the base date, and movements are more exaggerated in the upper parts of the dam wall. A permanent rise in elevation of approximately 0.5 mm can be observed at the crest since the base date (see Figure 6-22 and Figure 6-23).

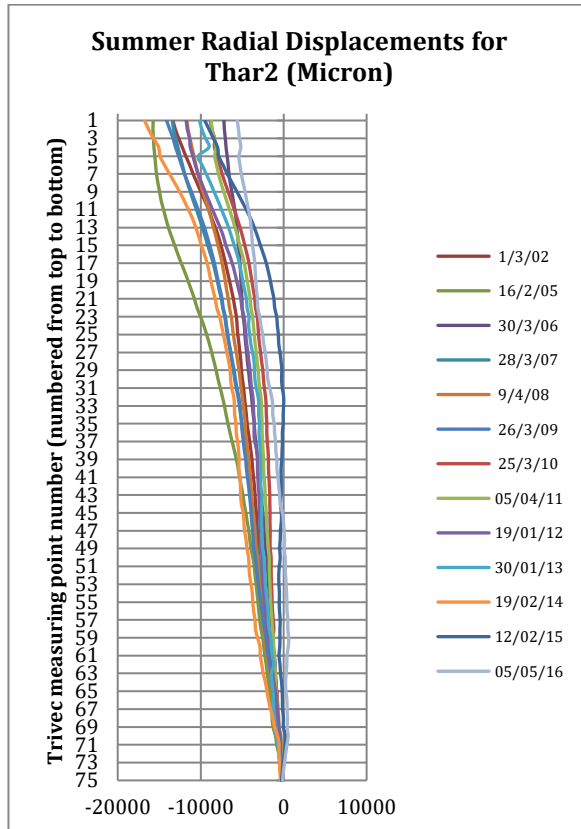
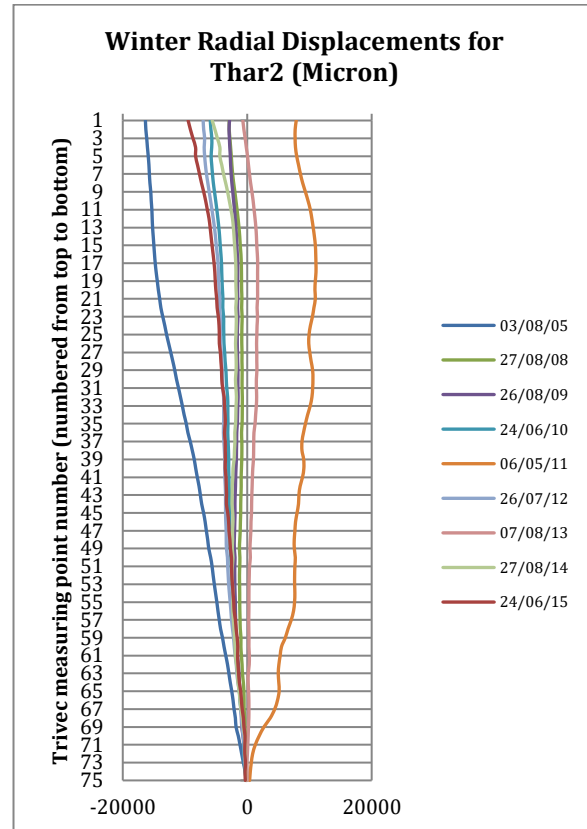
Figure 6-24: Summer radial displacements of Trivec borehole Thar2

Figure 6-25: Winter radial displacements of Trivec borehole Thar2

The radial movements show a very slight downstream trend since 2002 especially in the upper parts of the dam wall. A permanent downstream displacement of approximately 2.5 mm can be observed at the crest since 2002 (see Figure 6-24 and Figure 6-25).

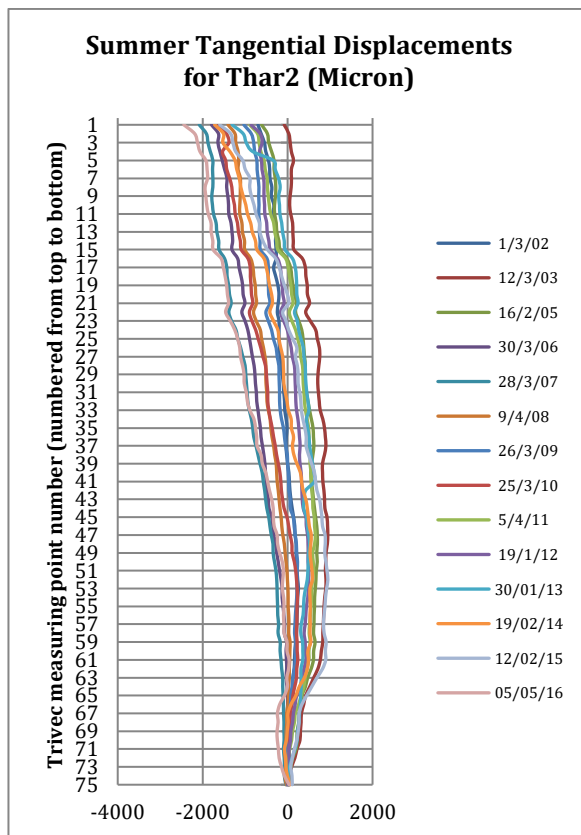
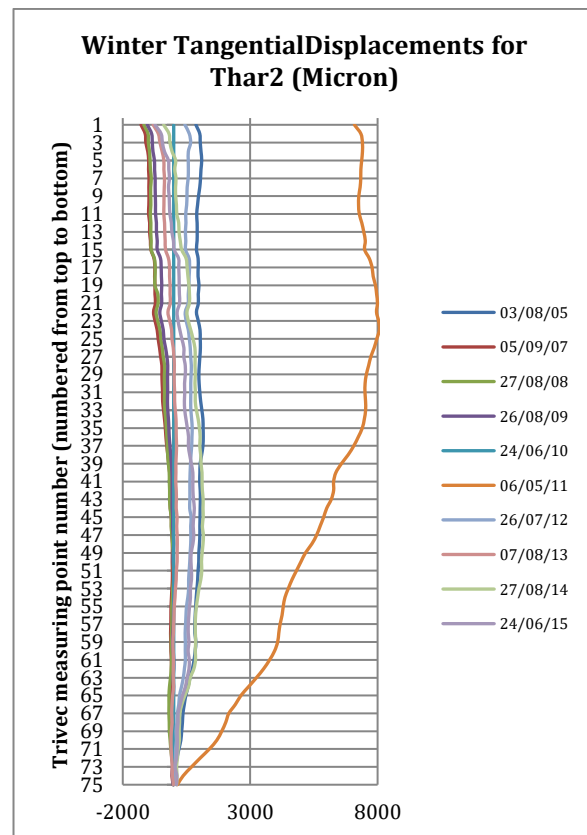
Figure 6-26: Summer tangential displacements of Trivec borehole Thar2

Figure 6-27: Winter tangential displacements of Trivec borehole Thar2

The tangential movements show a very slight trend of displacement towards the right flank relative to the base date, which become more exaggerated in the upper parts of the dam wall. A permanent displacement towards the right flank of approximately 1 mm can be observed at the crest since the base date (see Figure 6-26 and Figure 6-27).

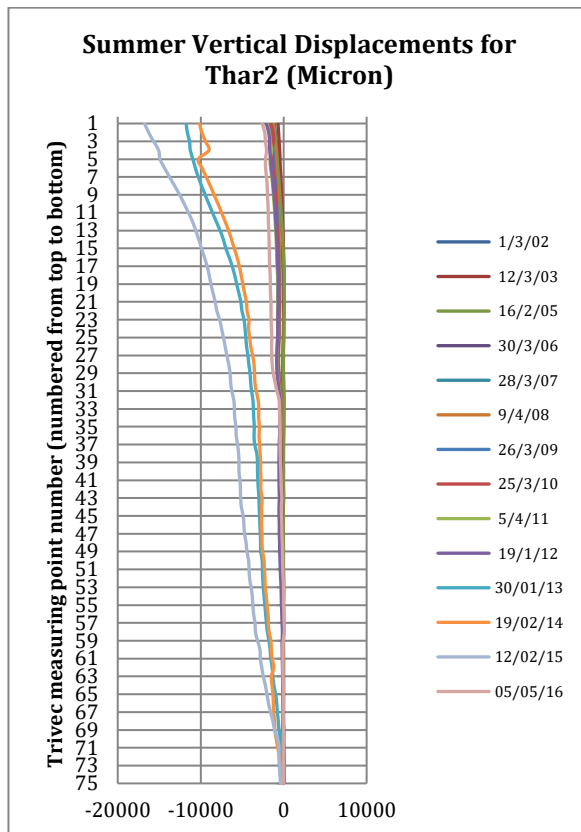
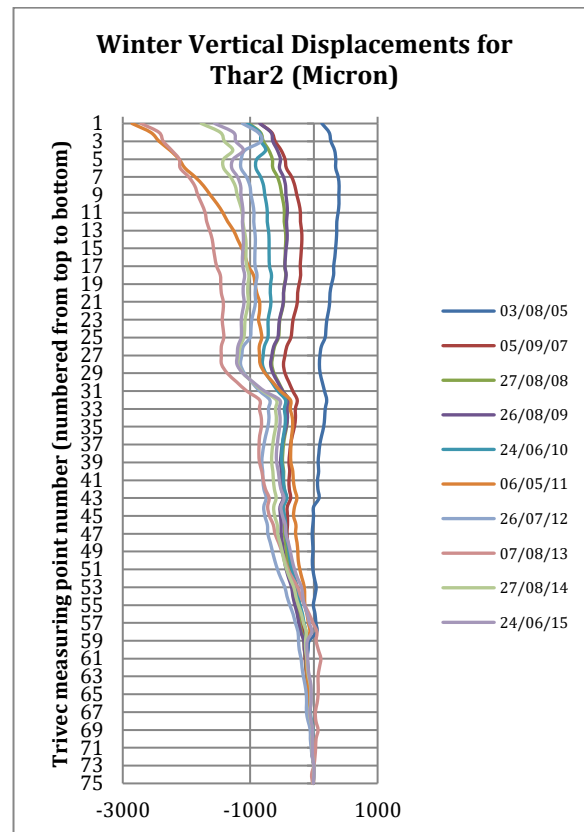
Figure 6-28: Summer vertical displacements of Trivec borehole Thar2

Figure 6-29: Winter vertical displacements of Trivec borehole Thar2

The vertical movements show a definite trend of rising elevations relative to the base date, and movements are more exaggerated in the upper parts of the dam wall. A permanent rise in elevation of approximately 2 mm can be observed at the crest since the base date (see Figure 6-28 and Figure 6-29).

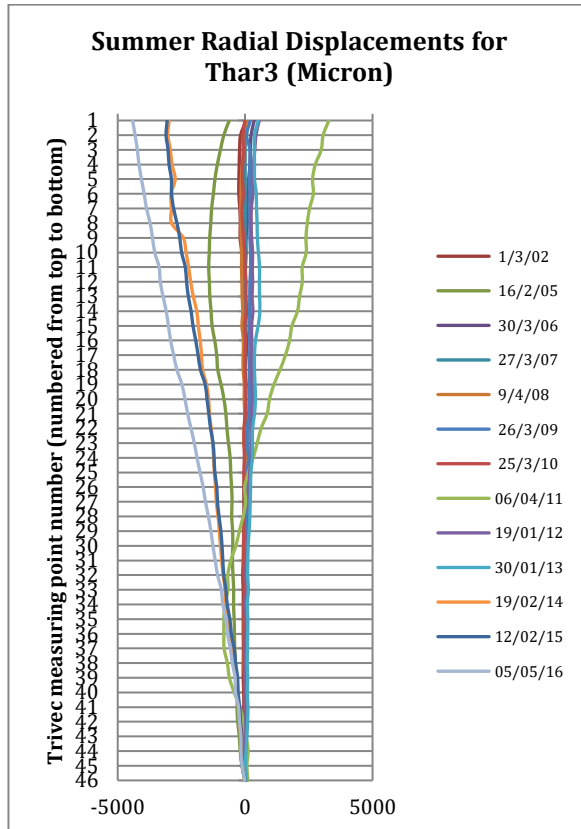
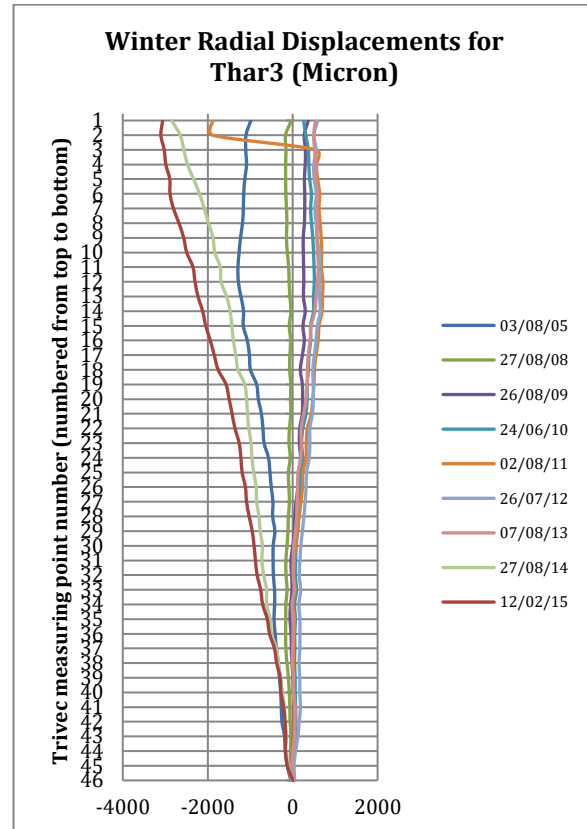
Figure 6-30: Summer radial displacements of Trivec borehole Thar3

Figure 6-31: Winter radial displacements of Trivec borehole Thar3

The radial movements show an upstream displacement trend relative to 2002, especially in the upper parts of the dam wall. A permanent upstream displacement of approximately 3 mm can be observed at the crest since 2002 (see Figure 6-30 and Figure 6-31).

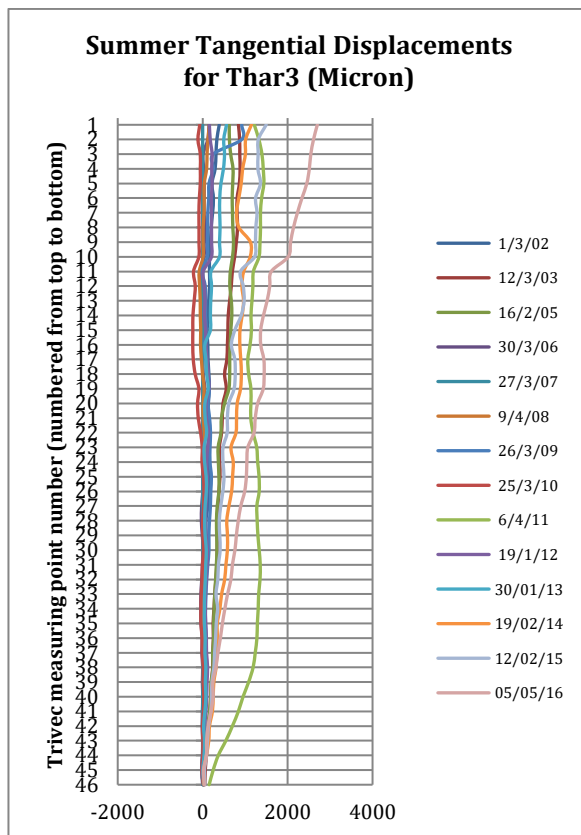
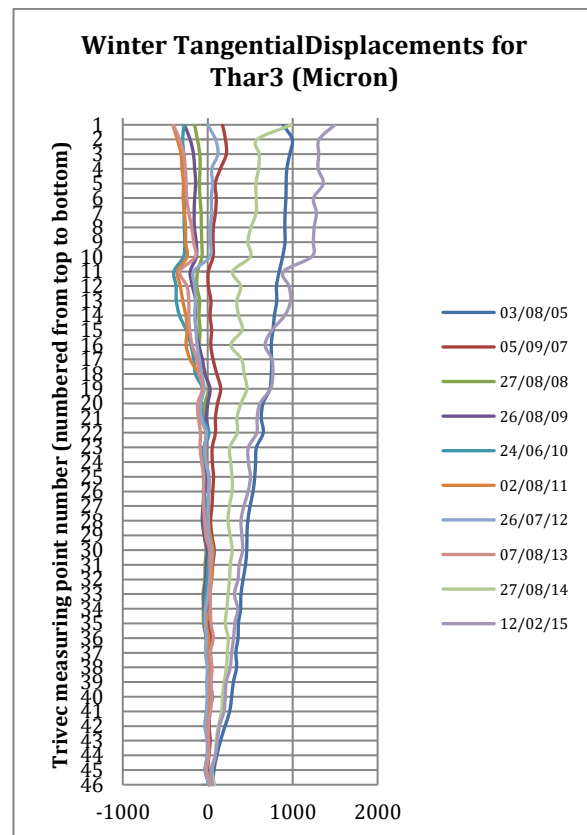
Figure 6-32: Summer tangential displacements of Trivec borehole Thar3

Figure 6-33: Winter tangential displacements of Trivec borehole Thar3

The tangential movements show a very slight trend of displacement towards the left flank relative to the base date, which become more exaggerated in the upper parts of the dam wall. A permanent displacement towards the left flank of approximately 1 mm can be observed at the crest since the base date (see Figure 6-32 and Figure 6-33).

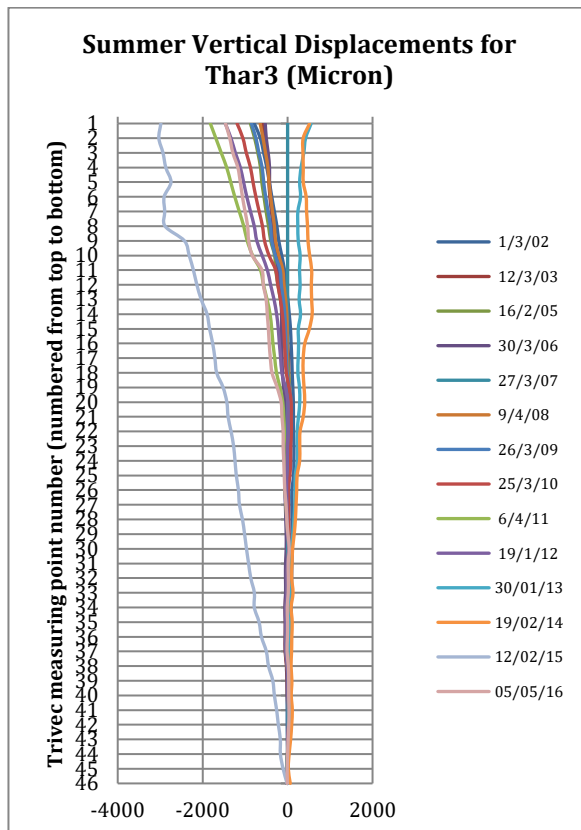
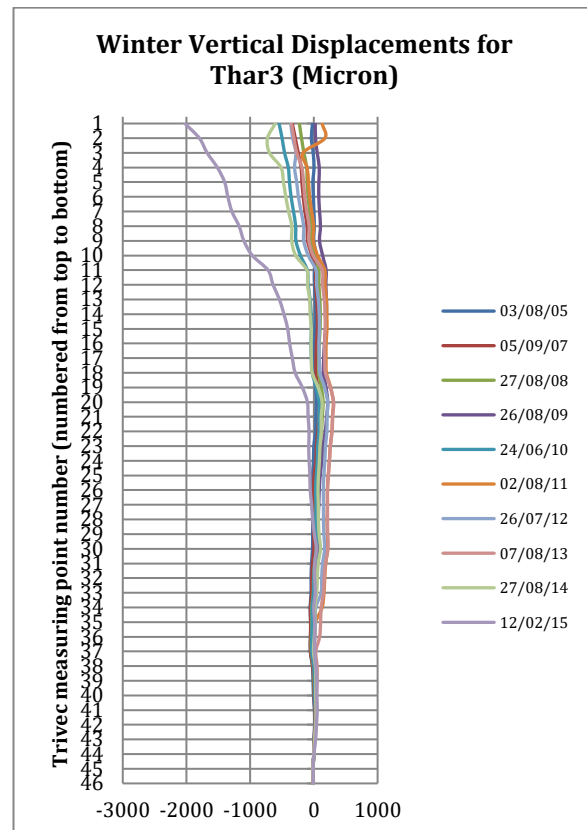
Figure 6-34: Summer vertical displacements of Trivec borehole Thar3

Figure 6-35: Winter vertical displacements of Trivec borehole Thar3

The vertical movements show a definite trend of rising elevations relative to the base date, and movements are more exaggerated in the upper parts of the dam wall. A permanent rise in elevation of approximately 1.5 mm can be observed at the crest since the base date (see Figure 6-34 and Figure 6-35).

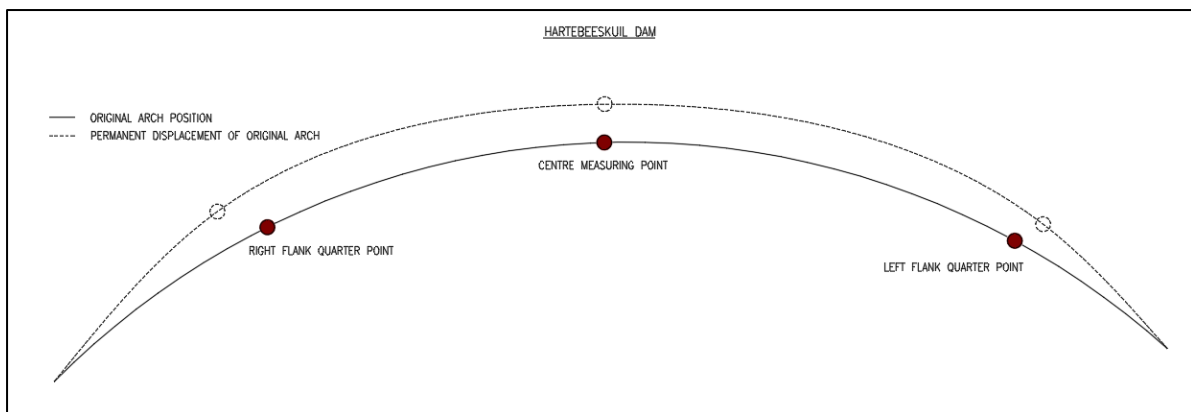
Figure 7-1: Schematic of permanent x-y displacement of Hartebeeskuil Dam

The permanent displacement and strain rates are all low, which may suggest that the AAR in the concrete has been happening at a slow rate. The vertical strain rates suggest that expansion only occurs in the centre of the dam. The entire arch has drifted upstream at a slow rate and the tangential strain rates suggest expansion in the direction of the abutments.

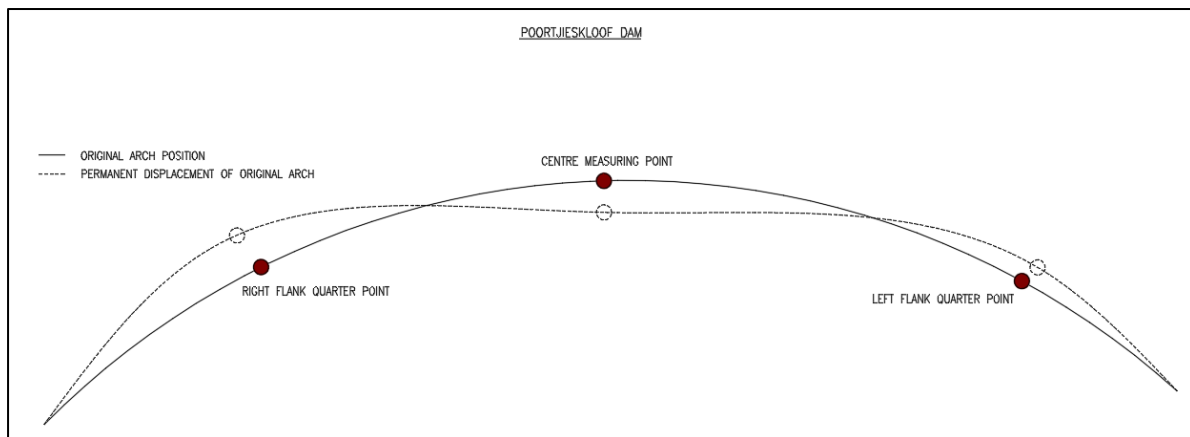
Figure 7-2: Schematic of permanent x-y displacement of Poortjieskloof Dam

The largest average annual strain rates are in the vertical direction. Generally, this is due to the fact that the concrete is mostly unrestrained in this direction, except at the interface with the abutments. As can be expected, the vertical strain rates increase towards the centre of the dam. Upstream drift is only evident at the flanks, but the centre of the dam has moved in a downstream direction. The tangential strain rates suggest expansion in the direction of the abutments.

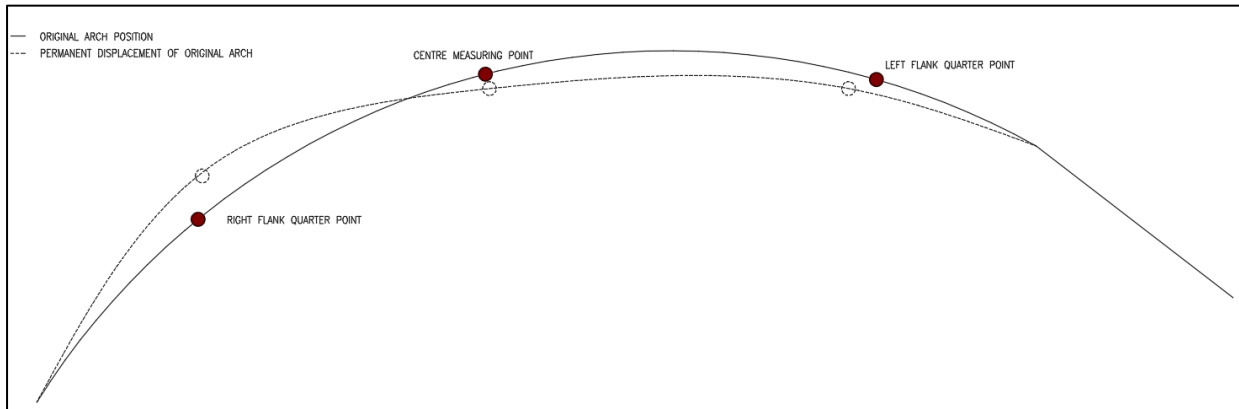
Figure 7-3: Schematic of permanent x-y displacement of Thabina Dam

The largest average annual strain rates are in the vertical direction. Generally, this is due to the fact that the concrete is mostly unrestrained in this direction, except at the interface with the abutments. As can be expected, the vertical strain rates increase towards the centre of the dam. Upstream drift is only evident at the right flank quarter point, but the centre of the dam and the left flank has moved in a downstream direction. The tangential movements show that the right and left flank have moved towards each other.

More recently, there seems to be a distinct increase in the average strain rates at Thabina Dam (refer to Table 7-4 which shows strain rates since 2010). It is possible that these increased strain rates are caused by AAR. However, experimental tests and further field observations will have to be performed to confirm this.
