CIV5017Z: MINOR DISSERTATION FOR THE DEGREE OF MASTER OF
ENGINEERING

An Analysis of the Impact of Chloride-Induced Corrosion on Reinforced Concrete Structures in the Port of Cape Town

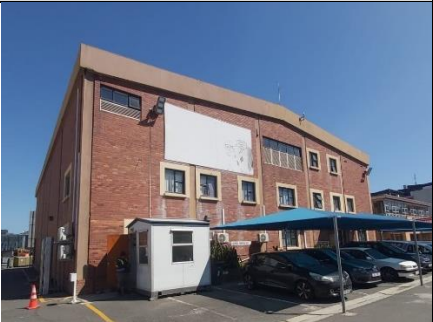
Structure name	Electrical Workshop		Structure type	Building		
Structure Location	33°54'39.46"S 18°25'29.02"E		Built	1967		
Assessment date	12/09/2023		Exposure	XS3a		
Type of member		Pictures		Description	Ratings	
Column North

Generally in a good condition with no visible rust staining and spalling.	Effects of corrosion	1
					Pop Outs	1
					Spalling	1
Column East				Generally in a good condition with no visible rust staining and spalling.	Effects of corrosion	1
					Pop Outs	1
					Spalling	1

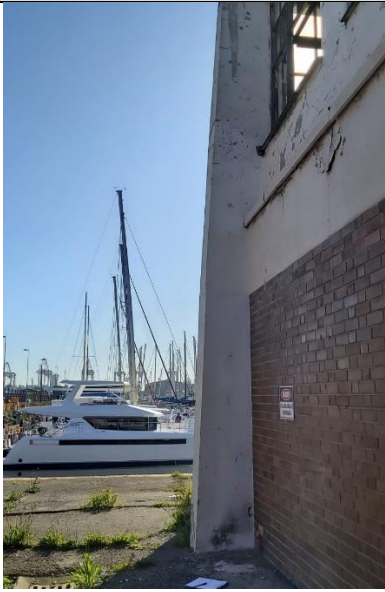
Structure name	Unitie Building	Structure type	Building		
Structure Location	33°55'12.89"S 18°26'29.29"E	Built	1977		
Assessment date	13/09/2023	Exposure	XS3a		
Type of member	Pictures		Description	Ratings	
Column East

Generally in a good condition with no visible rust staining or spalling.	Effects of corrosion	1
				Pop Outs	1
				Spalling	1
Column West

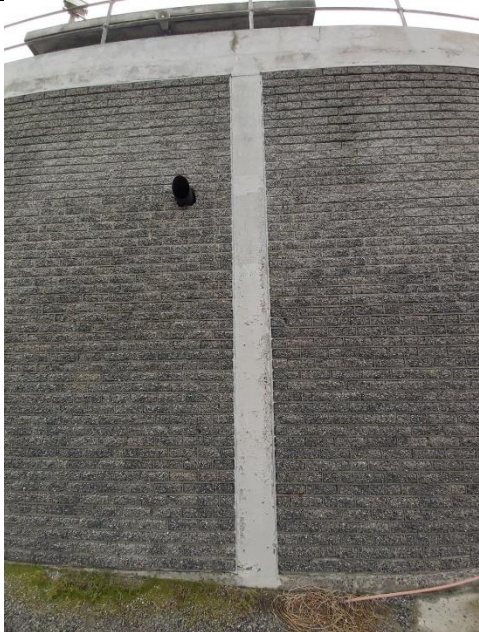
Generally in a good condition. No visual evidence of rust staining and spalling.	Effects of corrosion	1
				Pop Outs	1
				Spalling	1

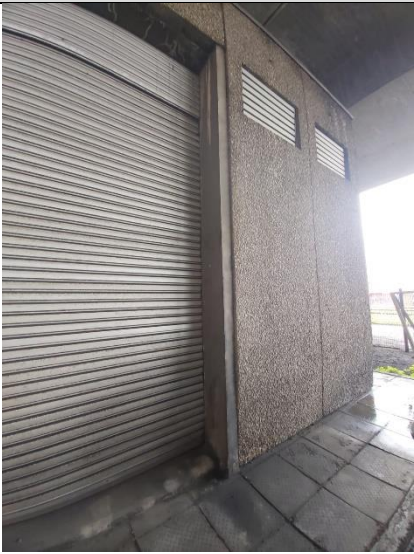
Generally in a good condition. No visible signs of spalling or rust staining.	Effects of corrosion	1
				Pop Outs	1
				Spalling	1
Column South

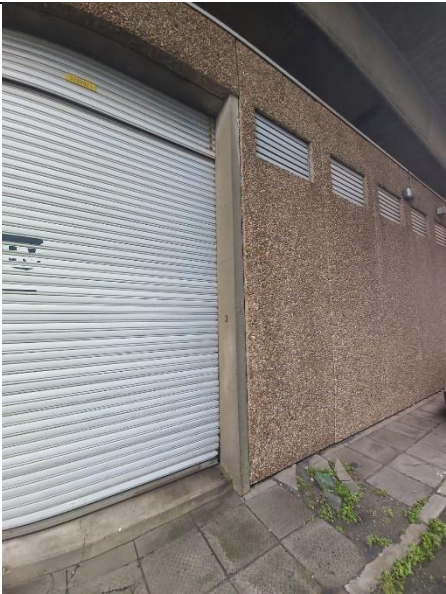
Generally in a good condition. No visible signs of spalling or rust staining.	Effects of corrosion	1
				Pop Outs	1
				Spalling	1

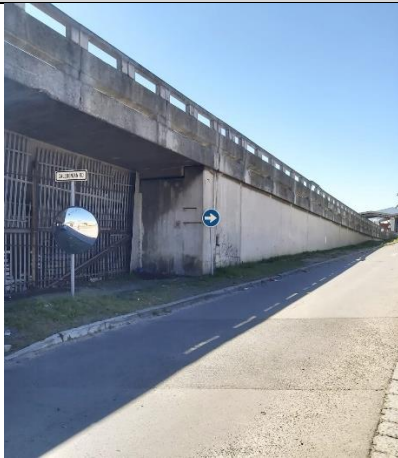
Generally in a good condition with no visible spalling and rust staining.	Effects of corrosion	1
				Pop Outs	1
				Spalling	1
Column

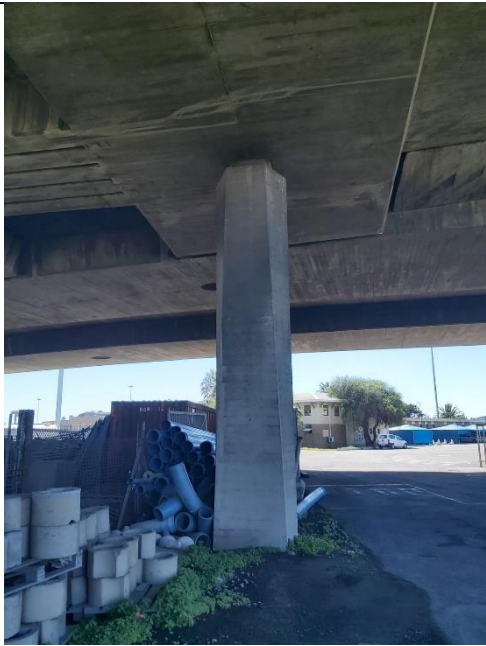
Generally in a good condition with no visible spalling and rust staining.	Effects of corrosion	1
				Pop Outs	1
				Spalling	1

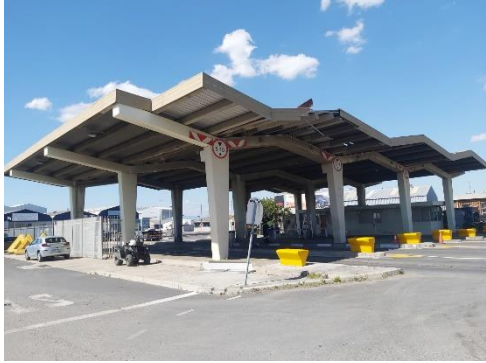
Generally in a good condition with no visible signs of spalling and rust staining.	Effects of corrosion	1
				Pop Outs	1
				Spalling	1
Column			Generally in a good condition with no visible signs of spalling and rust staining.	Effects of corrosion	1
	Pop Outs	1			
	Spalling	1
